N/A, IL Inspection prepared for: John Smith Date of Inspection: 6/15/2015 Age of Home: 1988 Sample report

> Inspector: Michael Doetsch License #450.000363 Barrington, IL Phone: 847-381-7210 Email: inspect@mc.net www.inspkt.com

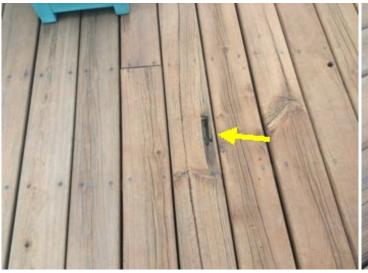
Evidence of wood deterioration observed.

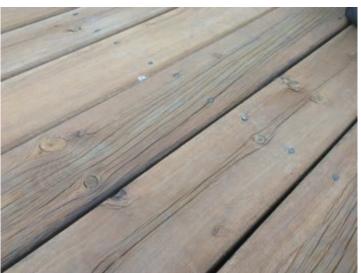
Evidence of nails/screws popping on the deck boards.

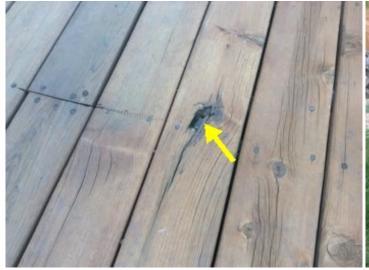
Evidence of wood deterioration observed.

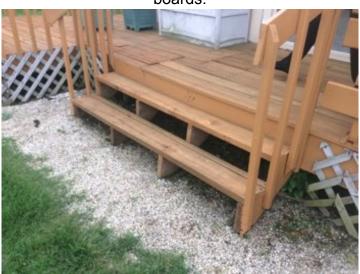
Deck does not appear to properly supported and needs repair.

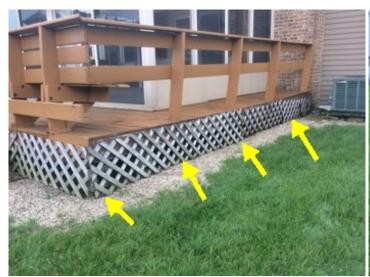
Deck does not appear to properly supported and needs repair.

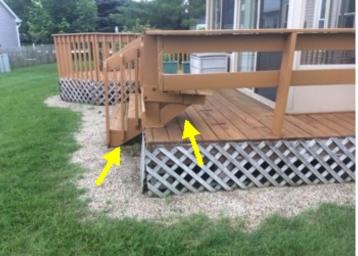
Unevenness of deck indicates the possibility of frost heaving.

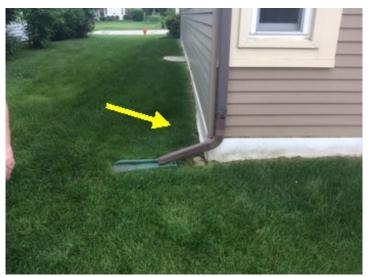
Flat and negative grade at foundation should be regraded.

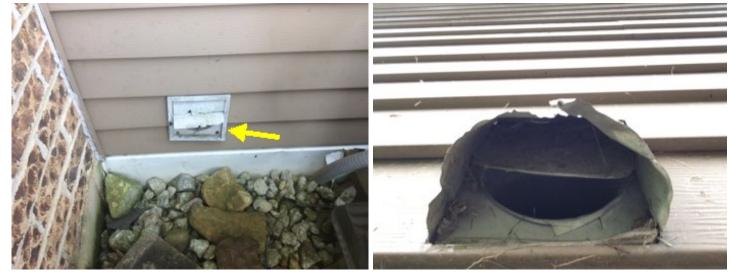
Damaged vanes on vent jack need repair.

Damaged vent jack needs repair.

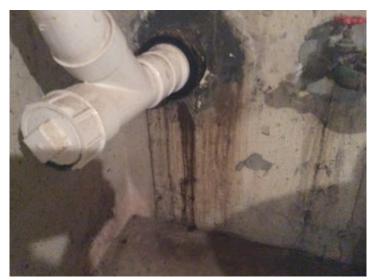
Evidence of seepage stains on foundation wall.

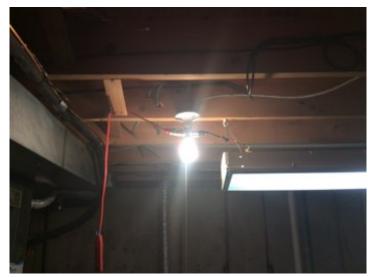
Evidence of amateur wiring noted.

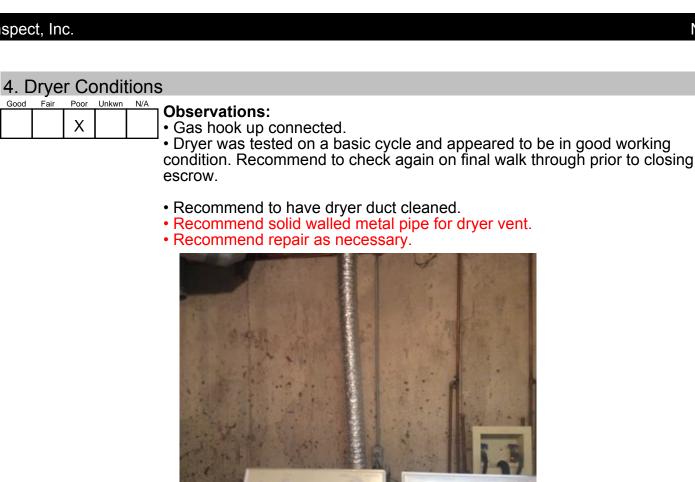
Recommend solid walled metal pipe for dryer vent.

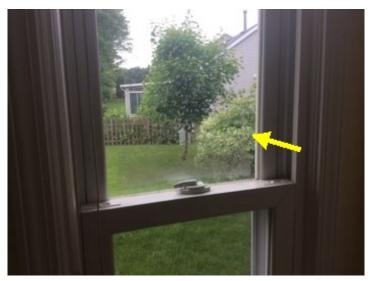
Lost seal in master bedroom.

• Recommend review by a qualified professional for repair or replacement as necessary.

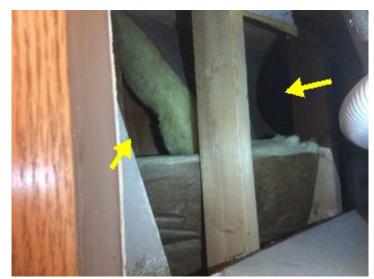
Missing insulation on outside wall under whirlpool tub.
