Keystone Home Inspections

Property Inspection Report

123 Main Street, Kokomo, IN 46901
Inspection prepared for: Sam Samples
Date of Inspection: 6/13/2014 Time: 9:00a
Age of Home: 44 Size: 5070
Weather: Sunny, 75

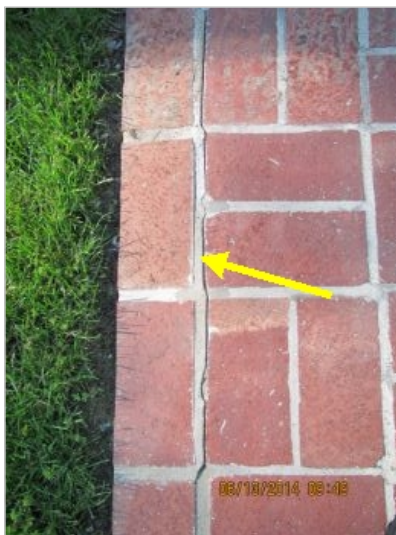
- Home walkways were constructed of brick.
- The Inspector observed few deficiencies of the walkways at the time of the inspection. Notable exceptions will be listed in this report.

Loose bricks on walkway to breezeway

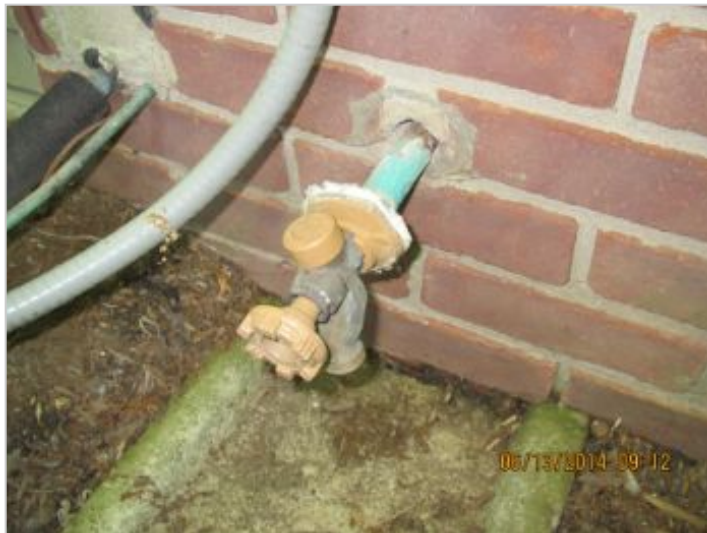
- An exterior faucet at the right side of the house was not properly attached. This condition should be corrected to avoid damage to the copper supply pipe.

Exterior hose bib detached from house

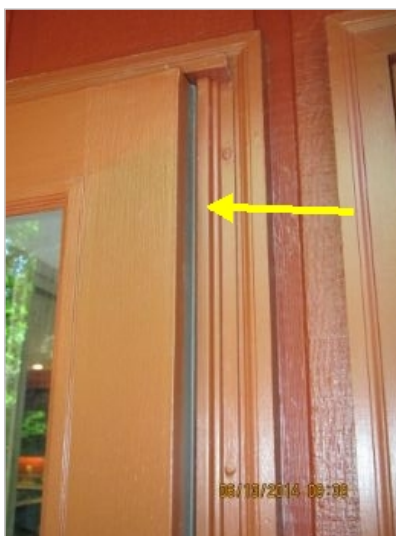
- The Inspector observed few deficiencies of door exteriors at the time of the inspection. Notable exceptions will be listed in this report. Inspection of door exteriors typically includes examination of the following:
 - Door exterior surface condition
 - Weather-stripping condition
 - Presence of an effective sweep (sweeps are gaskets which seal the area between the bottom of a door and the threshold).
 - Jamb condition
 - Threshold condition
 - Moisture-intrusion integrity
- Exterior storm door at rear of house breezeway had mis-aligned frame.

Mis-aligned frame on storm door makes it difficult to close.

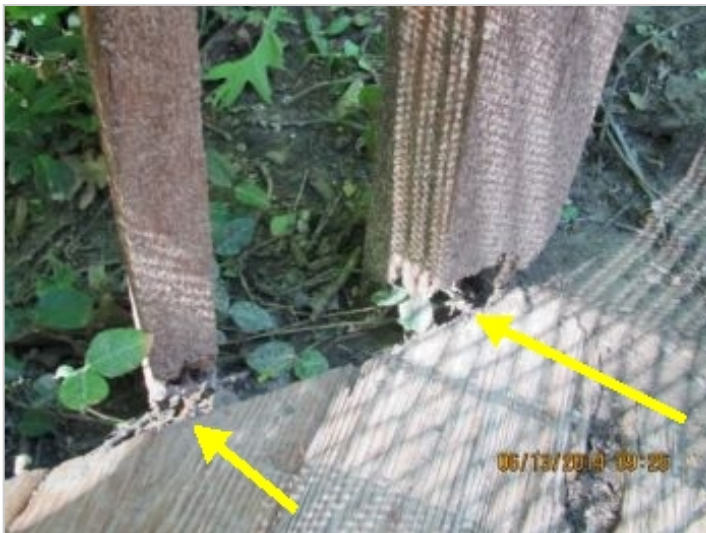
- Deck guardrail assemblies were loose and should be made secure by a qualified contractor.
- Post(s) supporting the deck guardrail assembly were loose and should be corrected by a qualified contractor.

Deck guardrail was severely rotted.

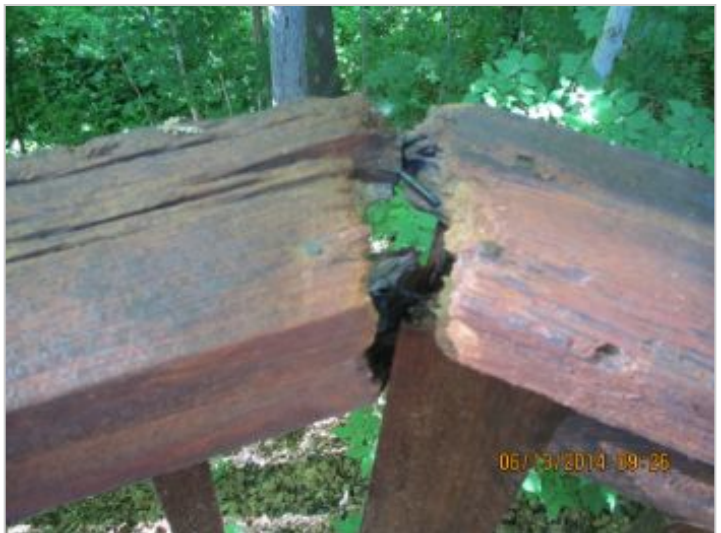
Deck guardrail was severely rotted.

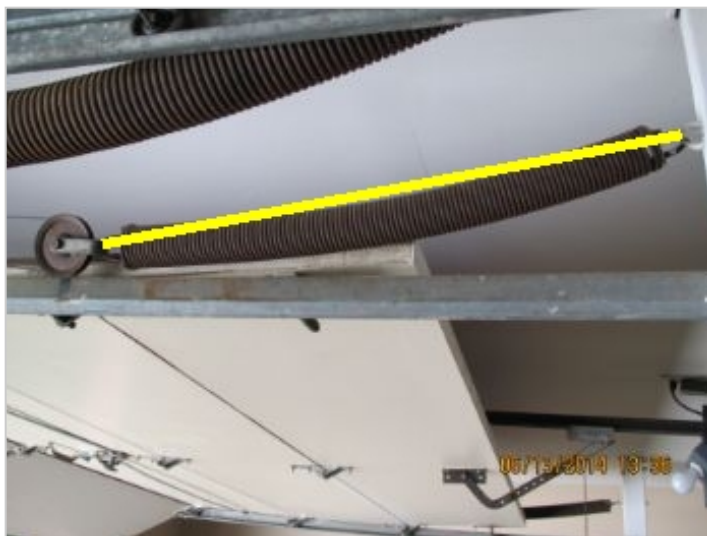
- Extension springs installed at the garage door did not have containment cables installed.
Extension springs should have containment cables installed to help prevent injury or death if a spring should break.
The Inspector recommends correction by a qualified contractor.

A containment cable should be installed in each of the extension springs

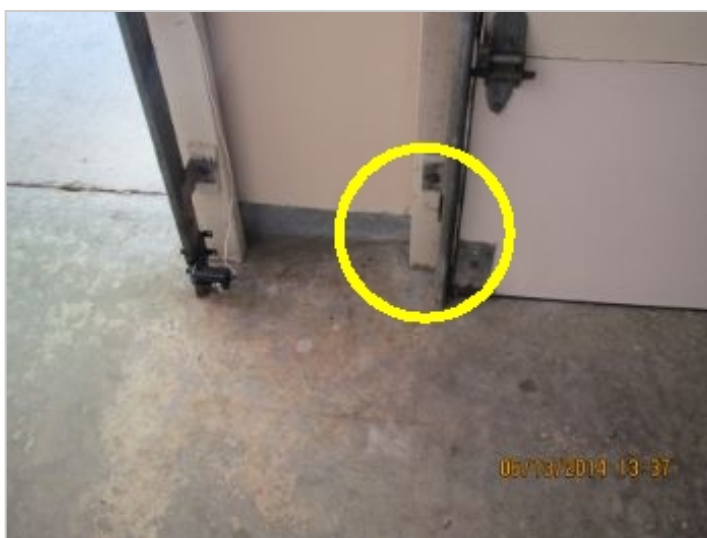
- The southern-most overhead garage door was not equipped with a photoelectric sensor. Photoelectric sensors are devices installed to prevent injury by raising the vehicle door if the sensor detects a person on a position in which they may be injured by the descending door. Installation of photo sensors in new homes has been required by building codes since 1993. Although the general home inspection is not a building code compliance inspection, the Inspector recommends installation of a photo sensor by a qualified contractor or technician for safety reasons.

One of the three openers did not have a photo sensor.

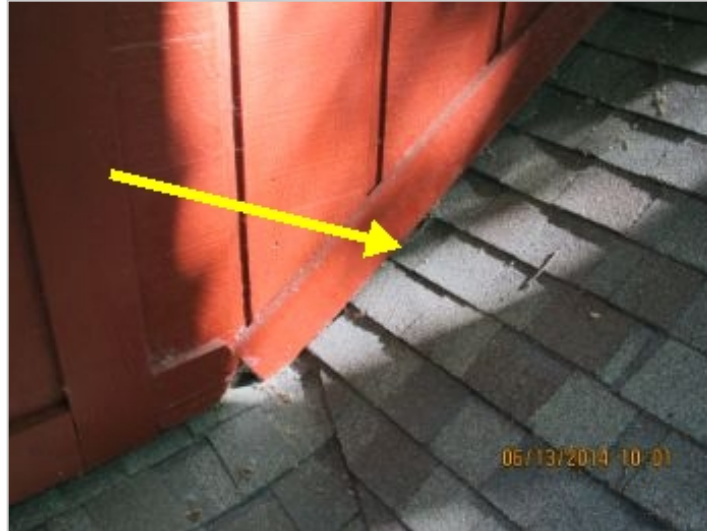
- Most sidewall junction appeared to be properly installed where required and in serviceable condition at the time of the inspection. Notable exceptions will be listed in this report.
- Siding was installed too close to the roof-covering material. Good building practice requires a gap of 1.5 inches minimum between the bottom of siding and the top of the roof.

Because this gap is small, debris accumulation could cause siding to rot. It is important to keep roof areas clean - especially with the large number of trees on this property.

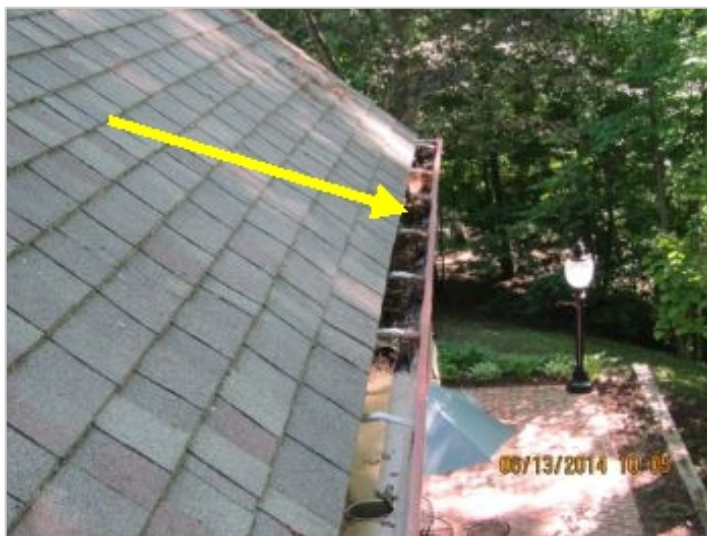
- Debris visible in the gutters at the time of the inspection should be removed to encourage proper drainage.

Some debris in gutter

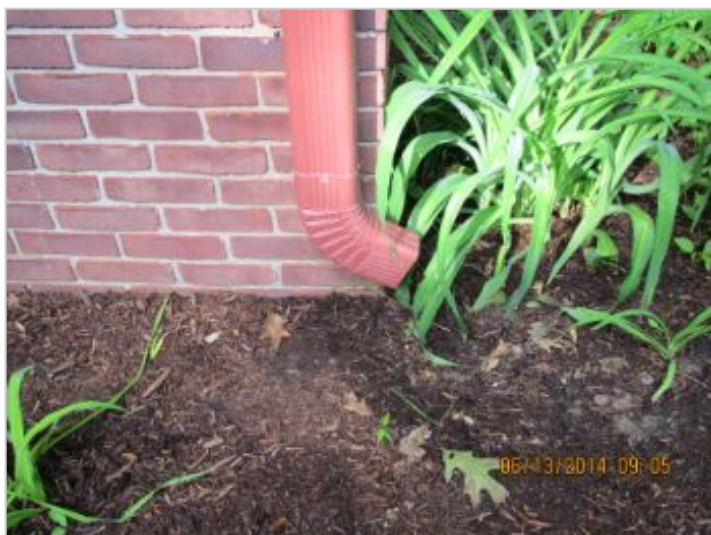
- One or more downspouts discharged roof drainage next to the foundation. This condition can cause problems by saturating soil. Saturated soil may suffer reduced ability to bear the weight of the structure above. If expansive soils exist near the foundation, elevated moisture levels can cause soil movement capable of damaging foundations. The Inspector recommends the addition of a downspout extension to discharge roof drainage a minimum of 6 feet from the foundation.
- Some downspouts appeared to be clogged with debris and should be cleared to encourage proper roof drainage.
- Some downspouts discharge directly onto the roof below. While this situation is sometimes unavoidable, it should be noted that it will shorten the lifespan of the roofing materials.

One or more downspouts discharged roof drainage next to the foundation.

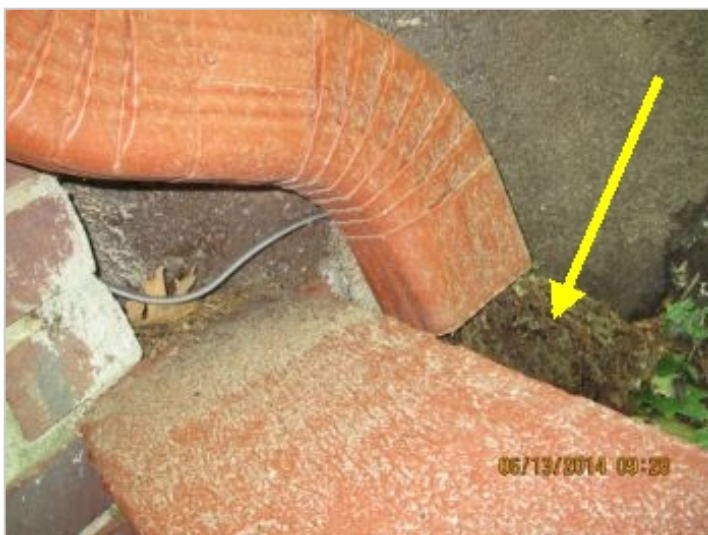
Some downspouts appeared to be clogged with debris.

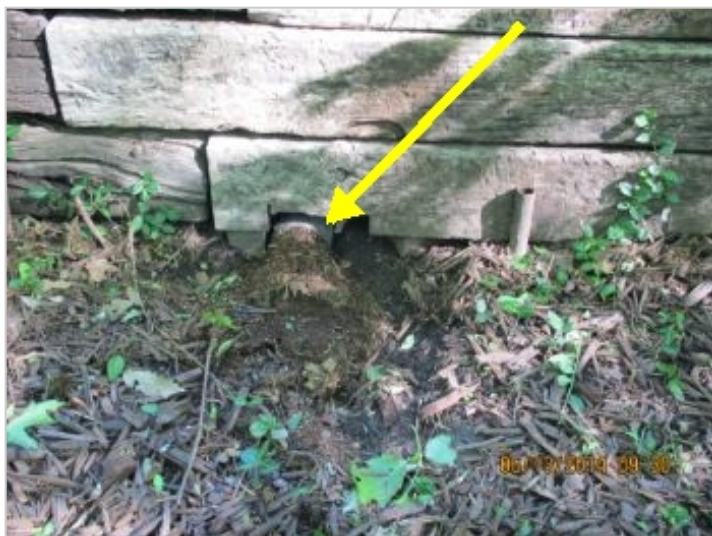
Some downspouts appeared to be clogged with debris.

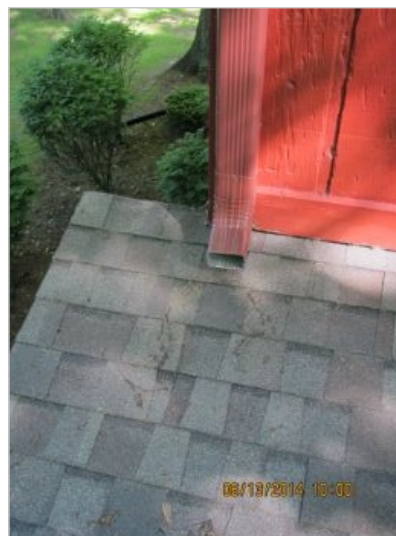
Some downspouts discharge directly onto the roof

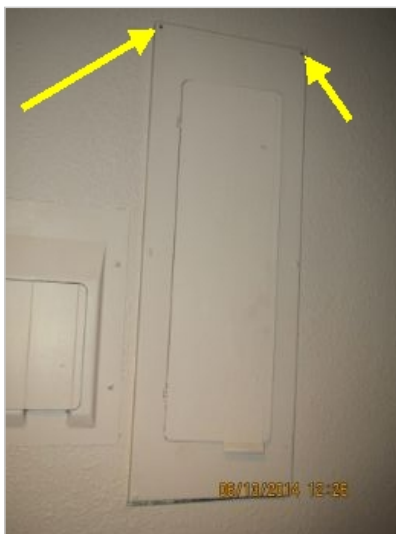
• The dead front cover of the service panel was missing screws at the time of the inspection. The Inspector recommends that appropriate screws be installed to securely attach the dead front cover.

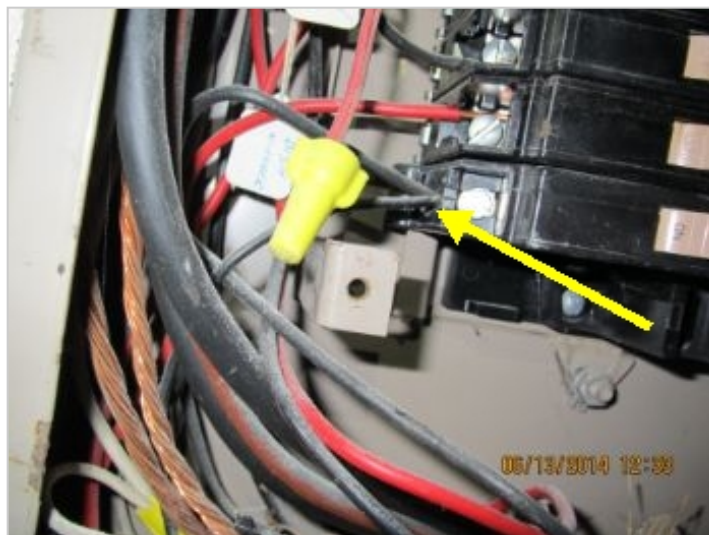
- Overcurrent protection of branch circuits was provided by circuit breakers.
- In the main electrical service panel, two wires were connected to a breaker designed for only one wire. This is known as a "double-tap" and is a defective condition which should be corrected by a qualified electrical contractor.

double tap on breaker

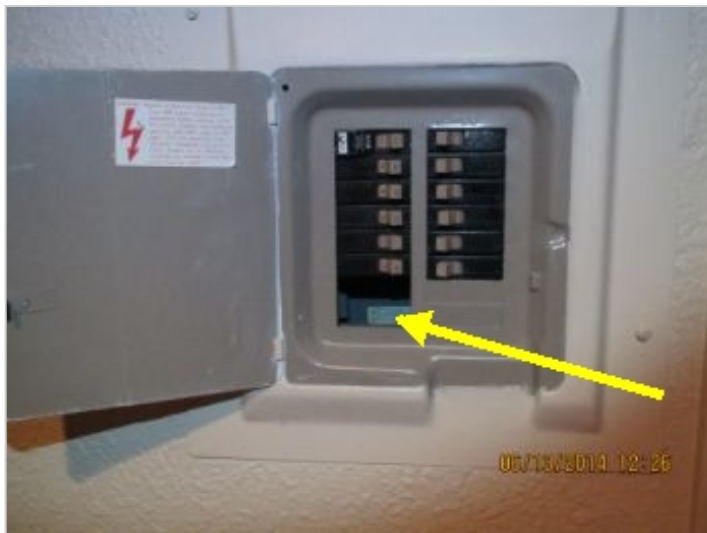
- Unfilled holes or knockouts in this distribution panel may allow persons to come into contact with energized electrical components. This condition is a potential shock/electrocution hazard and should be corrected by a qualified electrical contractor.

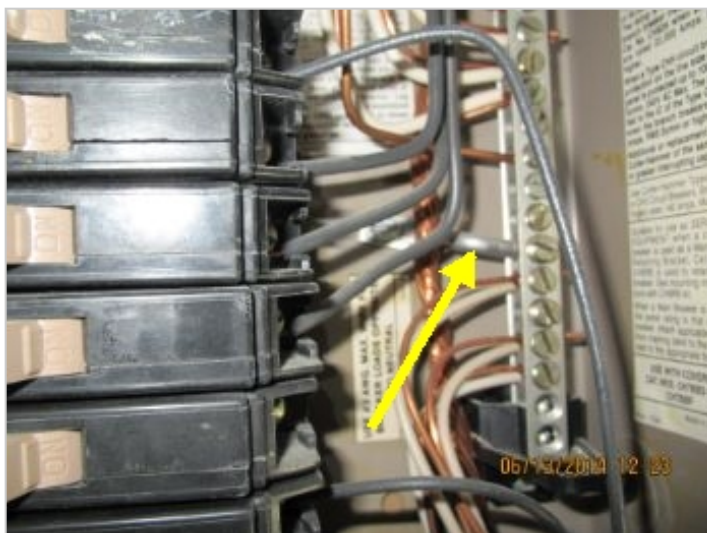
- This distribution panel had a neutral bus bar that was bonded to the metal panel enclosure. This condition is improper and is a potential electrical shock/electrocution hazard. The neutral bus bar should be electrically isolated from the enclosure. The inspector recommends correction by a qualified electrical contractor.

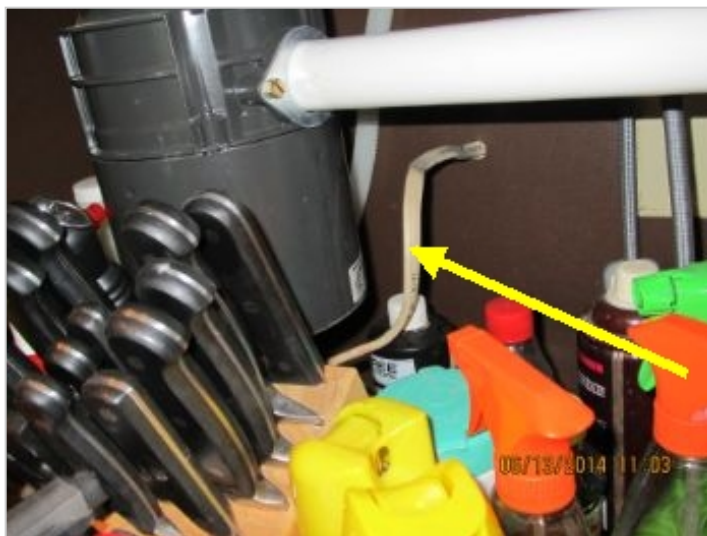
- The electrical connection to the garbage disposal was improper at the time of the inspection. The disposal should either be powered by an approved appliance cord plugged into a dedicated outlet or be wired directly to a main electrical or sub-panel, with properly spliced connections housed within a junction box with a cover installed, and electrical cable enclosed in conduit or armored flex. Corrections should be made by a qualified contractor.

Electrical wire should be in armored conduit

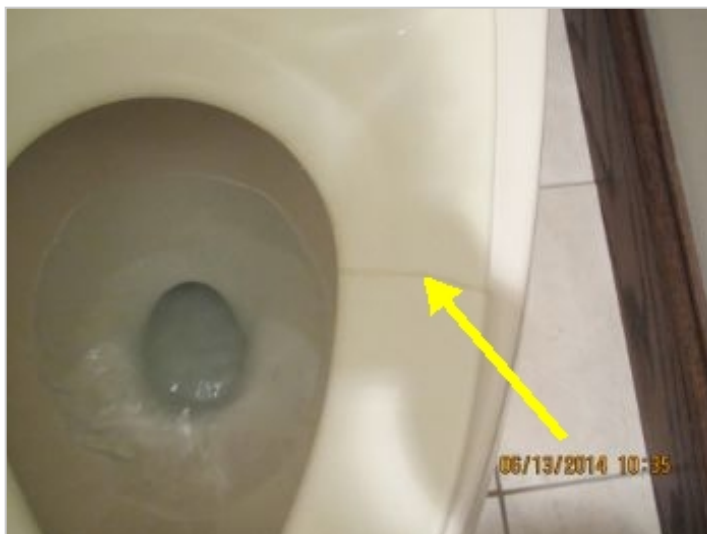
- In this bathroom, the toilet seat was damaged.

Cracked seat

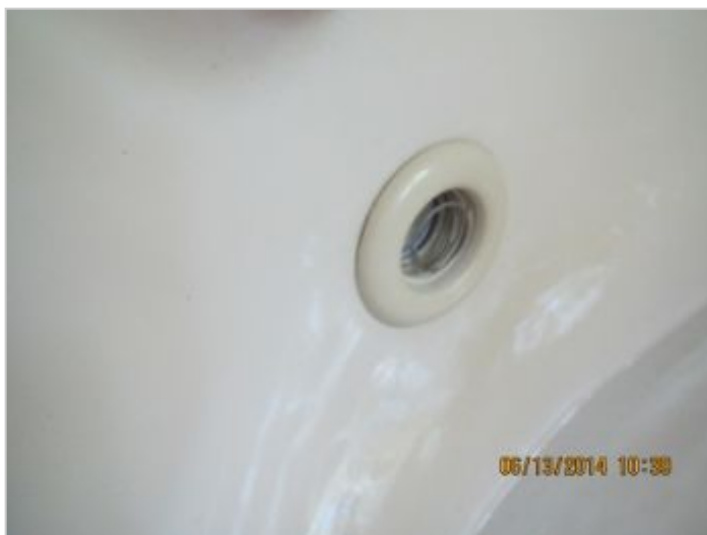
- No hatch was provided for access to the pump for the whirlpool tub. A hatch should be provided to allow for inspection, service and repair of tub, pump and electrical equipment.
- A jet nozzle was missing.
- Hot and cold water connections were reversed at the tub in this bathroom and should be corrected to prevent accidental scalding.
- The Inspector could not find the controls to check the operation of the jetted tub. Inspector recommends verifying location of controls and proper operation of jets prior to closing.

Missing jet nozzle

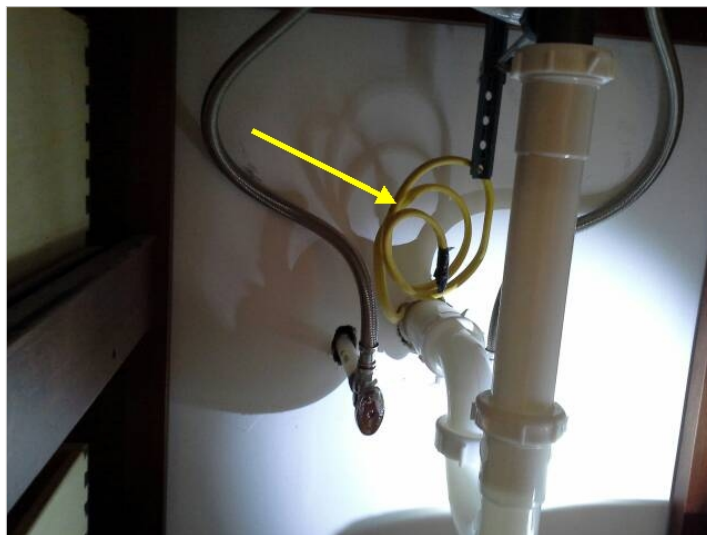
- An abandoned electrical wire was observed under the sink. This wire should be terminated in a junction box.

Loose wire under cabinet should terminate in junction box.

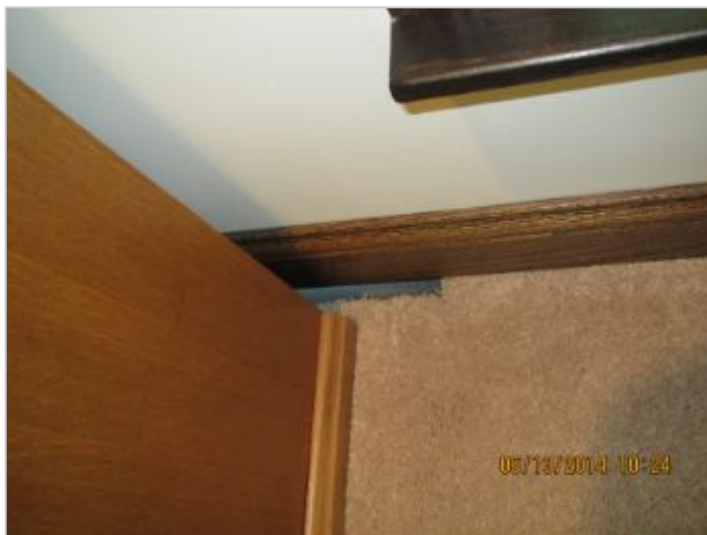
- A register cover in this bedroom was missing and should be replaced.

Registers missing in two places

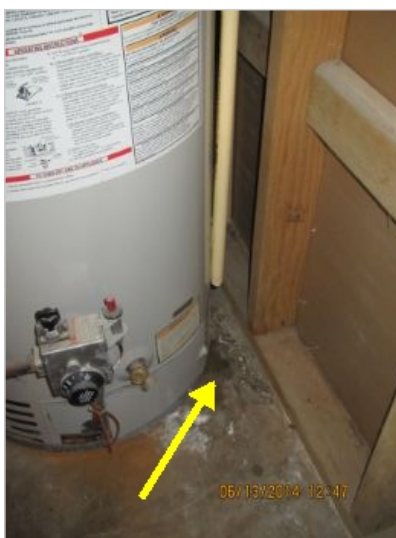
- The pressure relief valve was leaking at the time of the inspection and should be replaced by a qualified HVAC technician or plumbing contractor.

Small amount of leakage from TPR valve

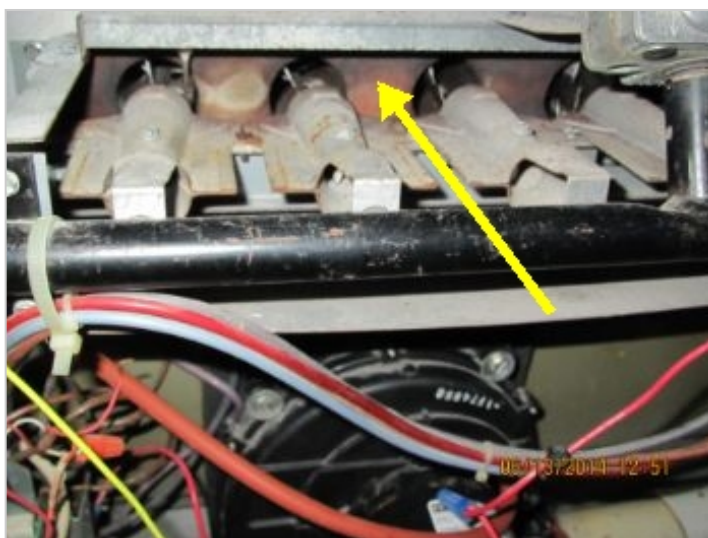
- Rust flakes on the furnace burner assembly may affect the burner function. The Inspector recommends service by a qualified heating service technician.

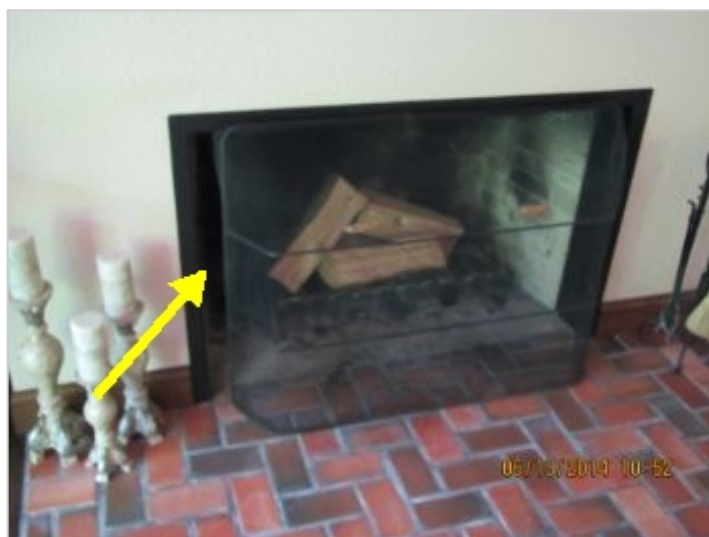
- The wood-burning fireplace in the living room had an ember barrier that was too small. This condition is a potential fire hazard as it may allow hot embers to be deposited on the combustible floor-covering material.

Ember barrier too narrow for fireplace opening

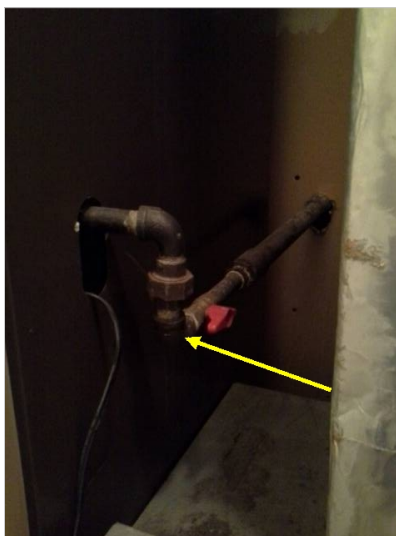
- The gas pipe supplying fuel to the furnace had no drip leg installed. Drip legs are designed to collect excessive moisture and particulates so that they don't enter the furnace gas valve. The inspector recommends that a drip leg be installed by a qualified plumbing contractor.

No drip leg on gas line

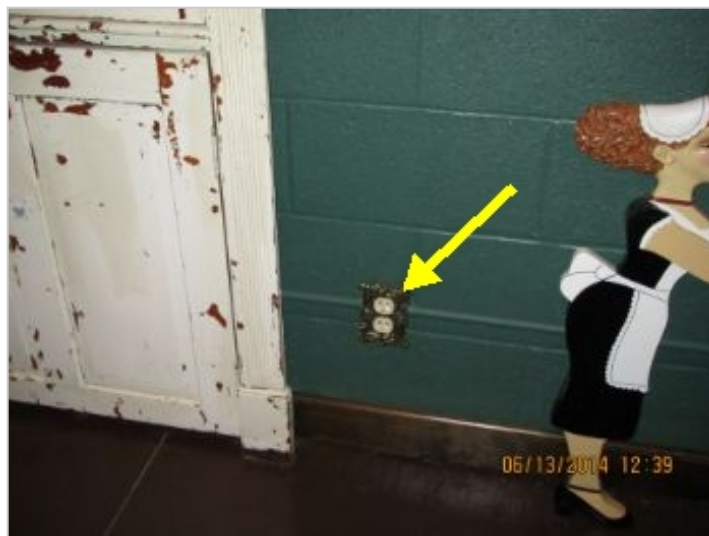
Consider adding GFCI protection of these outlets.

All basement outlets were non-GFCI

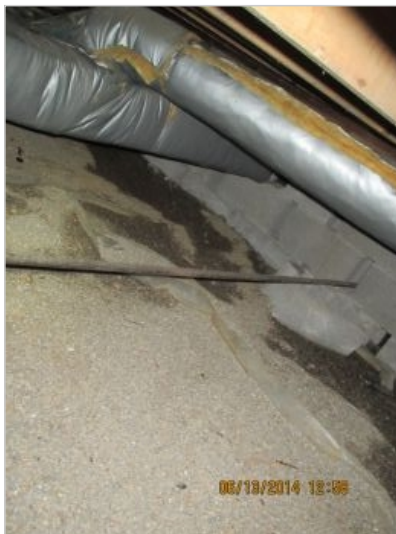
- Soil in the crawlspace was visibly damp or wet. This condition may be the result of rising ground water or may result from surface runoff seeping under and/or through the foundation walls. High moisture levels in soil beneath the foundation can effect its ability to support the weight of the structure above and may cause structural damage from soil movement. Moisture intrusion can also damage home materials and encourage the growth of microbes such as mold. The source of the moisture should be identified and the condition corrected.
