302 Ave B, Cloquet, MN 55720  
Inspection prepared for: Leigh Deppa  
Date of Inspection: 8/5/2014

## Coleman Home Inspections

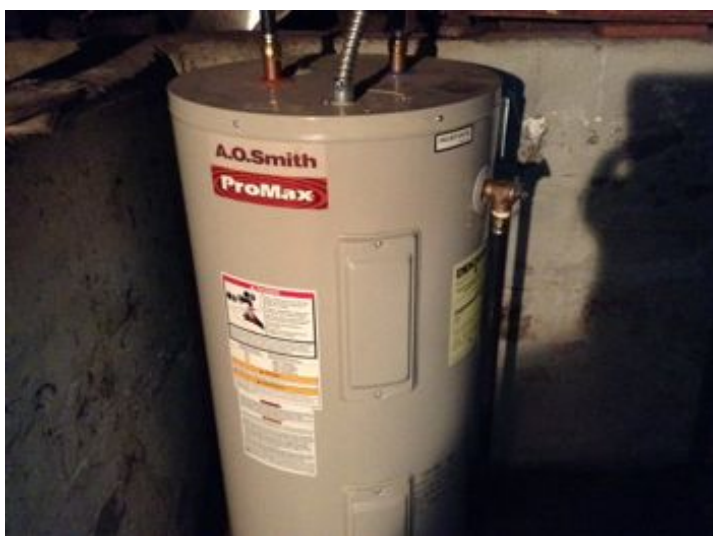
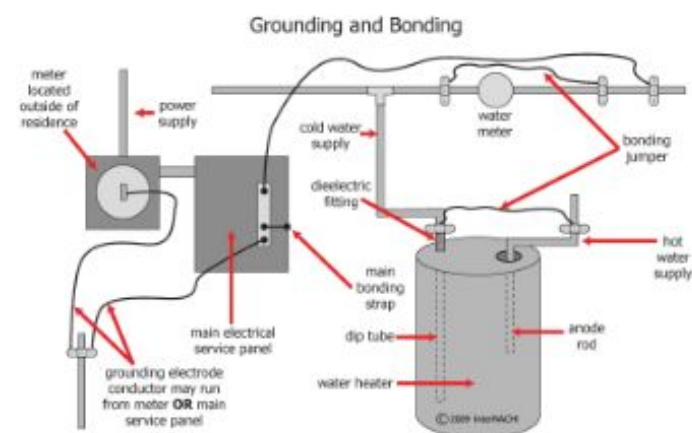
Page 22 Item: 3	Condition of Water Heater	<p>The Temperature Pressure Relief (TPR) valve discharge tube must be made out of metal piping and end no more than 6" from the floor.</p> <p>No electrical bonding is present between the hot and cold water lines on the water heater.</p>
-----------------	---------------------------	--

Note the bonding jumper placement on the hot water heater

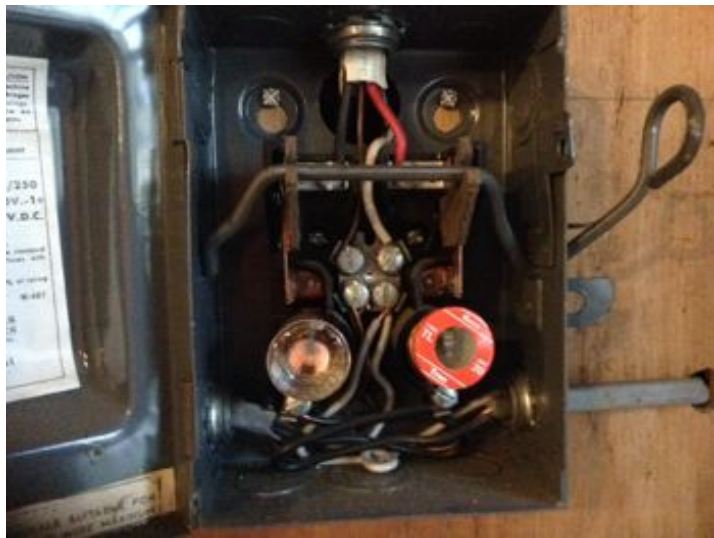
Page 32 Item: 8	Electrical Condition	Fuses in the garage fuse panel must be replaced with 20 amp max fuses.
-----------------	----------------------	--

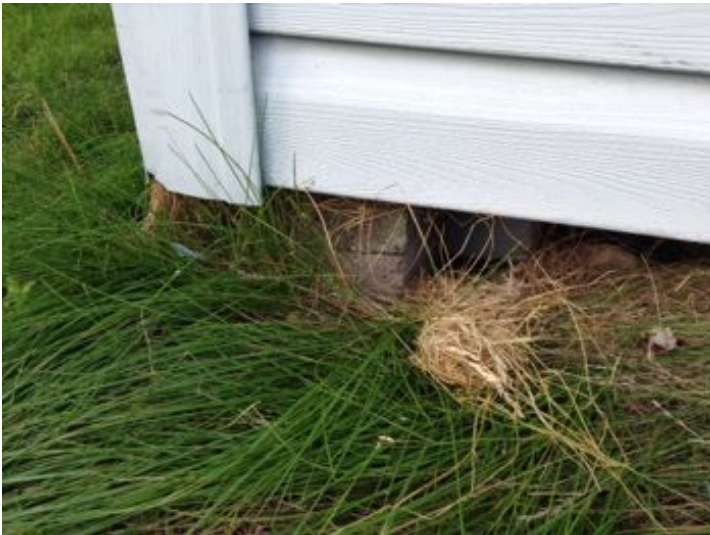
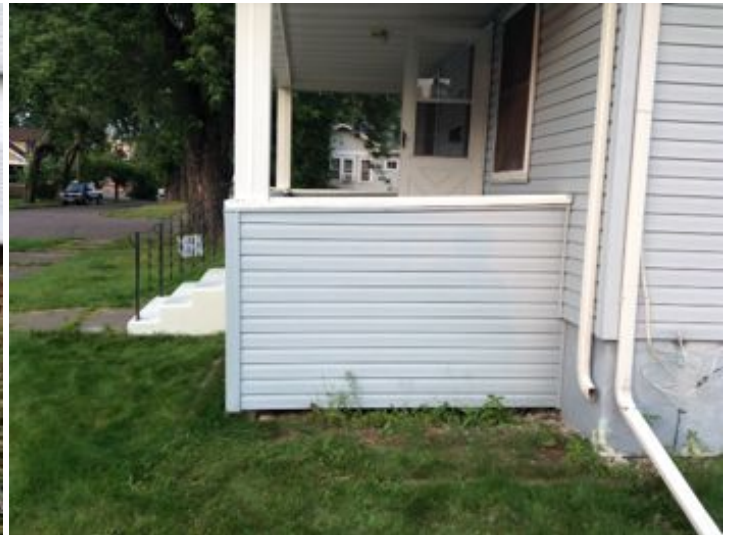
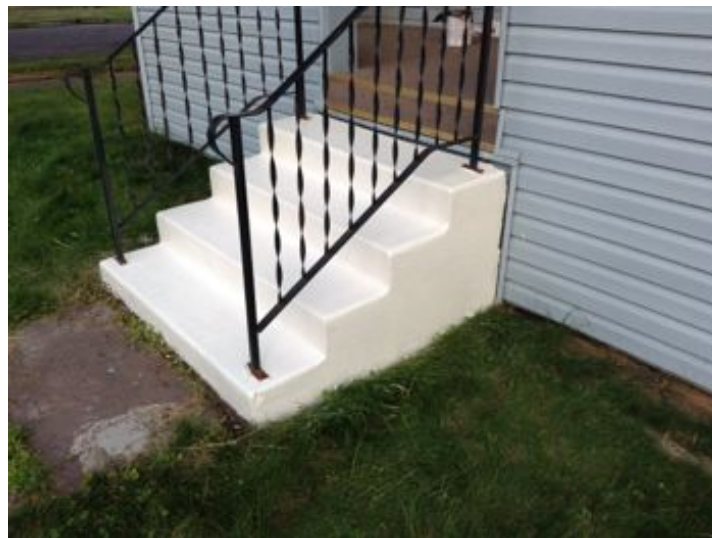
**Front porch of the house leans away from the house. This seems to be due to settling of the porch footings.**

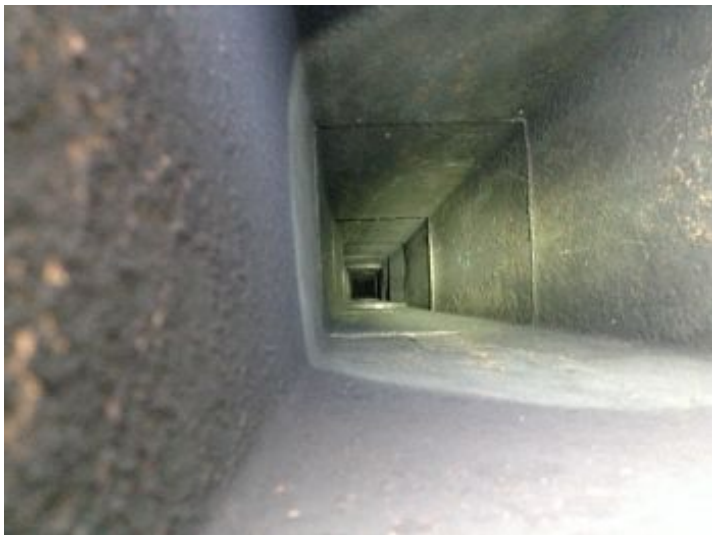
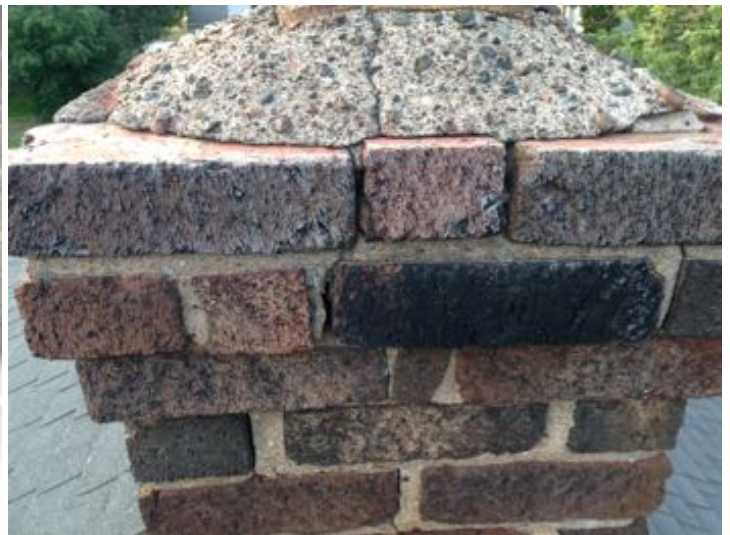
Observations: Chimney screen damage/missing. Unwanted wildlife can potentially block the chimney. Recommend installing the proper type cap. Tuck pointing needed at the mortar joints on the chimney.

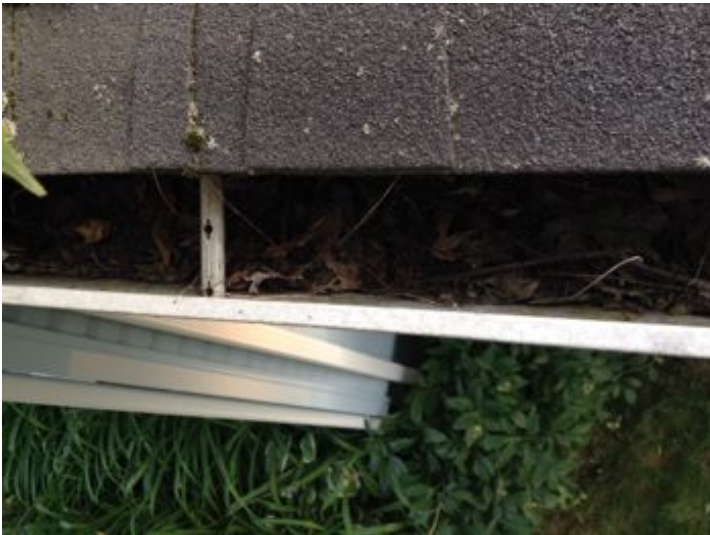
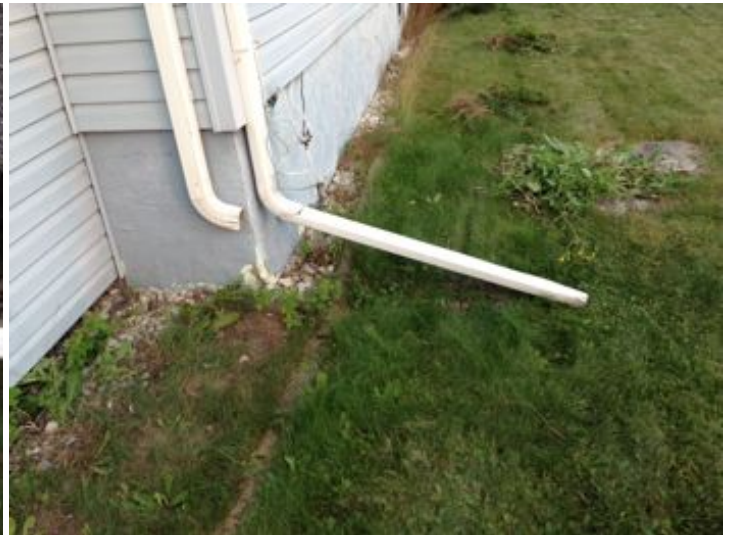
The gutters are full of leaves & debris. Water can intrude into the interior. Recommend cleaning the gutters and monitoring monthly and clean as needed.

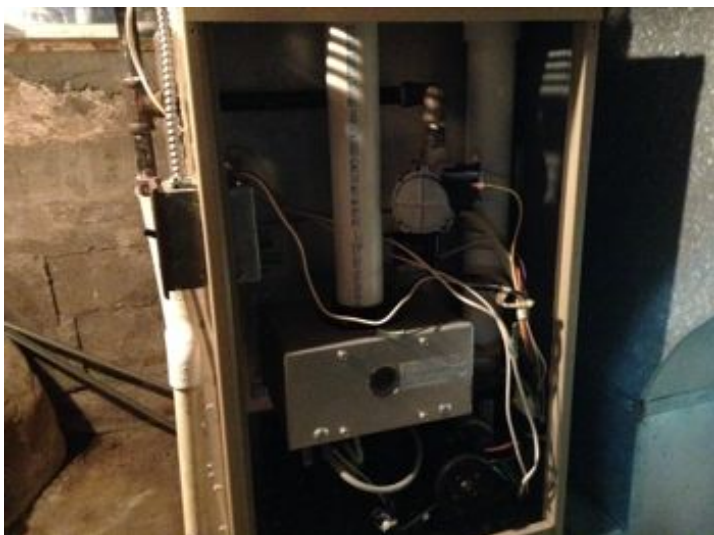
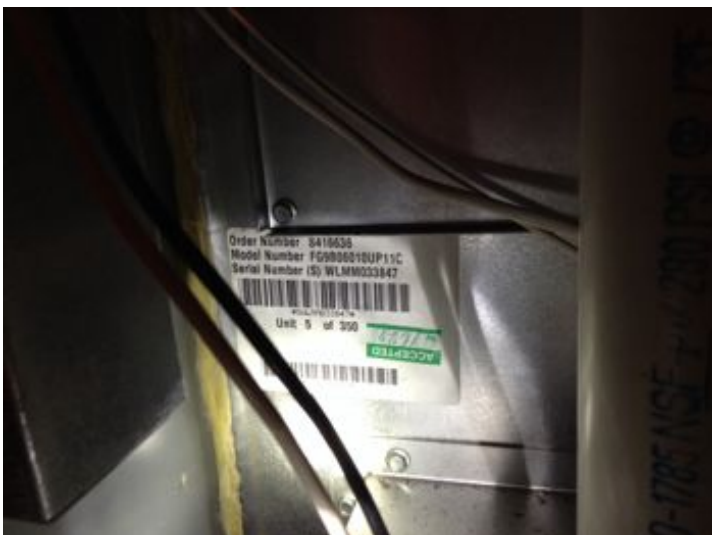
Furnace was missing the filter. I suggest adding a filter to the unit immediately.

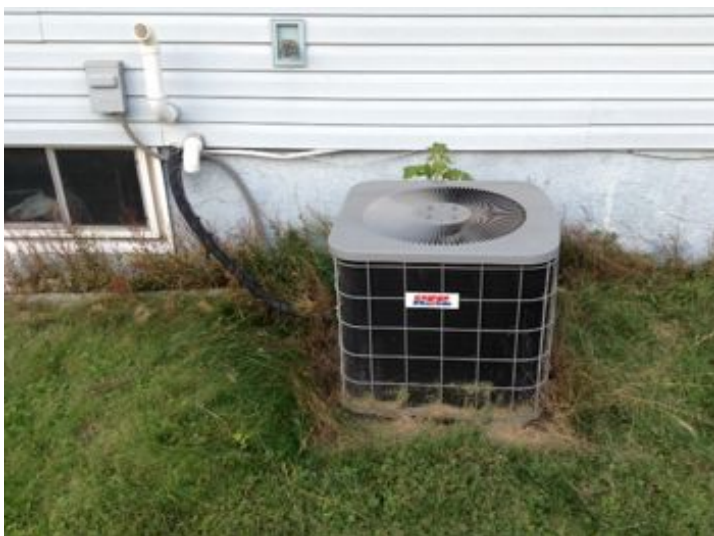
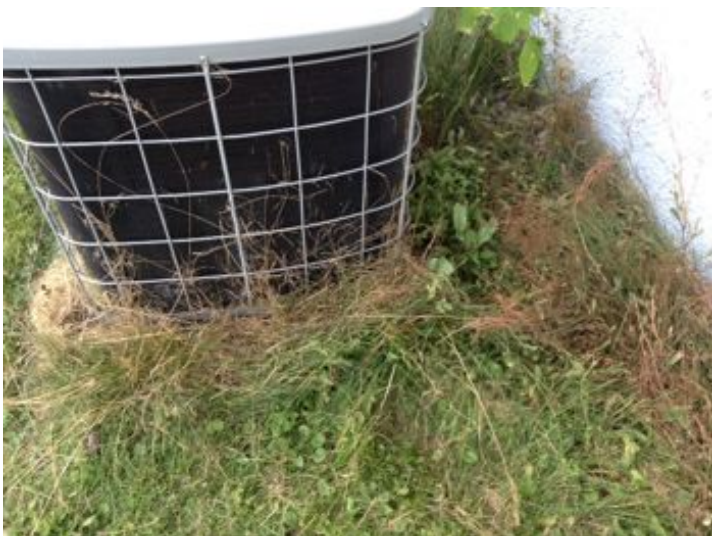
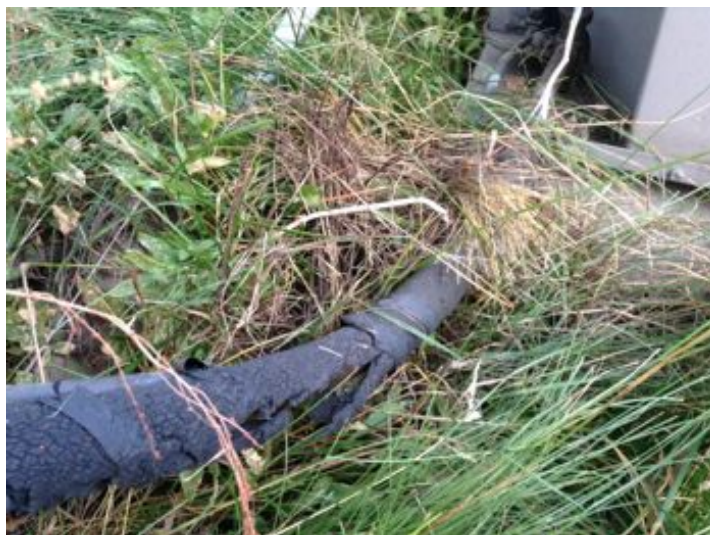
Observations: Level a/c condenser unit and keep grass and debris from building up on the condenser coils.

Protect insulation on the suction line of the A/C condenser. Also the insulation on the control wire for the condenser unit is damaged and needs to be replaced.

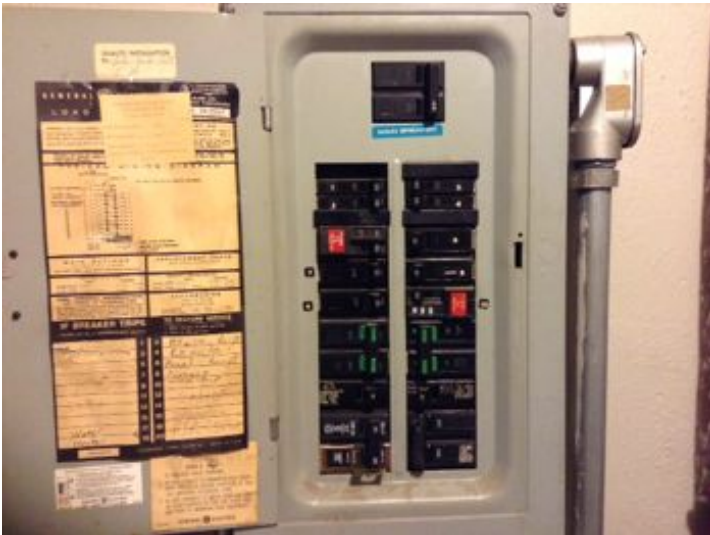
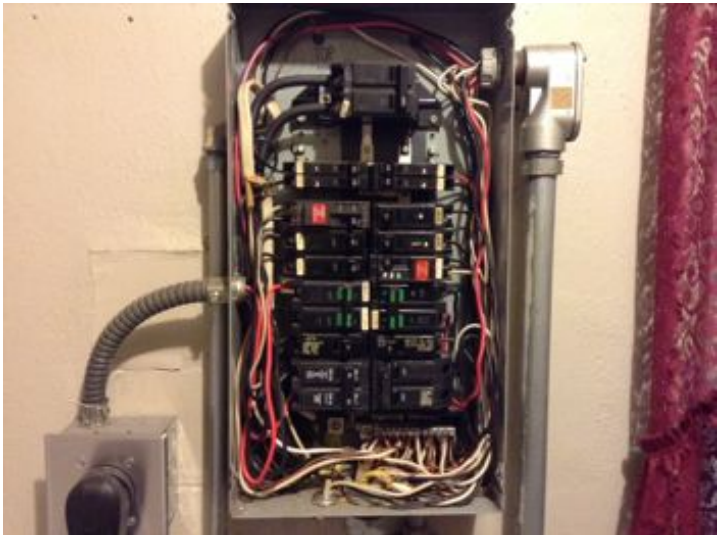
Observations: There is no additional room for breakers

Knock outs need to be covered.

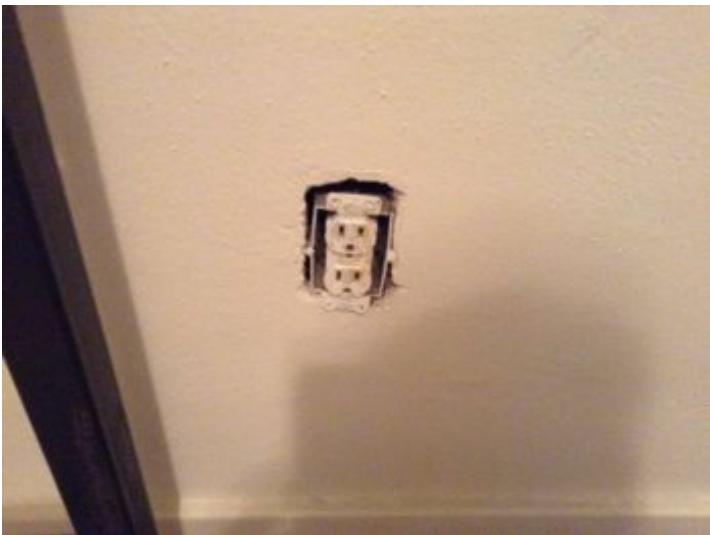
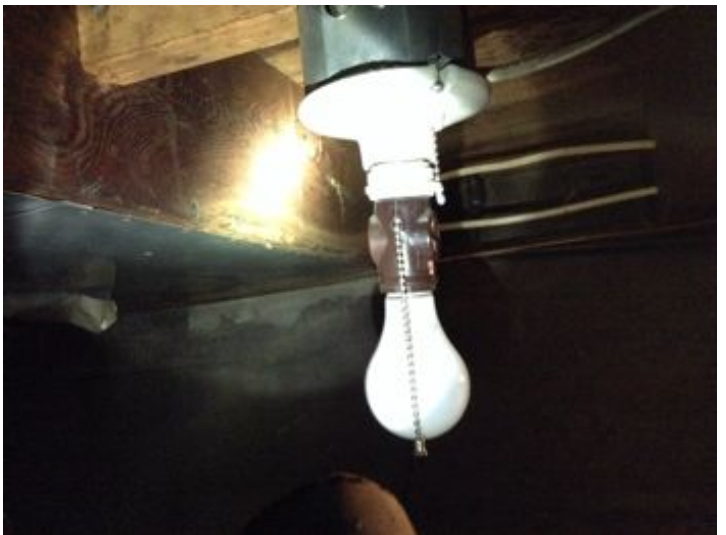
Porcelain light fixture is broken in the basement

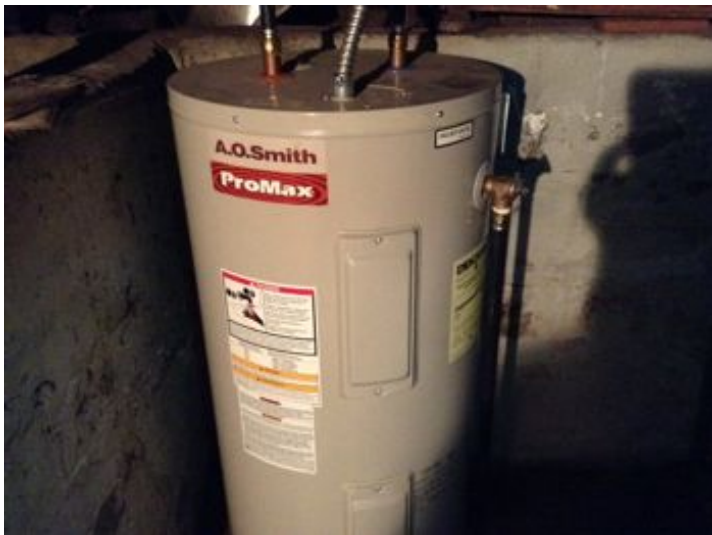
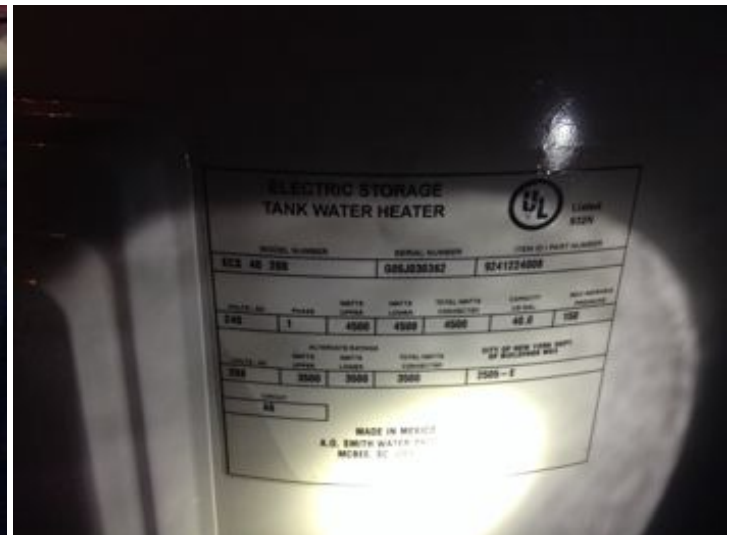
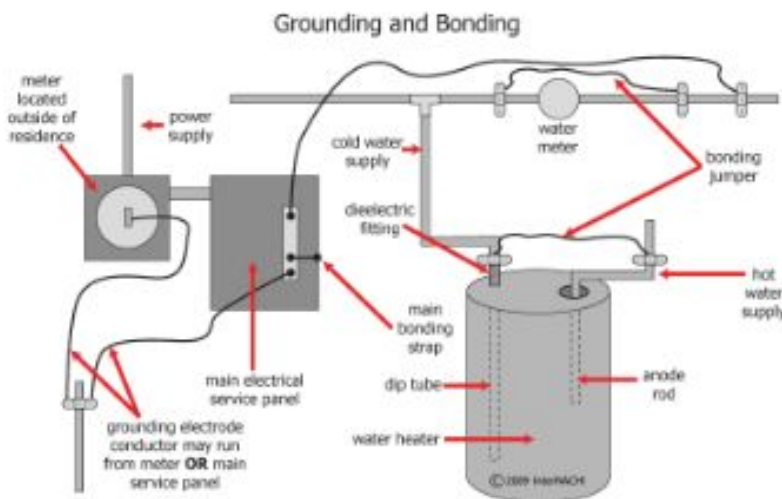
Observations: The Temperature Pressure Relief (TPR) valve discharge tube must be made out of metal piping and end no more than 6" from the floor.

No electrical bonding is present between the hot and cold water lines on the water heater.

Note the bonding jumper placement on the hot water heater

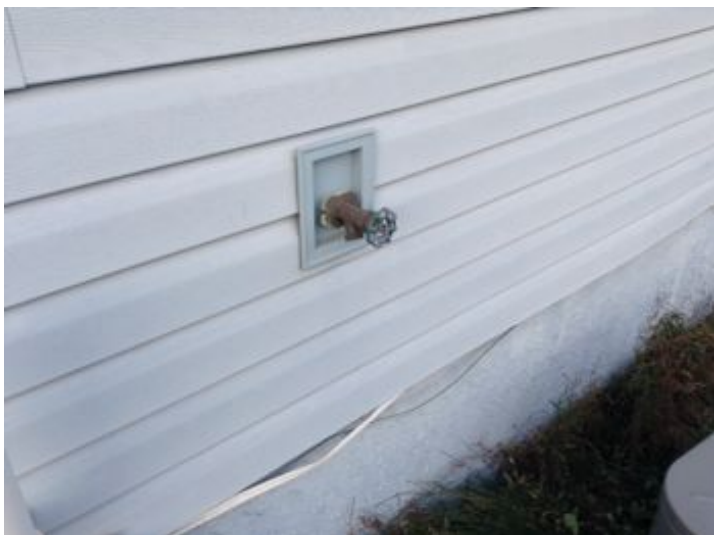
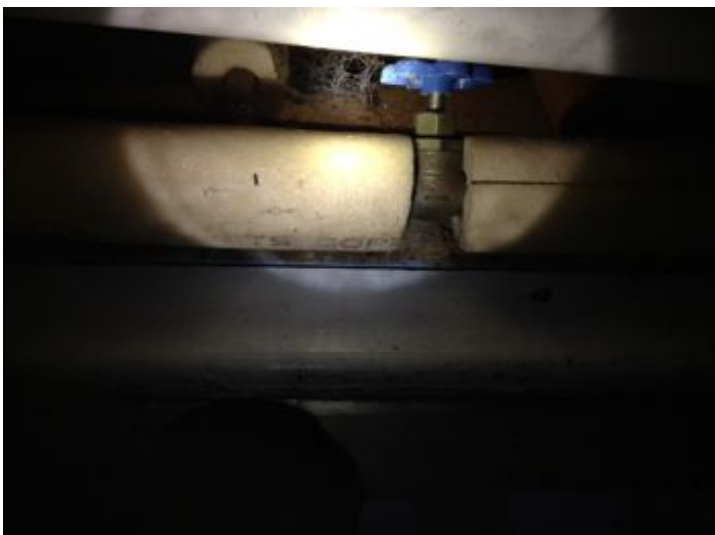
Observations: I suggest upgrading the hose bibs to the anti-siphon + frost free type. They will prevent contaminants from entering the drinking water and also not allow the faucet to freeze as easily during the winter months. Appeared to have been winterized, at time of inspection.

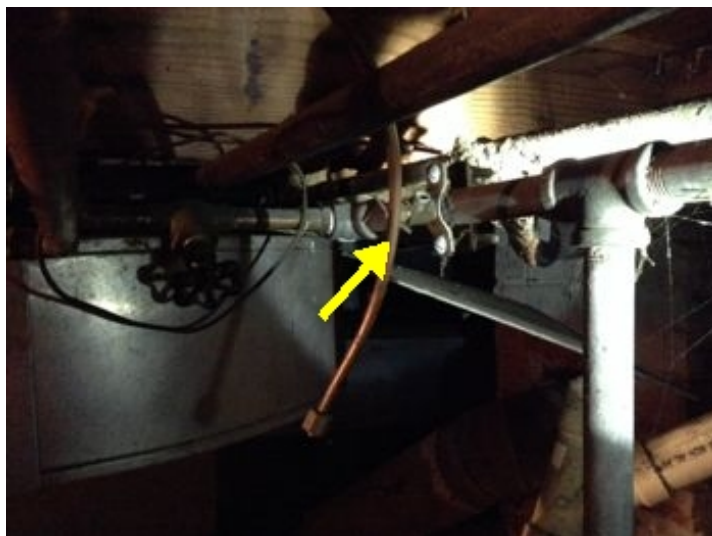
Two saddle valves were found in the basement. Monitor them for leaking over time.

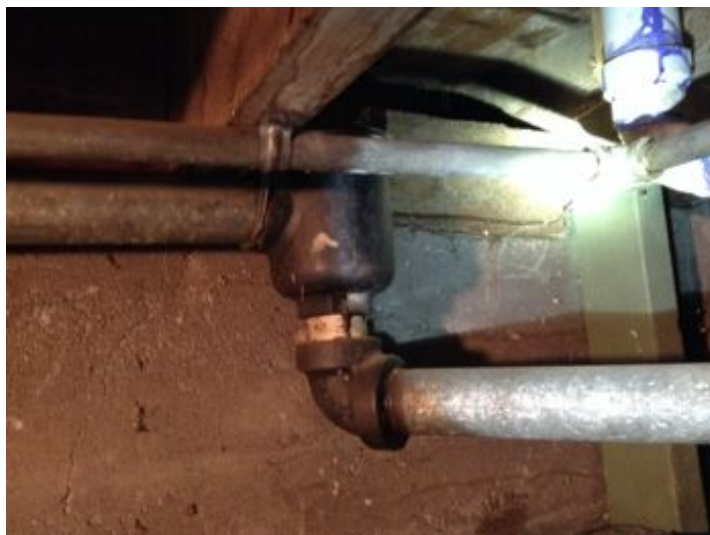
Drum trap from the shower is susceptible to plugging and can cause a slow drain.

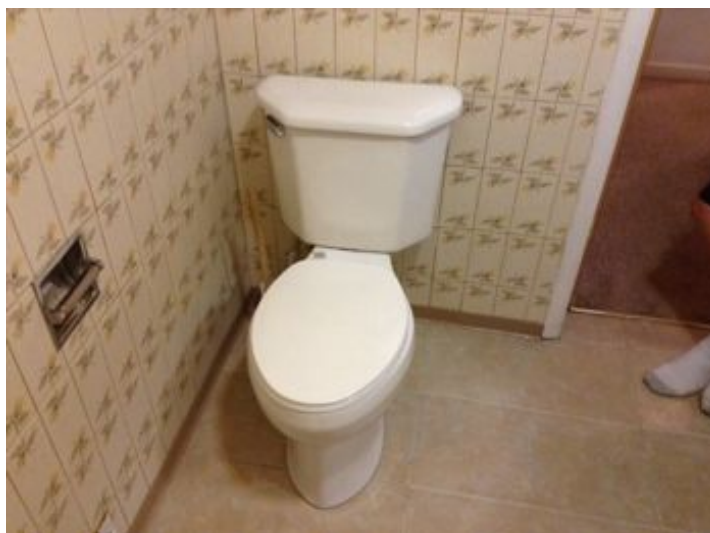
Observations: **The toilet is loose on the floor**

**A loose toilet can be as simple as tightening the closet bolts that secure the toilet, or could indicate something more serious like a broken closet flange. Suggest having a plumber check into the problem further.**

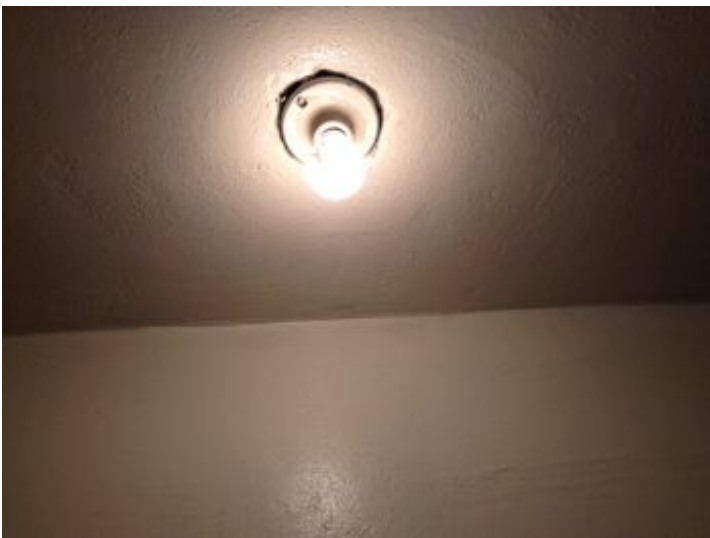
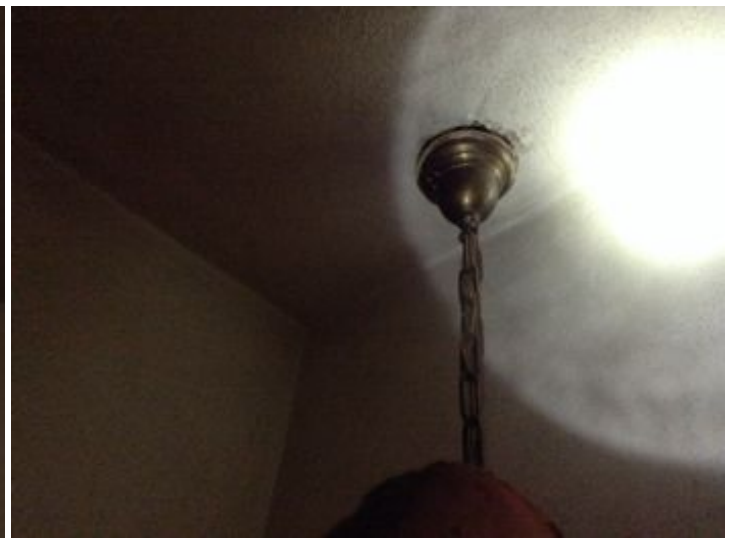
Observations: Lights inside closet should not be an exposed bulb. Bulbs can be broken when storing items, or if stored items tip over. Suggest adding a light fixture with a cover to protect the bulb from damage and coming in contact with flammable materials.

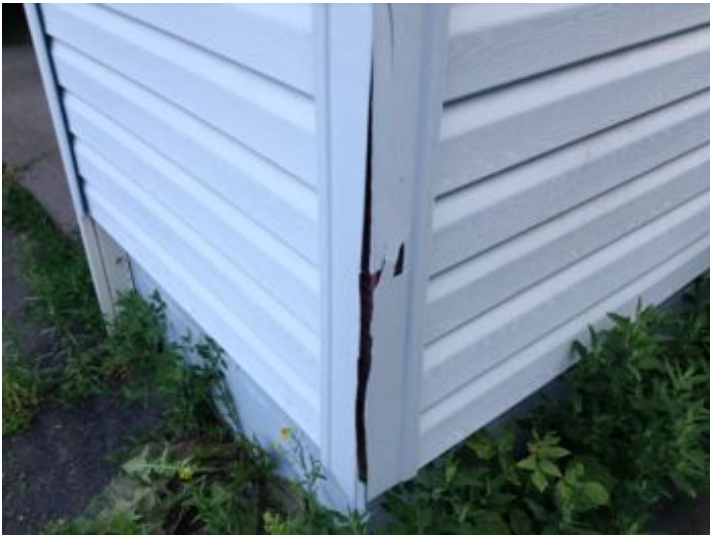
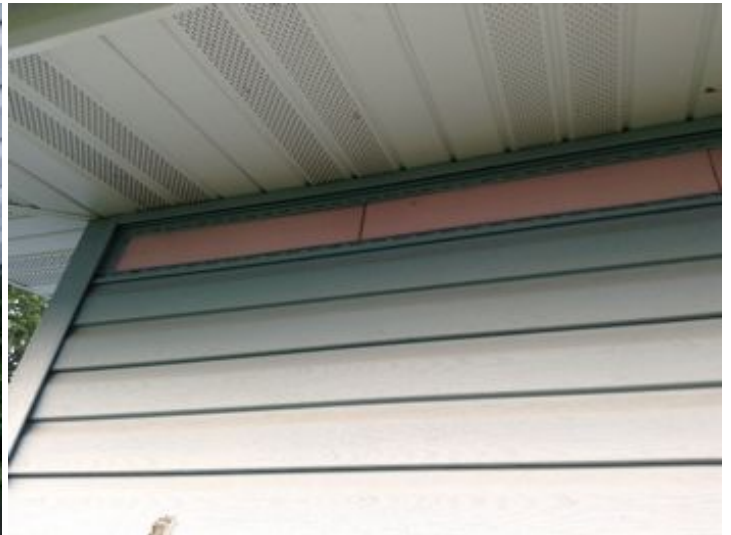
Observations: Cladding is damaged and in need of repair in a few places. Minor damage to northeast corner of the garage cladding. Cladding missing at the rear upper wall of the garage.

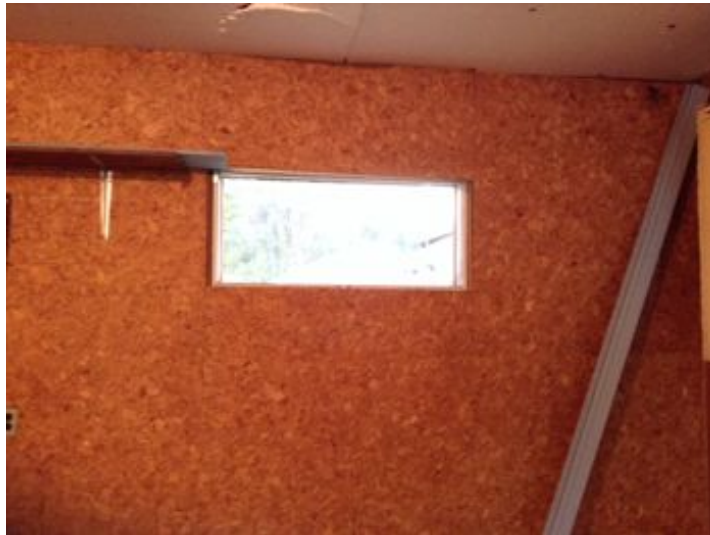
One window was broken and being repaired at the time of the inspection.

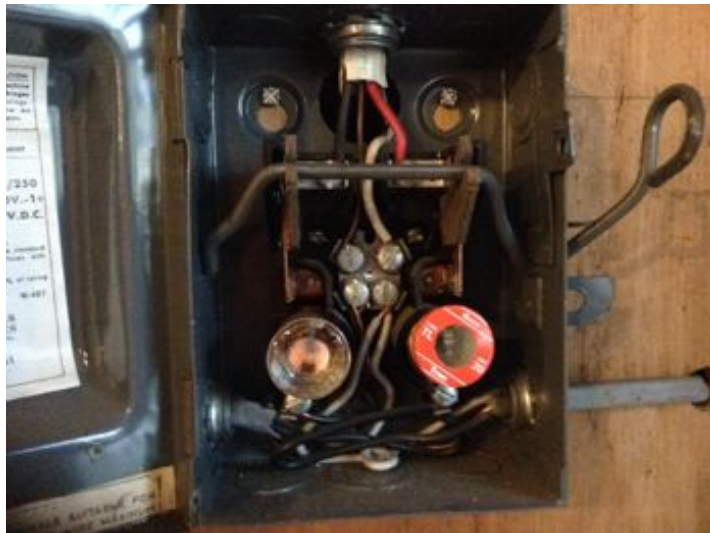
**Fuses in the garage fuse panel must be replaced with 20 amp max fuses.**
