4 Seasons Home Inspections LLC

Property Inspection Report

9515 6th Ave NW, Seattle, WA 98117
Inspection prepared for: Shannon Hurst
Date of Inspection: 2/22/2013 Time: 10am
Age of Home: 91 yrs Size: 2160sqft
Weather: Rainy; Temperature is 42 degrees
Report # 13059

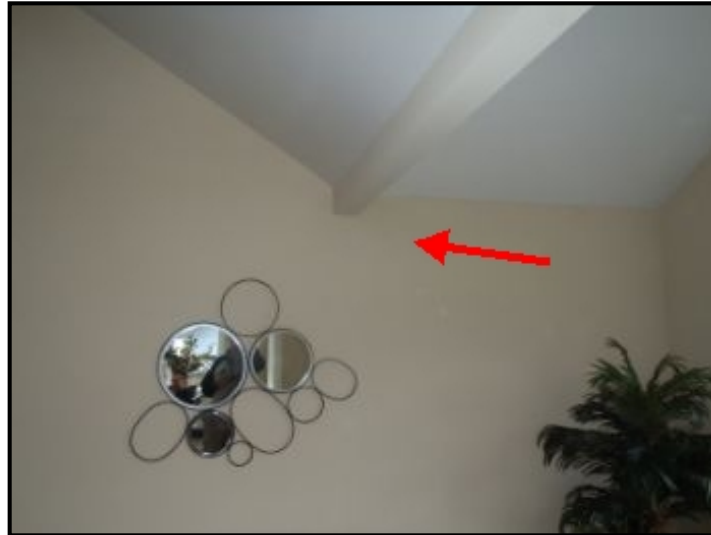
Visible leaking noted on the ceiling at a few locations. We recommend contacting a qualified contractor to evaluate the roof and the drywall in this area and repair as necessary.

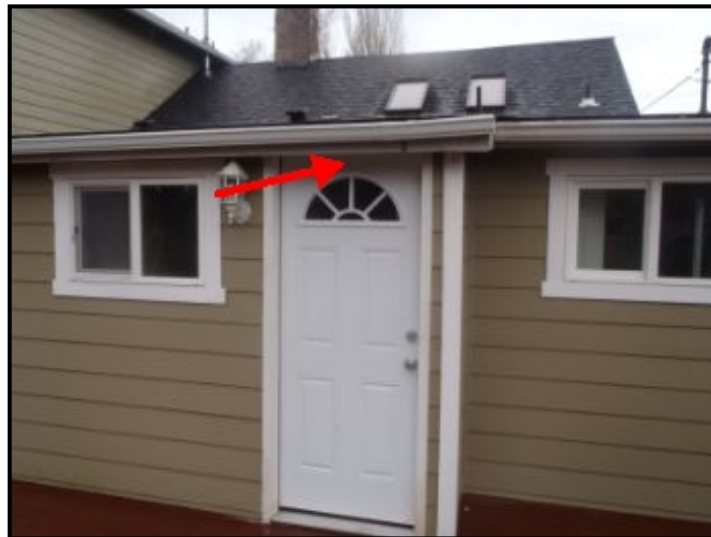
The eave is hanging too low into the path of the exterior door way near the laundry room. This could be a safety hazard. Recommend repair.

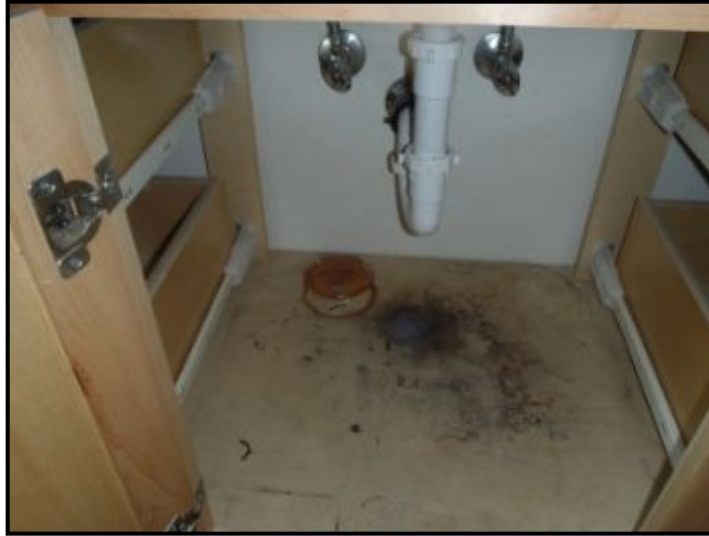
There is damage to the right side cabinet under the sink.

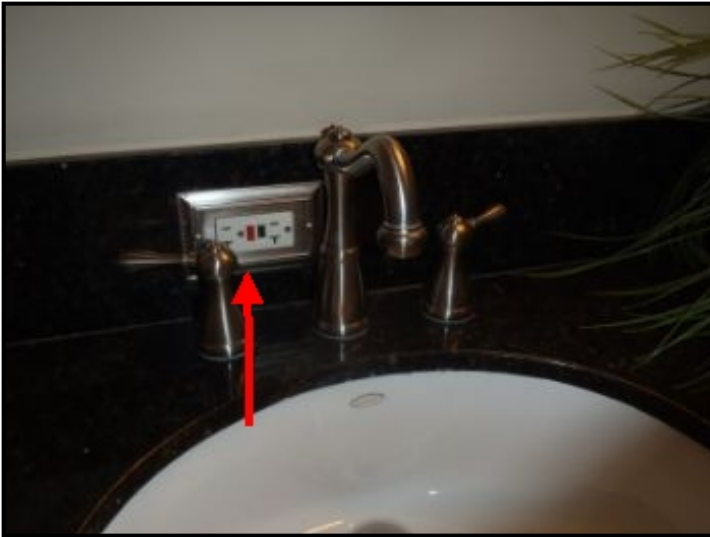
The electrical outlet behind the sinks are not functional at their current locations.

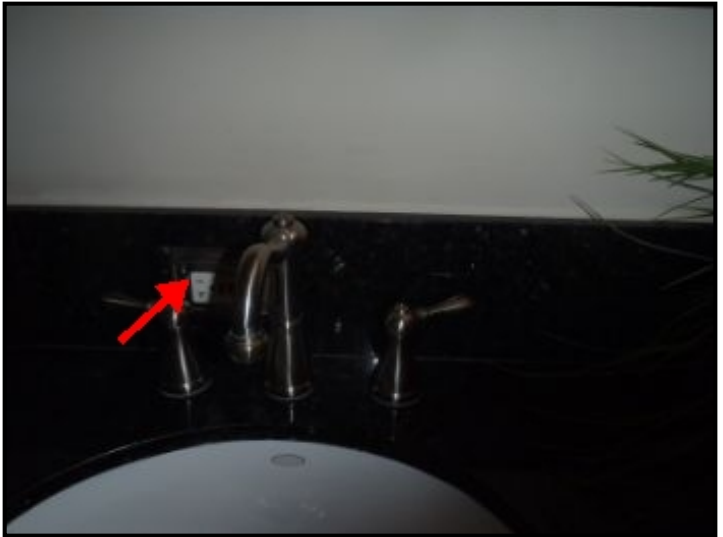
A plug will not fit here.

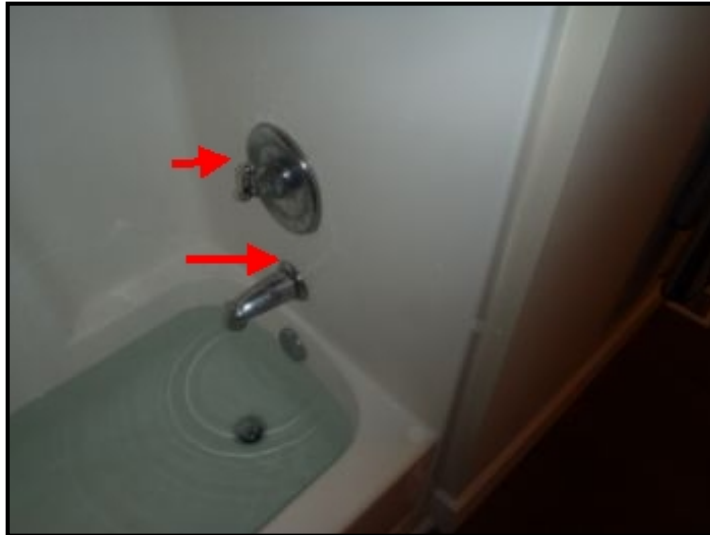
The shower faucet and handles are loosely mounted.

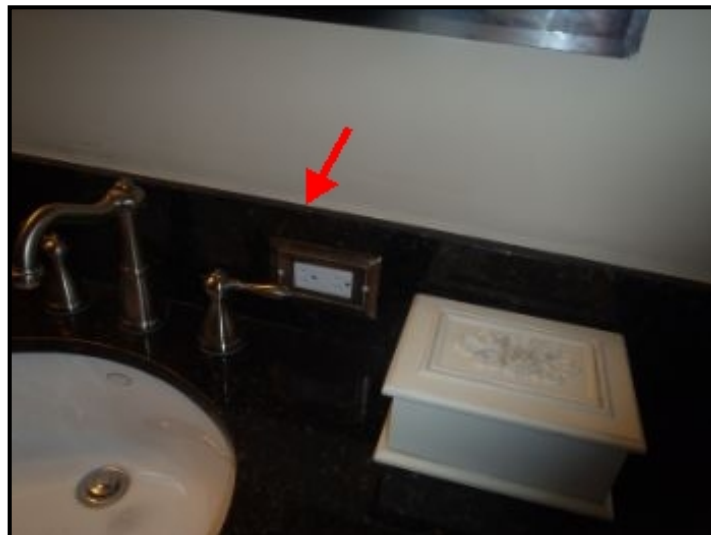
The outlet behind the sink cannot be used because of lack of access.

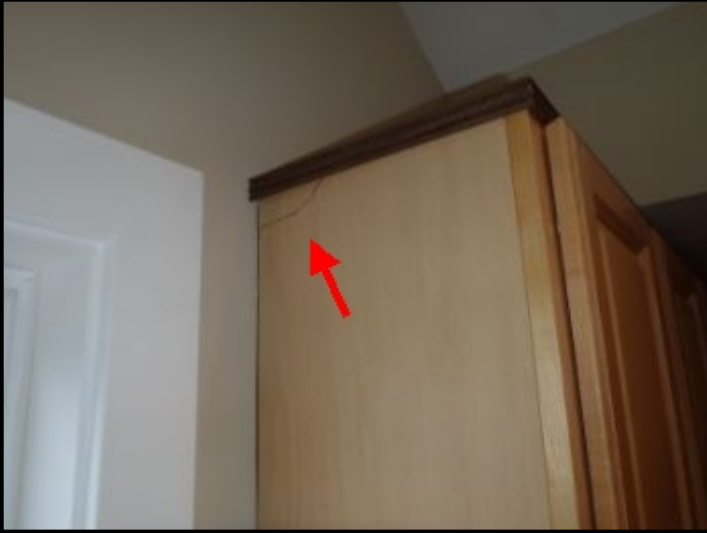
There is cracked cabinet above the kitchen sink.

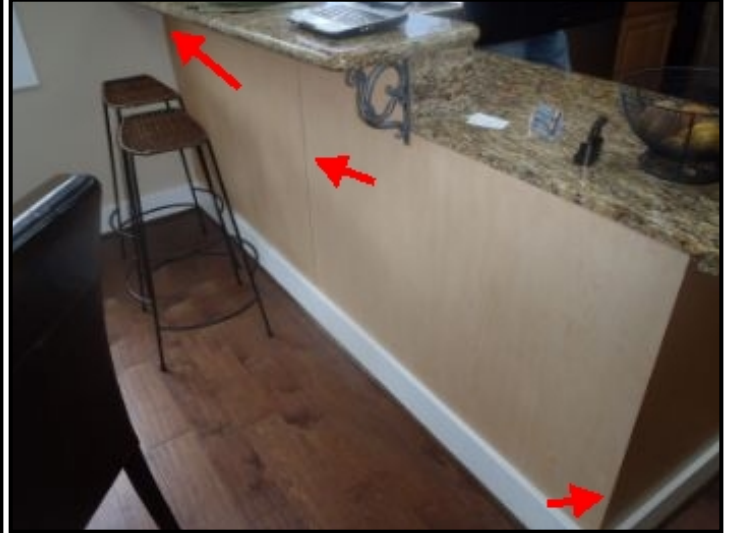
The cabinet are missing trimwork at numerous locations.

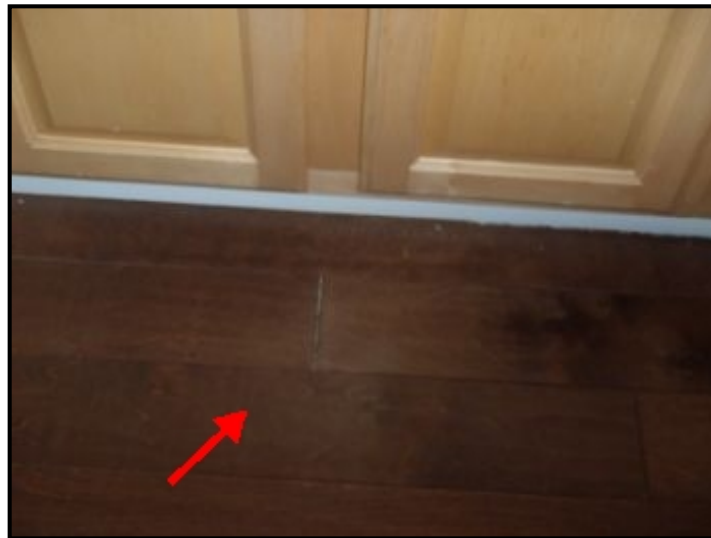
There are gaps in the hardwood flooring showing signs of poor craftsmanship.

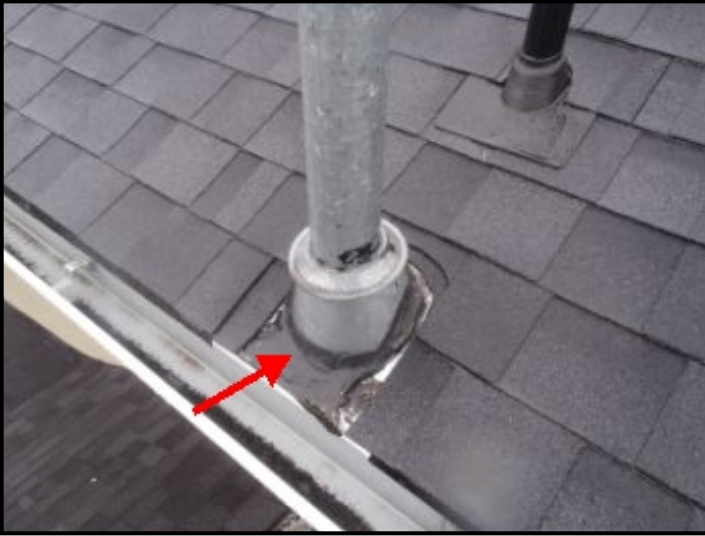
Flashings are mastic covered, recommend re-sealing all through the roof vents and projections as a part of routine maintenance.

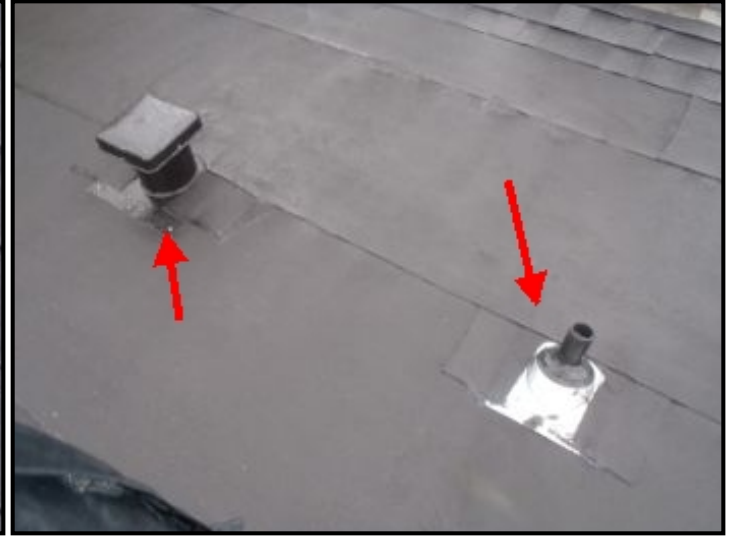
The vent flashings on the lower roof are improperly installed.

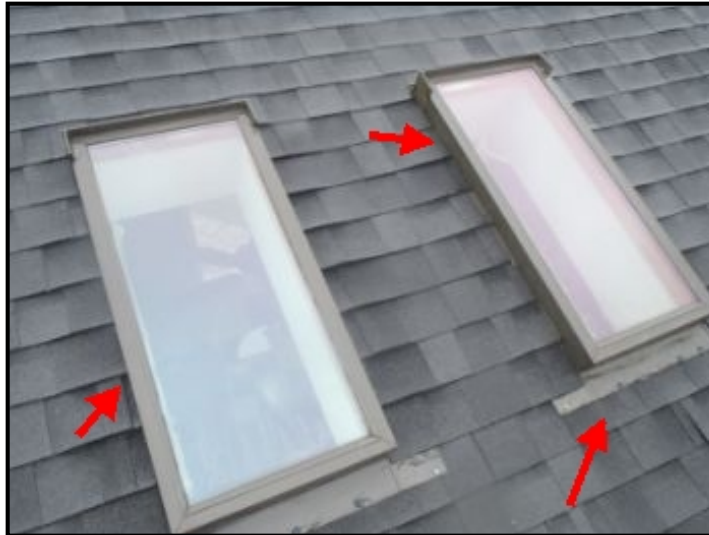
Skylights have very poor flashing installation.

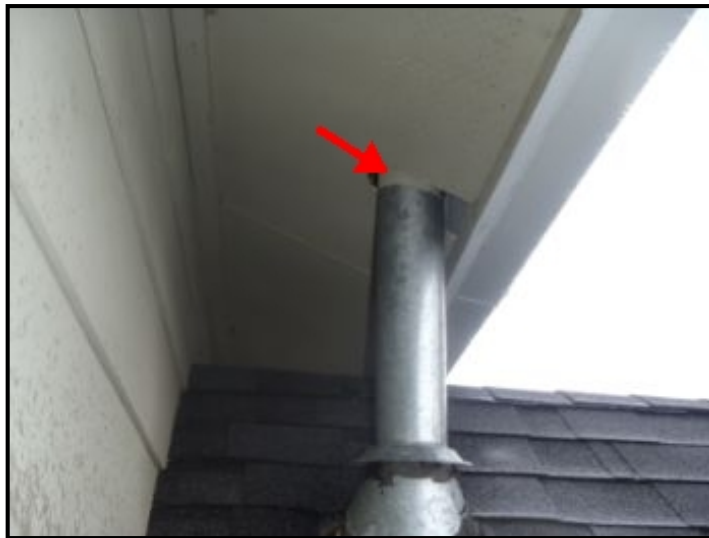
The exhaust vent lacks proper clearance to combustible materials at the top portion of the roof.

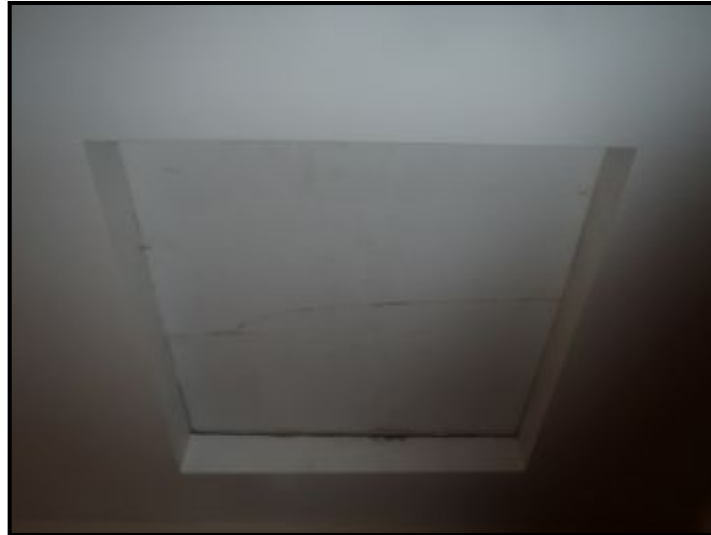
Drywall access panel is damaged.

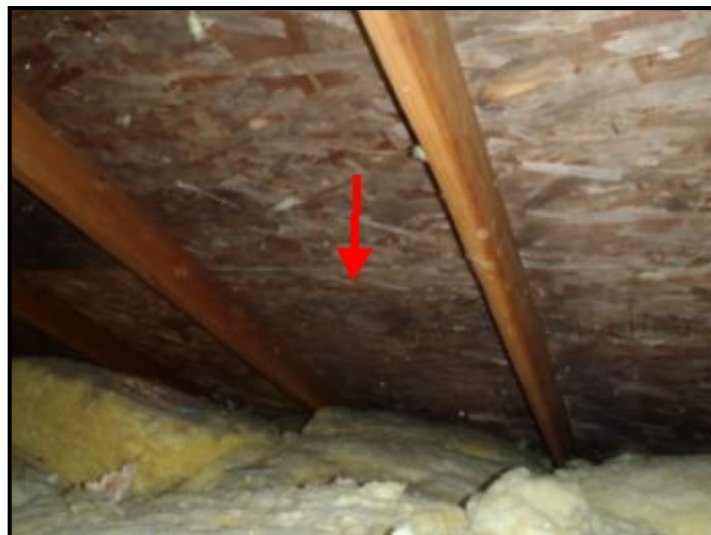
Some areas of attic sheathing are blackened by a mold like substance. It is a small area on the north side of the upper attic. Recommend removing insulation from blocking the ventilation in the eaves to cure problem.

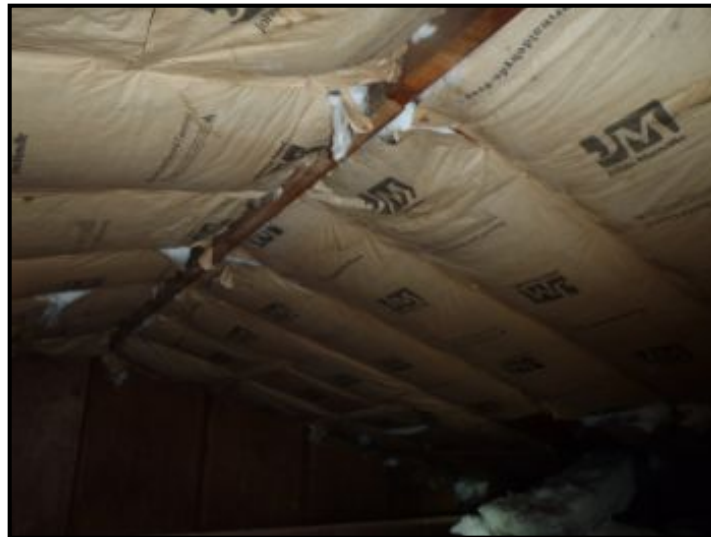
The insulation in the garage attic is improperly installed

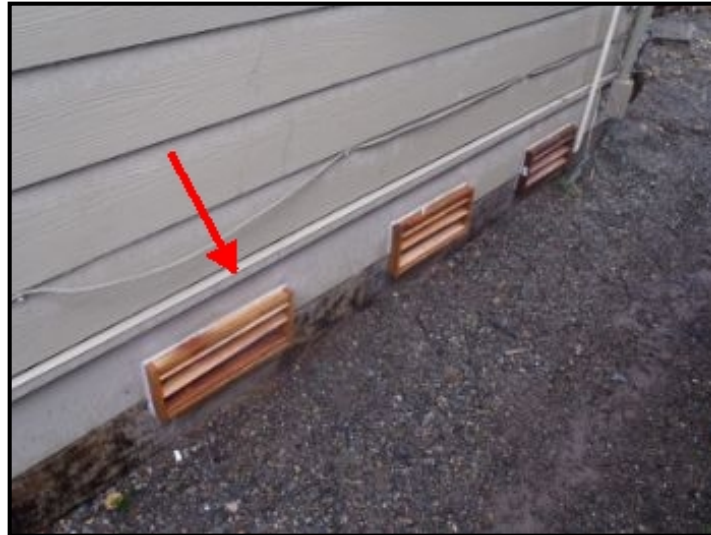
The foundation vents on the left side of the house are in need of paint.

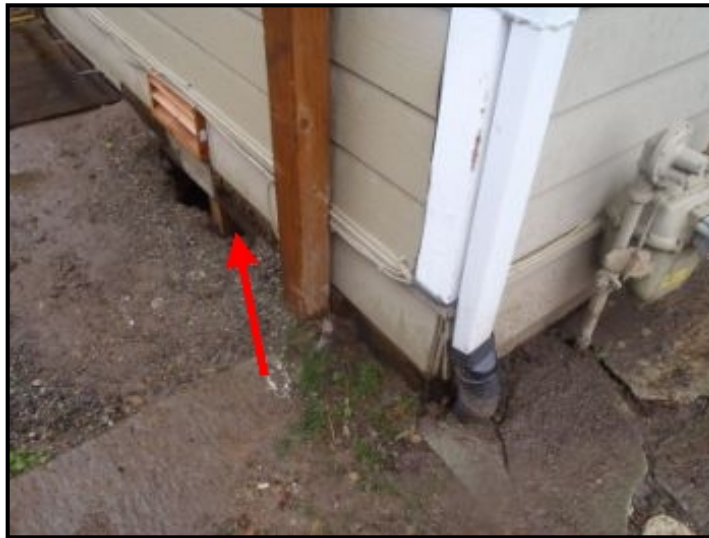
- There is no foundation perimeter around the older part of the house. This is a very important system of the house. Recommend a full evaluation by a licensed structural engineer and make repairs as necessary.
- There crawlspace is left wide open to a animals around the perimeter. There is a lot of earth to wood contact with plywood trying to be used a skirting. Recommend no earth to wood contact.

There crawlspace is left wide open to a animals around the perimeter. There is a lot of earth to wood contact with plywood trying to be used a skirting. Recommend no earth to wood contact.

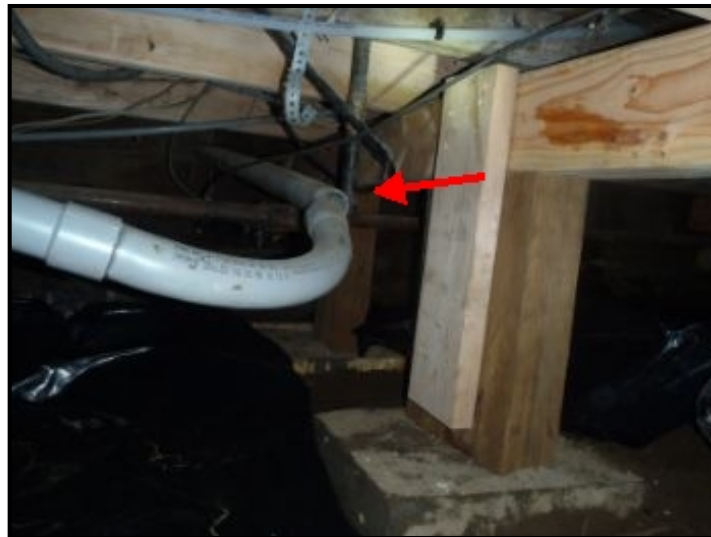
a separated fitting on the electrical conduit id noted.

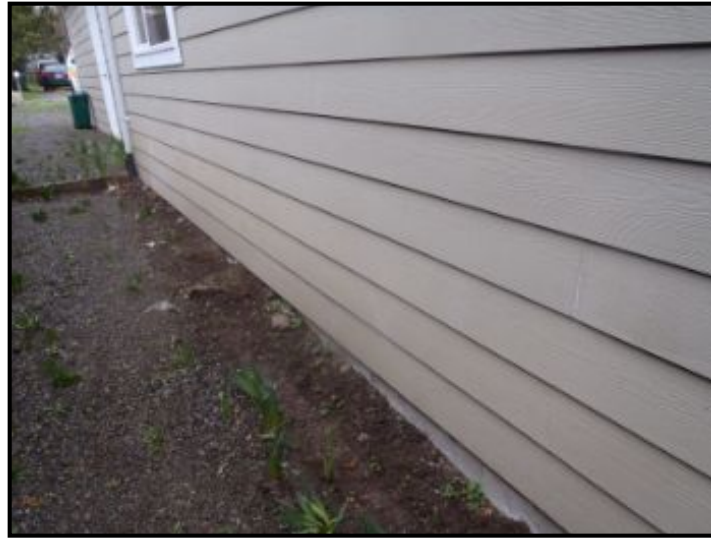
Siding to Soil contact or proximity. This may provide entrance of moisture or insects to siding. Recommend grading soil so there is at least 6" of space (where practical) between the siding and the soil below and checking for any damaged trim and siding materials.

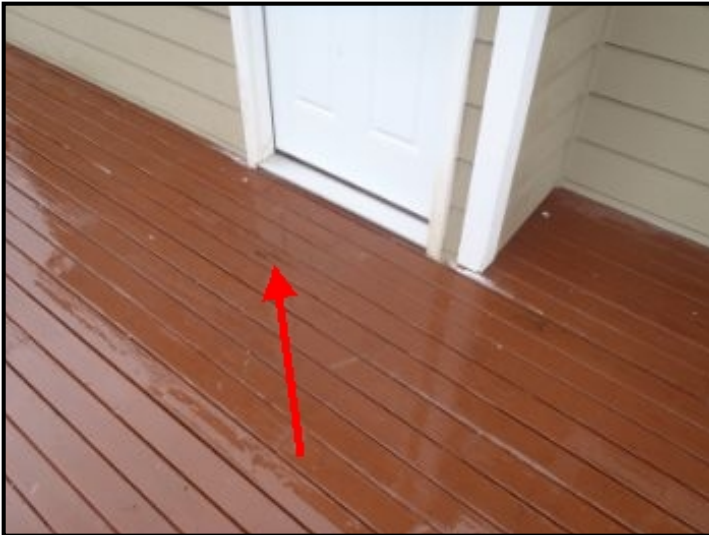
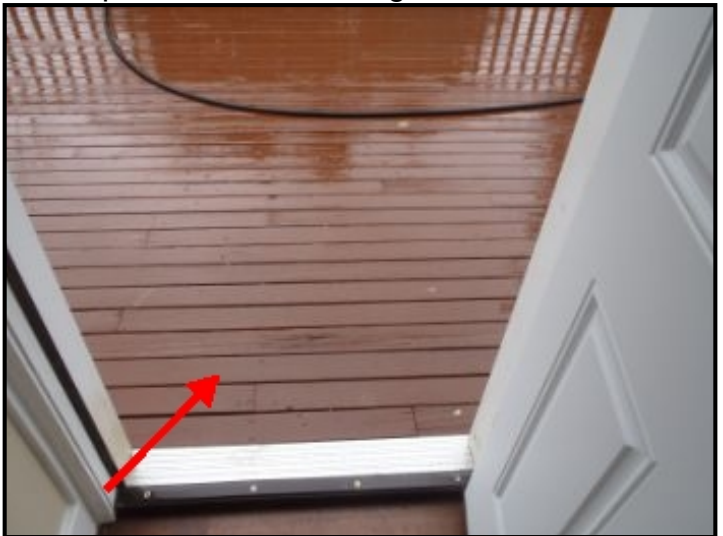
Rotted Wood planks near the back door on the left side.

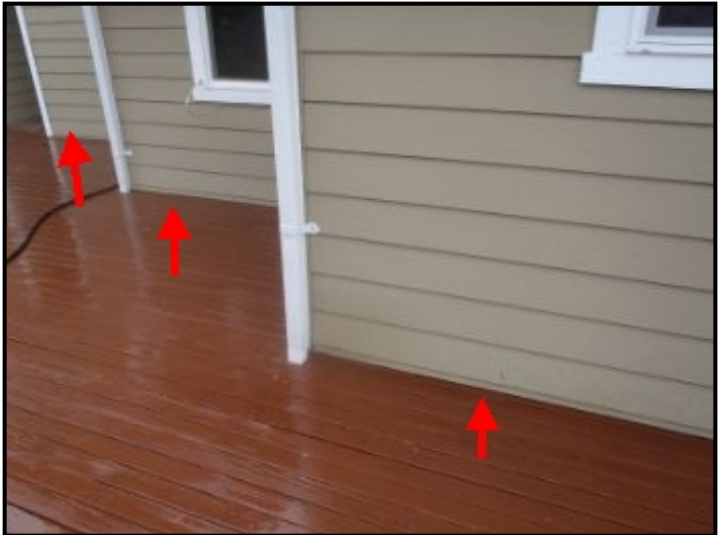
Missing properly installed flashing where the deck attaches to the house. This is a important to prevent future damage to the house.

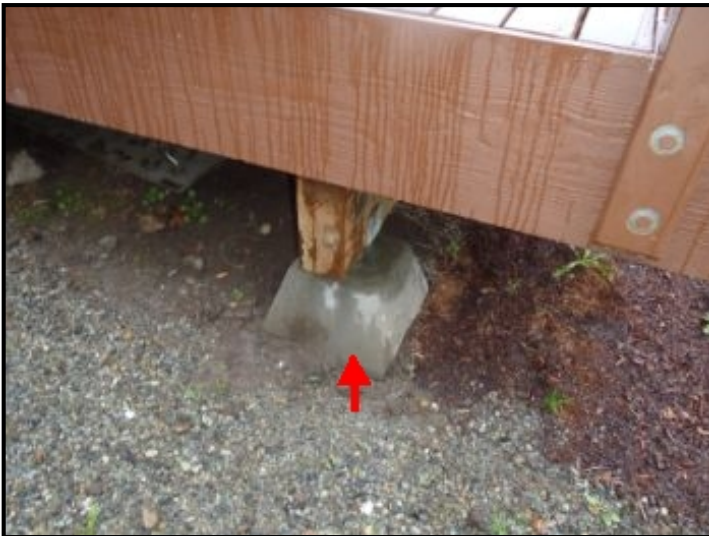
Unstable supports. Pier blocks are used as the foundation. Recommend installation of proper footings under the deck post.

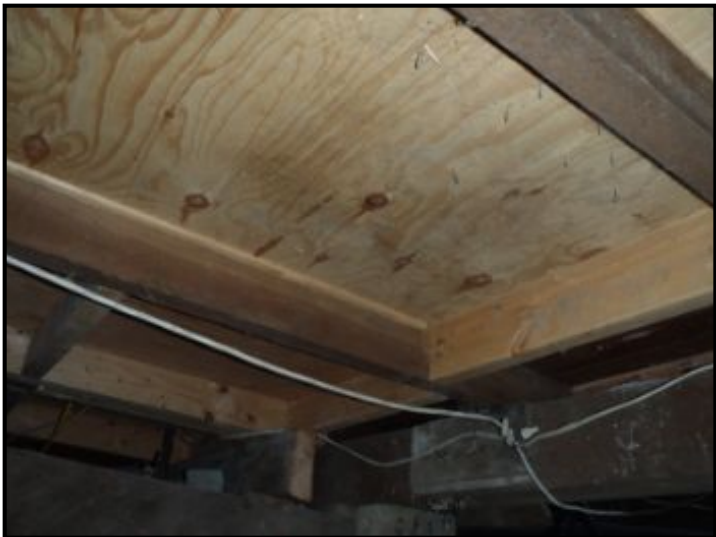
- Recommend review of floor support system by a qualified contractor for any repair or upgrades needed to structure.
- Floor joist appear to be over spaces for proper support. Joist are constructed with 2X4 material. Beams are being installed through out crawlspace to take up structural deficiency of floor system. Some joist show signs of deterioration and are sistered to other joist. It is a large mess in the floor system and it should be fully evaluated by a structural engineer.

Floor joist appear to be over spaces for proper support. Joist are constructed with 2X4 material. Beams are being installed through out crawlspace to take up structural deficiency of floor system. Some joist show signs of deterioration and are sistered to other joist. It is a large mess in the floor system and it should be fully evaluated by a structural engineer.

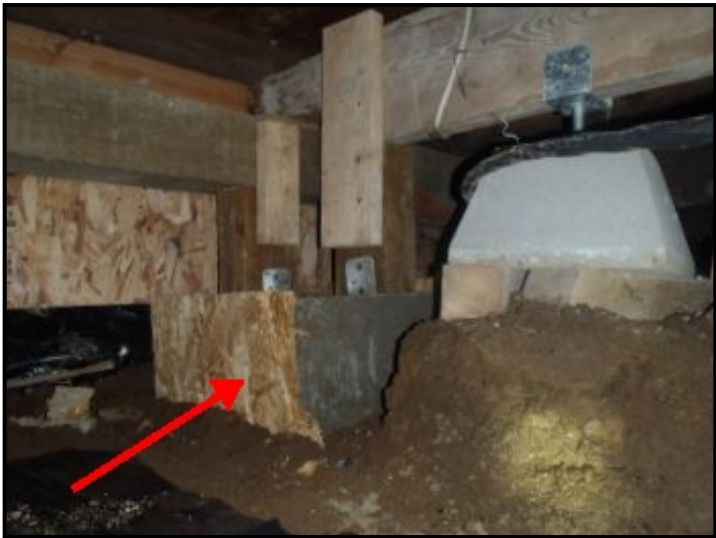
For boards are left on piers. Recommend removal.

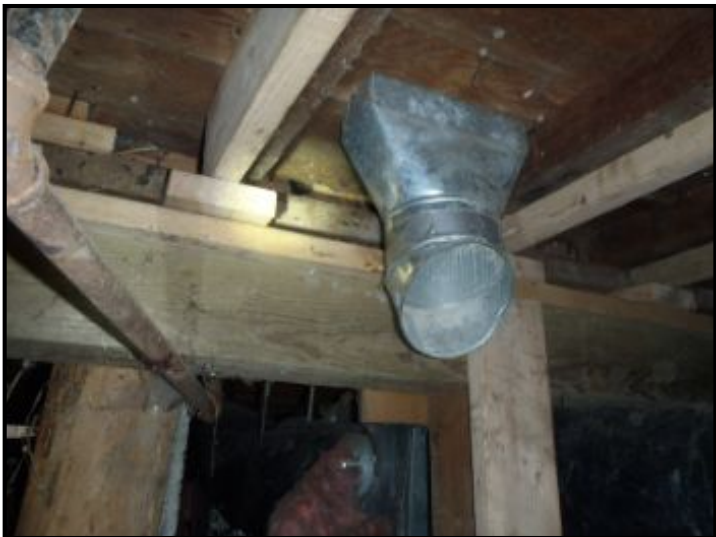
There is missing ductwork to a register in the rear bedroom.

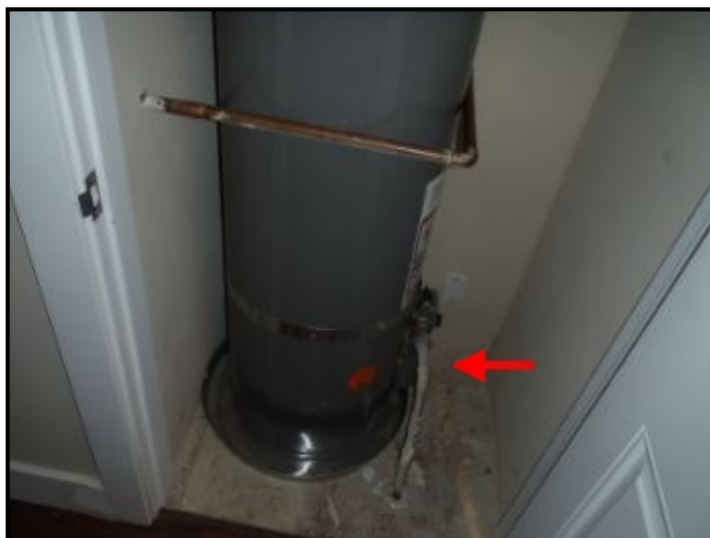
There is improper clearance around the water heater to view the pilot.
