1st Inspection Svcs

Home Inspection Report

1234 Sample Road, Sample City, FL 12345

Date of Inspection: 10/1/2024 Time: 9:00 a.m.

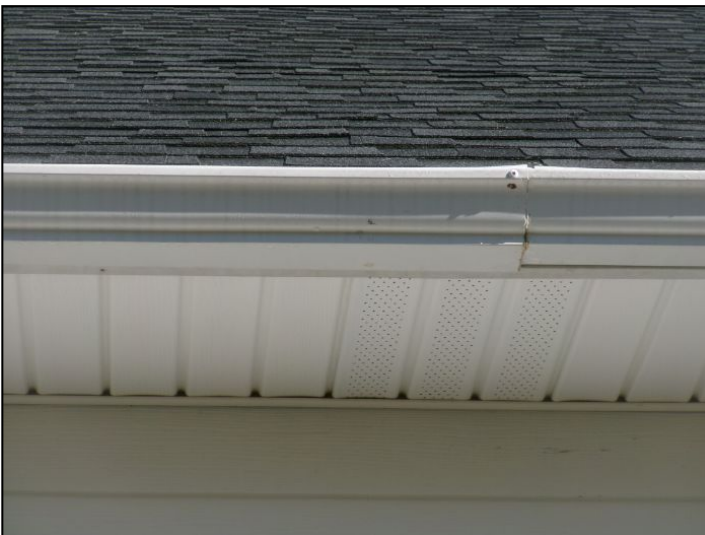
5.1. The gutter system needs some maintenance/repair.

Gutter needs maintenance/repair

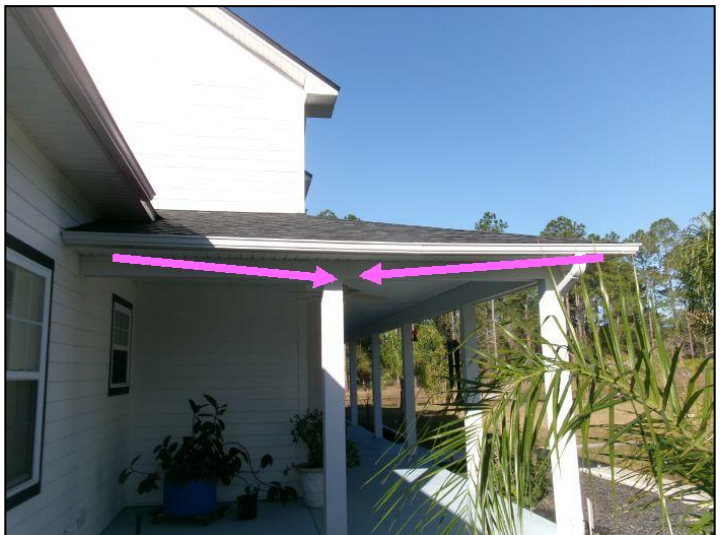
Gutter dips

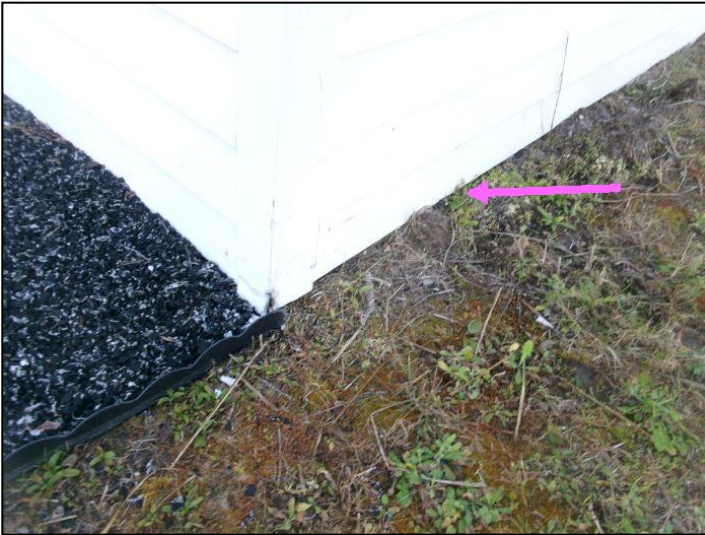
4.1. Siding to Soil contact or proximity. This may provide entrance of moisture or insects to siding. Recommend grading soil so there is at least 4" of space (where practical) between the siding and the soil below and checking for any damaged trim and siding materials.

Siding to soil contact

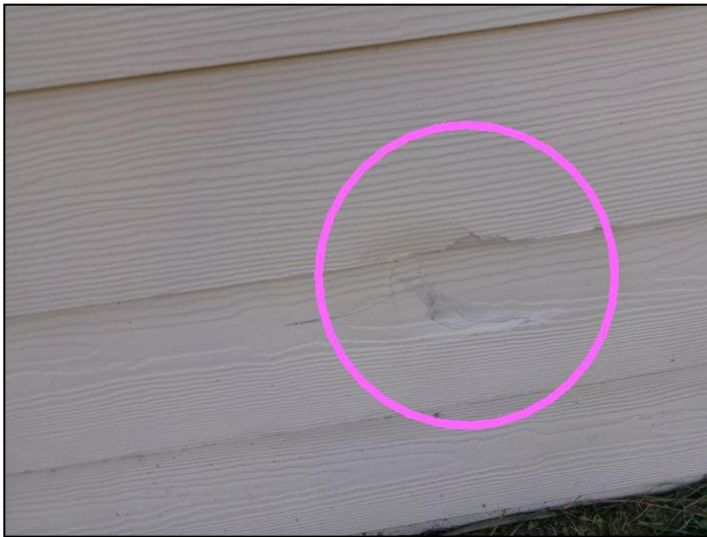
2.1. Siding damage was noted on the right elevation.

Siding damaged at several locations

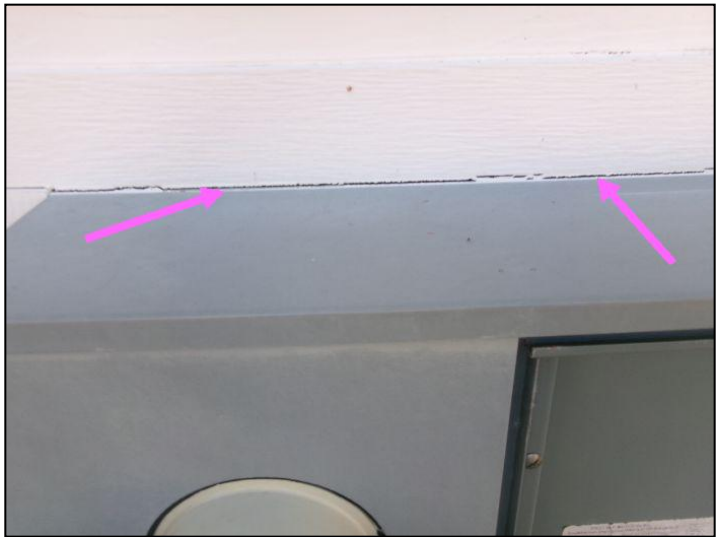
2.2. Some minor cracking was noted in a few areas around the perimeter of the dwelling. No visual evidence of structural problems was found, however, the cracks should be filled.

Cracks need sealing

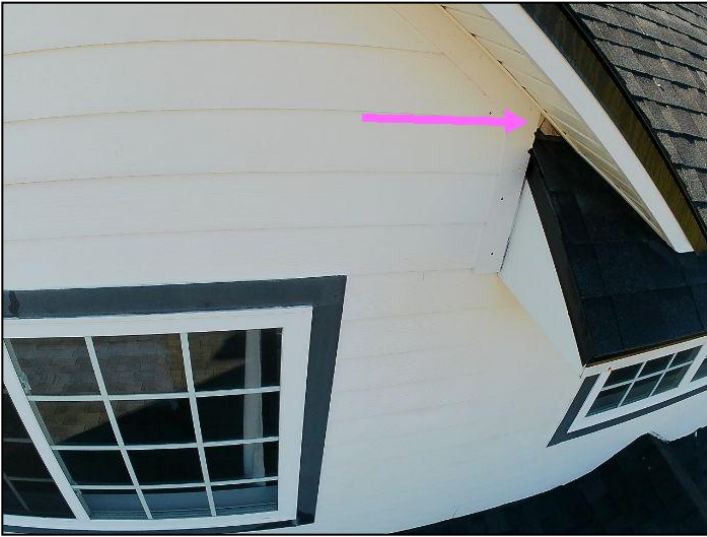
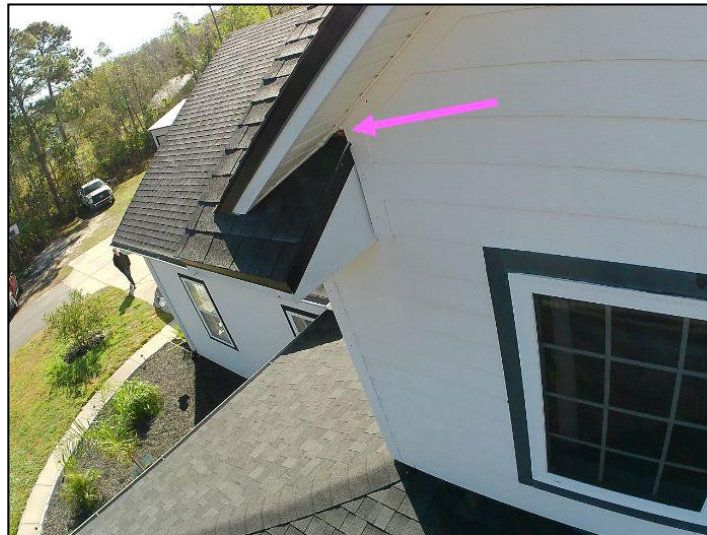
2.4. There are a few openings on the exterior walls. We recommend these be sealed as to prevent pest and moisture intrusion.

All exterior openings need sealing

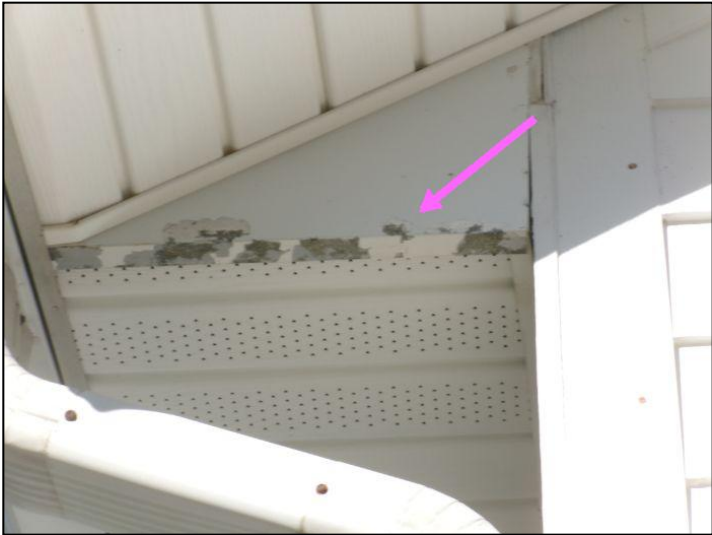
- 6.1. We noted paint damage to the fascia in a few areas.

Paint peeling

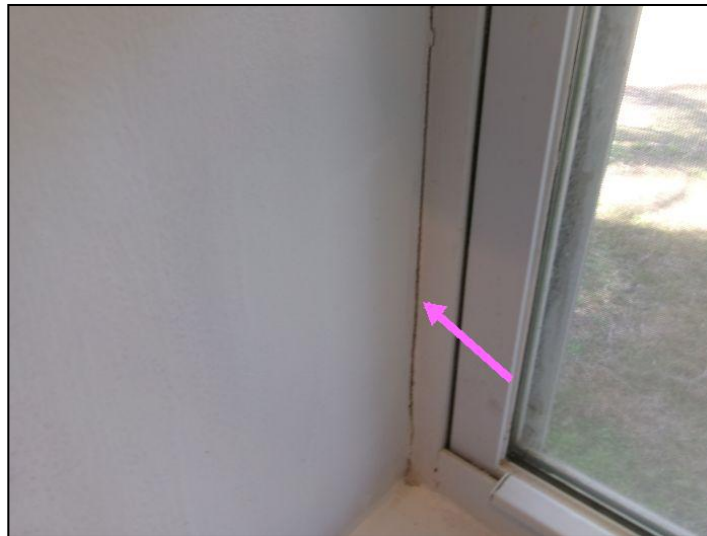
- 3.1. Window units tested were in satisfactory condition with any exceptions noted. Most windows need periodic adjustment or minor repair over time to work properly.
- 3.2. The main entry door appeared to be in satisfactory condition.
- 3.3. The unit is equipped with caller visibility.
- 3.4. Interior doors were in satisfactory condition with any exceptions noted.
- 3.5. The door from the interior to the garage was in satisfactory condition, and was equipped with a self closing device to prevent accidental carbon monoxide poisoning.
- 3.6. Garage door pressure safety return (auto reverse) was inoperative. Recommend this be repaired as to avoid a safety hazard.
- 3.7. Several windows need interior sealing.

Windows need sealing

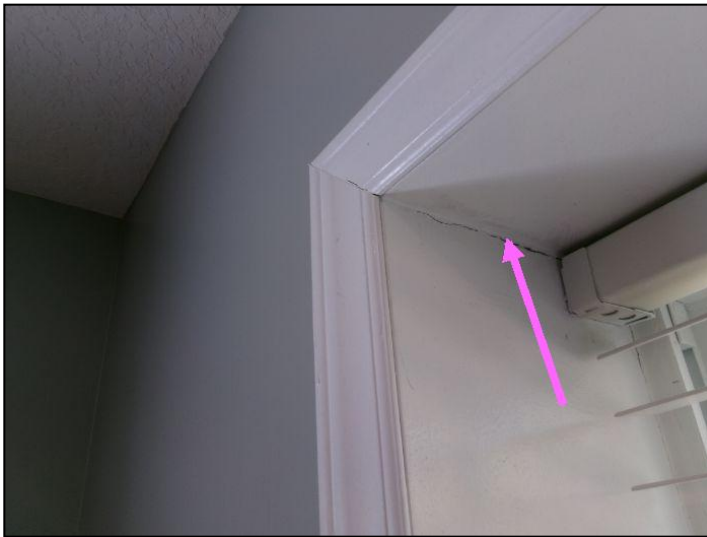
- 5.1. There was trim in need of sealing in a few areas around the dwelling.
- 5.2. Tile in guest bathroom is in need of grout/sealing. We are unable to determine the condition of underlying material.

Cracks need sealing

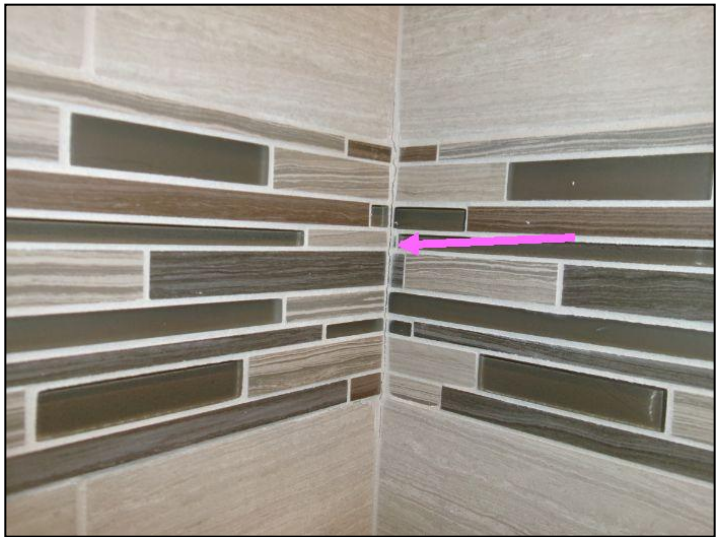
Shower/tub tile needs grout/sealing

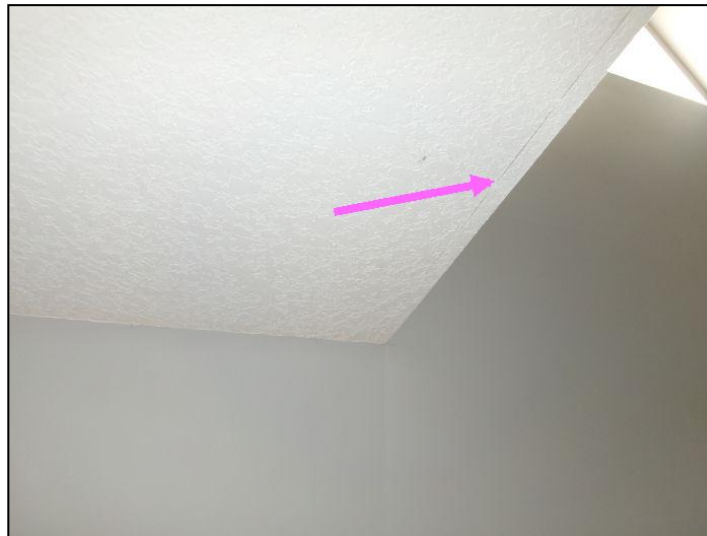
7.1. At the time of the inspection, we found minor (i.e. hairline or less than 1/8" etc.) cracking on plaster ceilings. These can be repaired the next time any painting is done in these areas.

Cracks need sealing

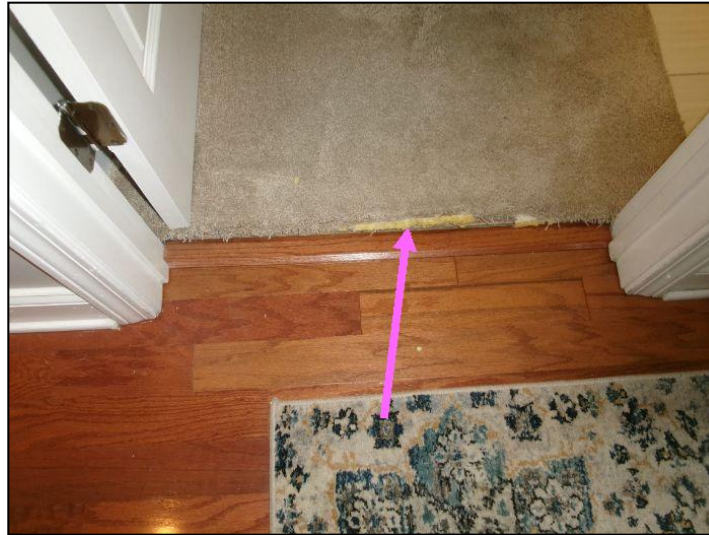
9.1. Larger threshold recommended in the doorway to avoid a trip hazard.

Threshold needed

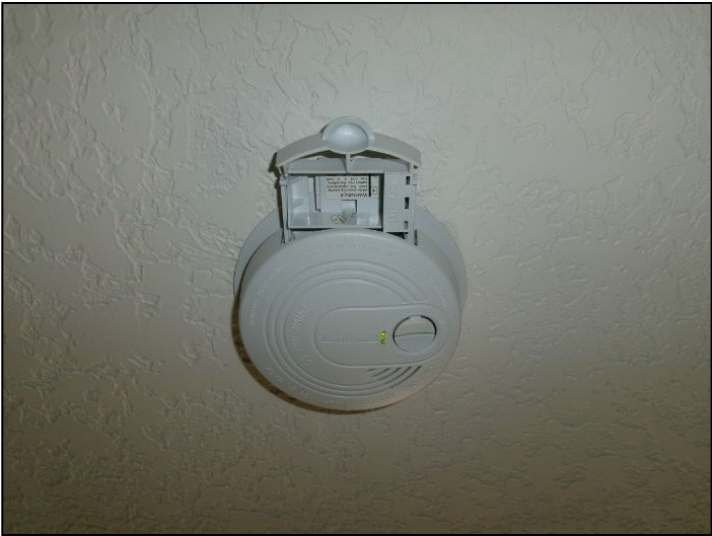
13.3. The smoke alarms were not operational at the time of this inspection.
13.4. We noted no carbon monoxide detector installed at the time of this inspection.

Smoke alarms inoperative

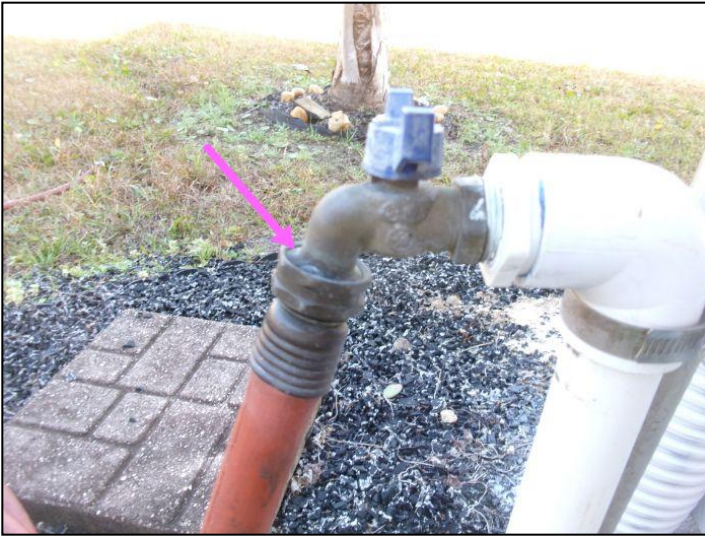
- 3.1. The hose bib(s) did not have [backflow prevention](#). We recommend all outside bibs have backflow prevention as to prevent contamination of the potable water within the dwelling.

Hose bib(s) need back flow prevention

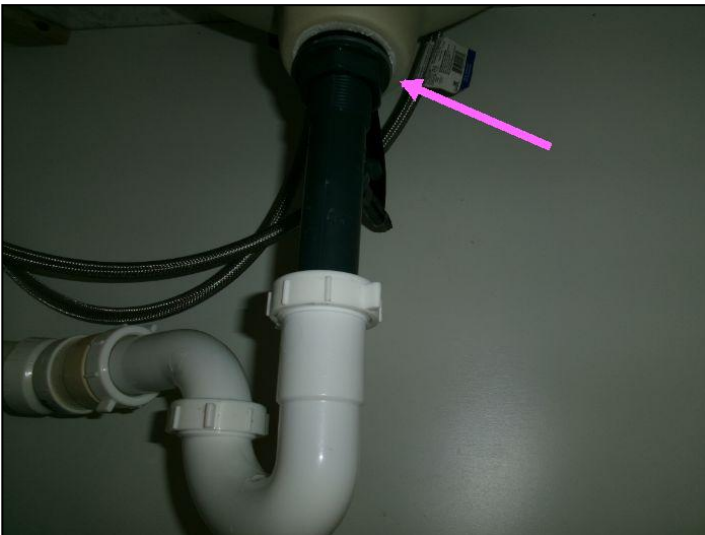
5.1. The master bathroom sink drain pipe was leaking.

Drain leaks

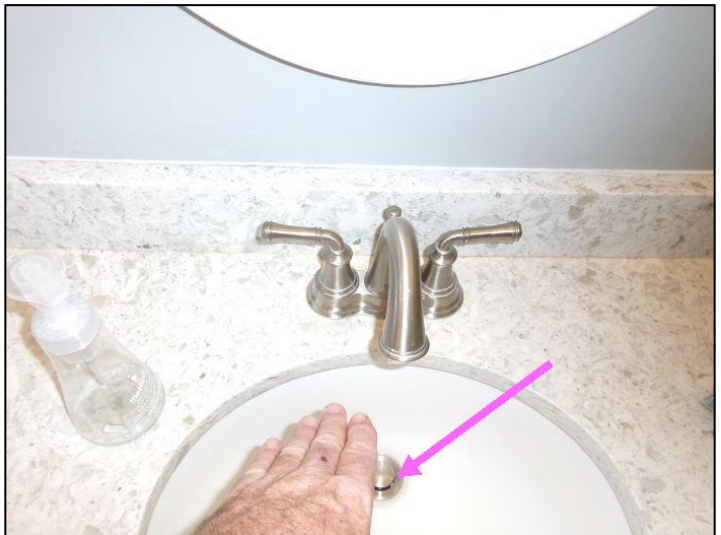
5.2. The master bathroom sink stopper assembly was inoperative/missing.

Sink stopper inoperative/missing

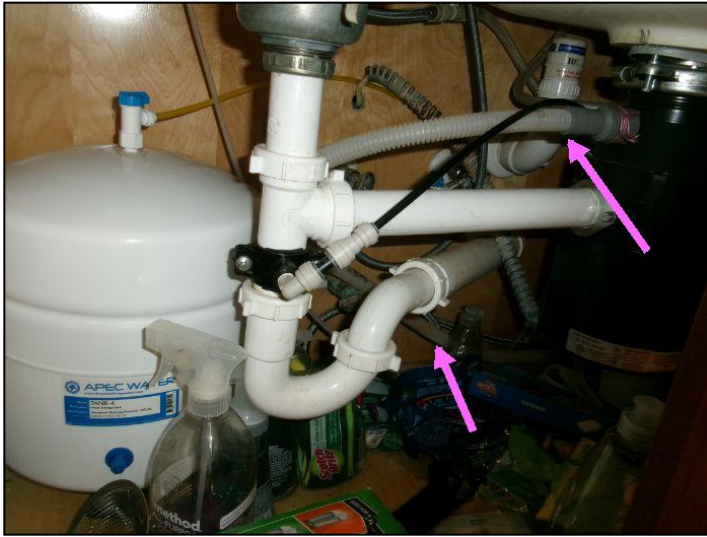
5.3. The dishwasher was missing a hi loop drain.

No Hi loop drain

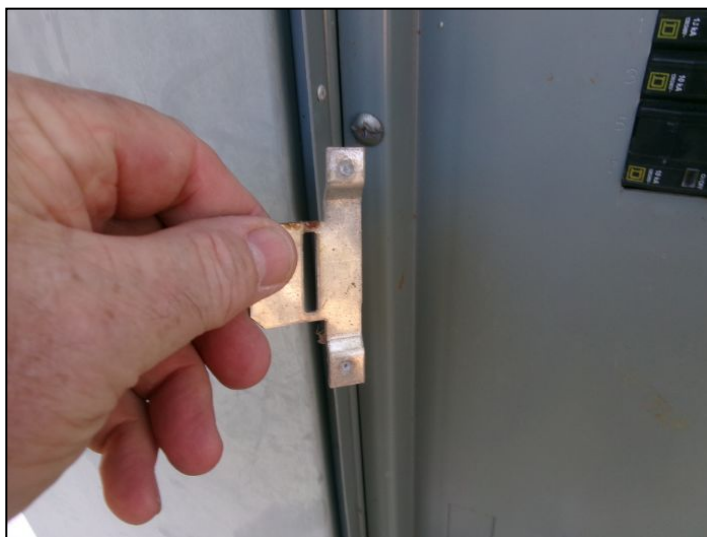
- 2.1. Panel lock / latch was damaged. Recommend repair or replacement.

Latch / lock damaged

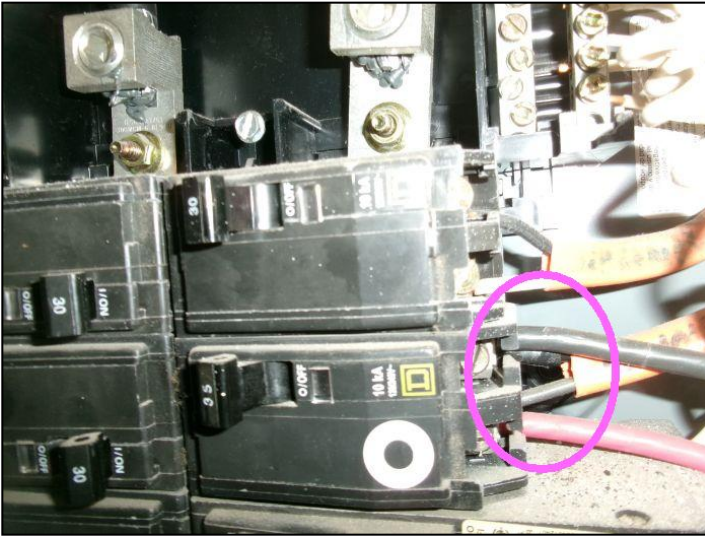
Double tapped breaker(s)

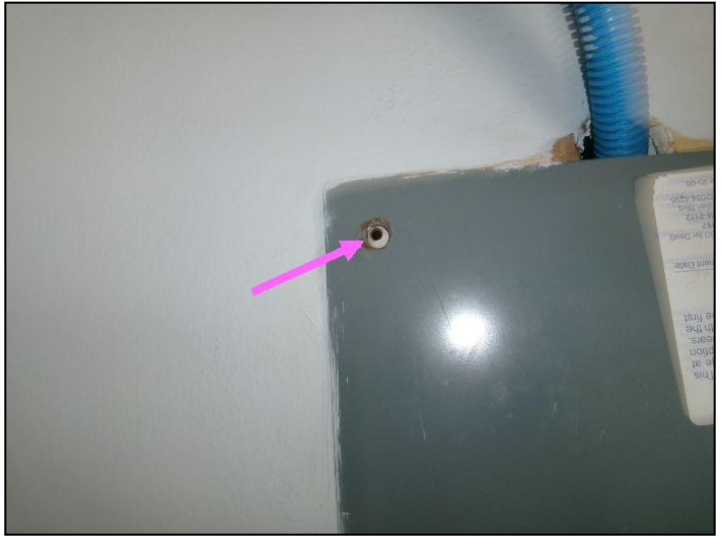
4.3. Panel cover screw(s) missing.

Panel missing screws

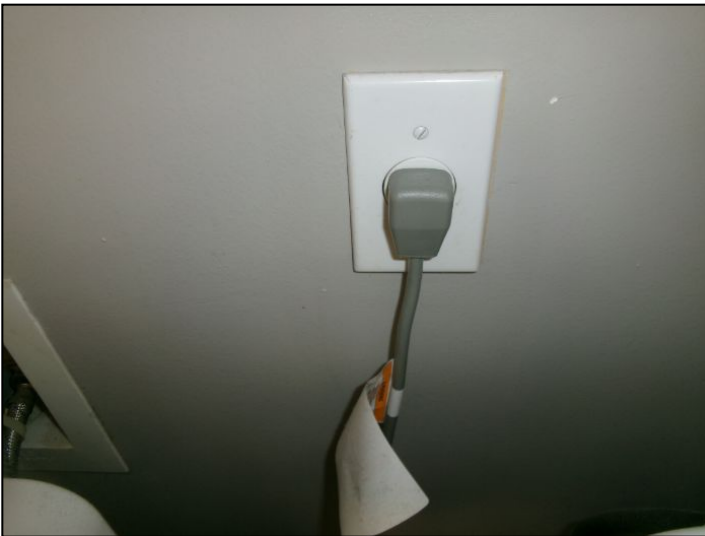
Clothes washer outlet not GFCI protected

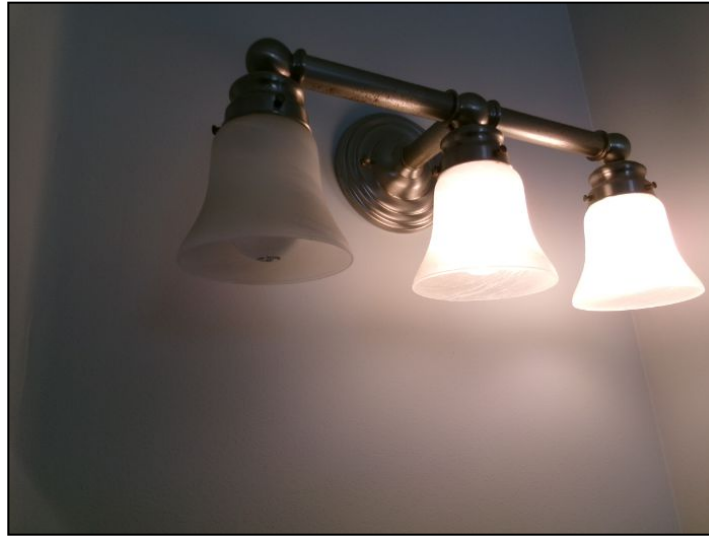
7.2. There were several ceiling lights that were inoperative..Bulbs?

A few ceiling lights inoperative..Bulbs?

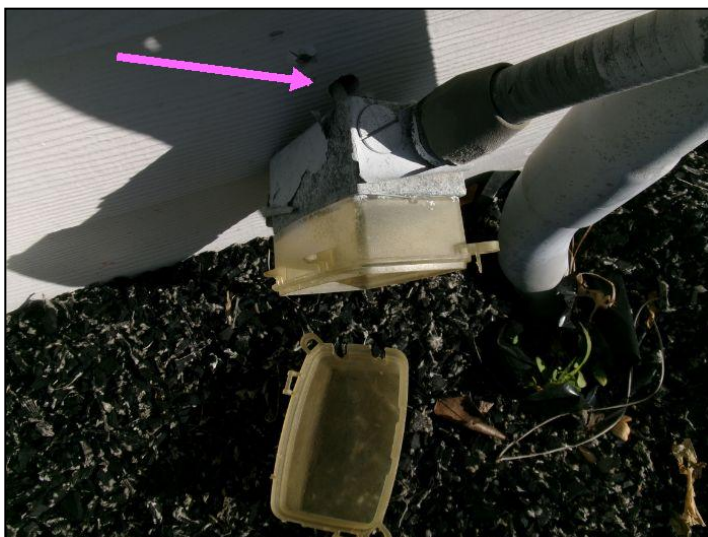
Receptacle loose

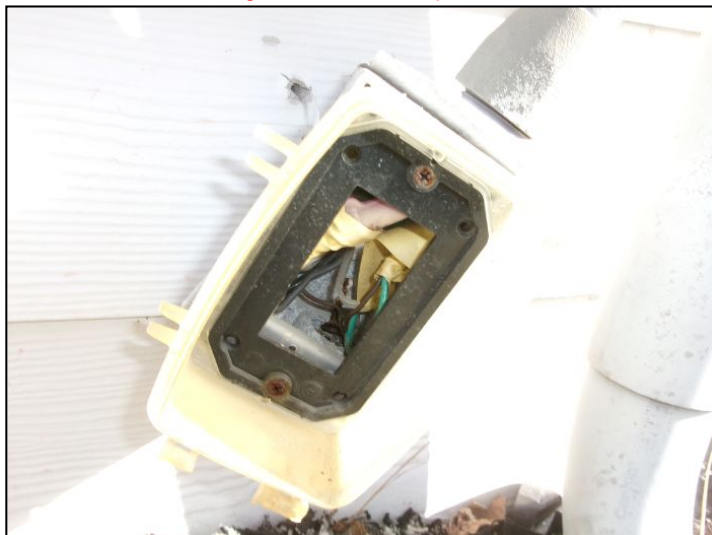
Receptacle damaged

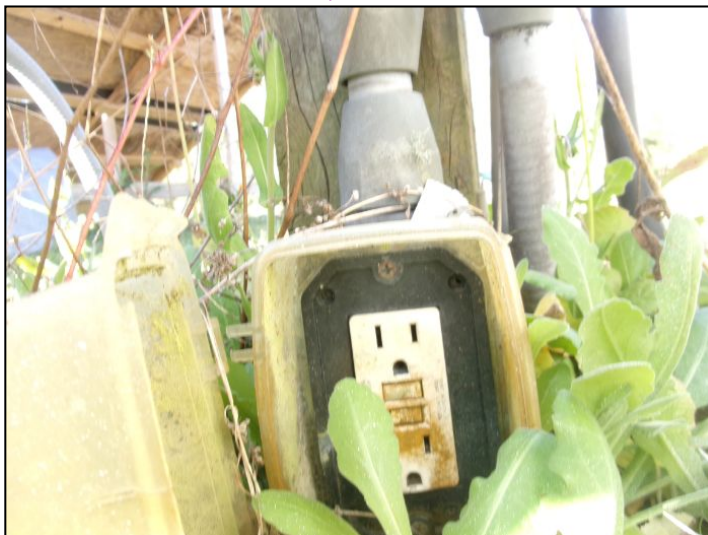
Outlet inoperative

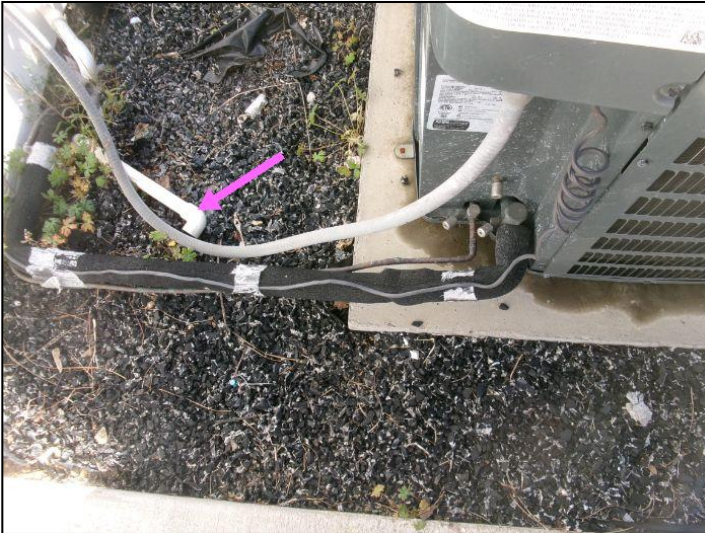
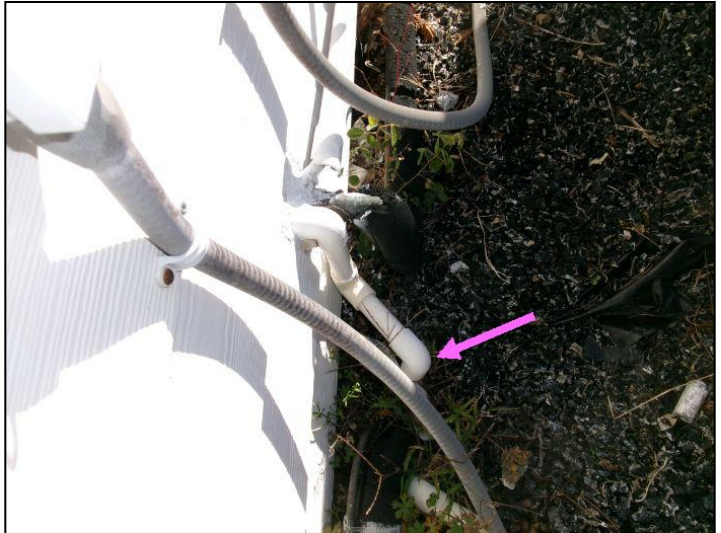
2.4. We recommend moving the condensate drains further from the foundation, so as to avoid erosion.

Drain should be moved away from foundation

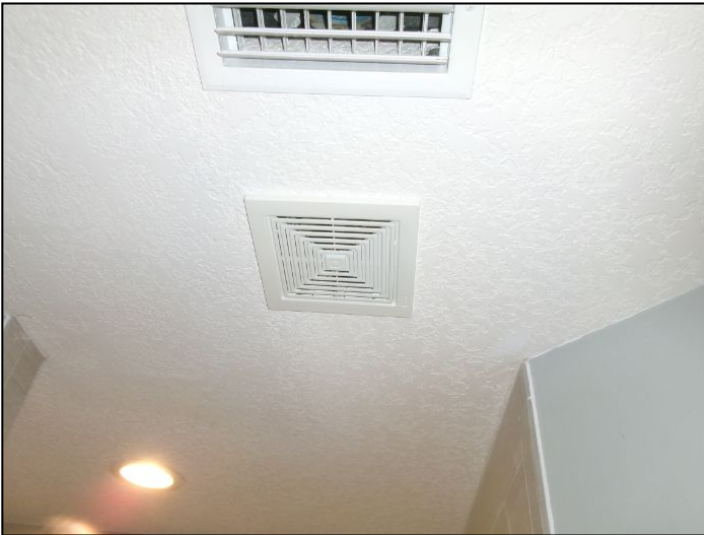
- 4.1. The exhaust vent in the master bathroom shower area was inoperative.
- 4.2. The guest bathroom vent was not blowing full temperature. Recommend evaluation by a licensed HVAC contractor.

Bathroom exhaust fan inoperative

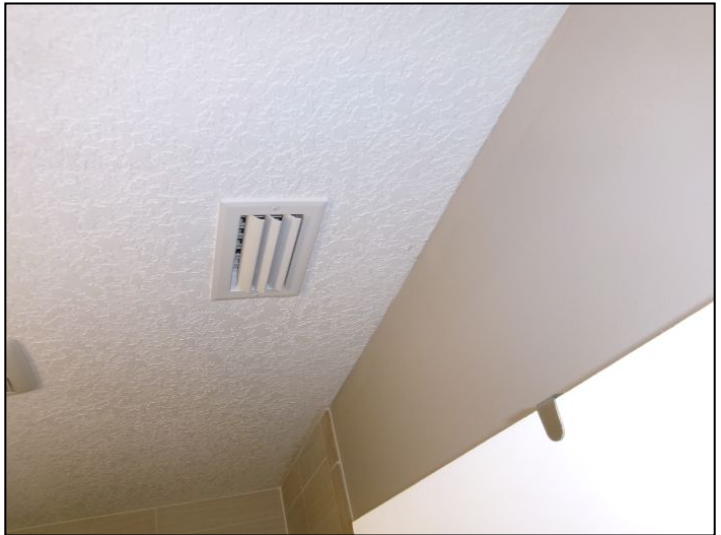
Less than full operation

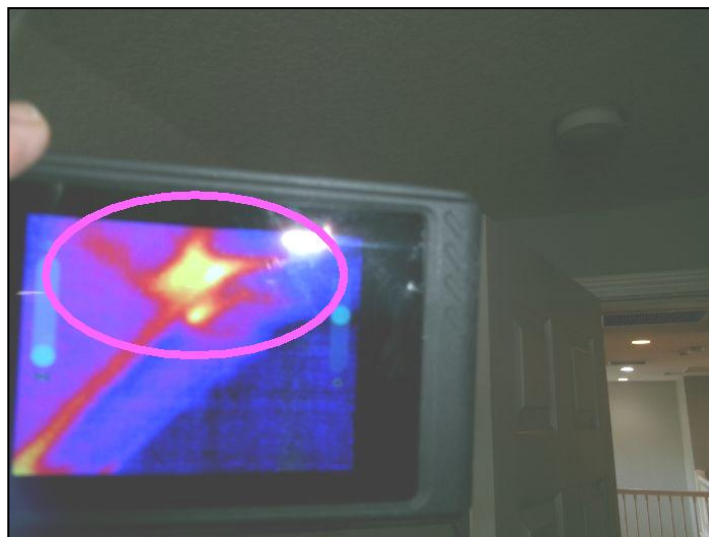
6.1. Thermal imaging of the ceiling showed excessive heat entry at several locations. The usual cause of this is missing and/or inadequate insulation.

Displaced / missing insulation

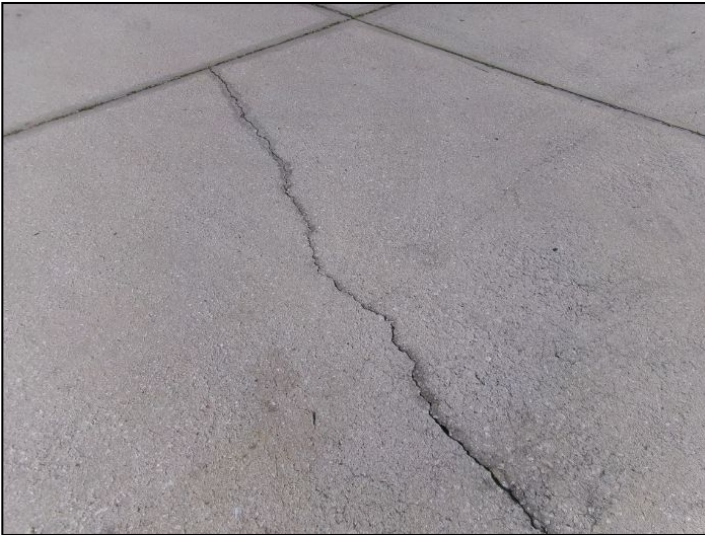
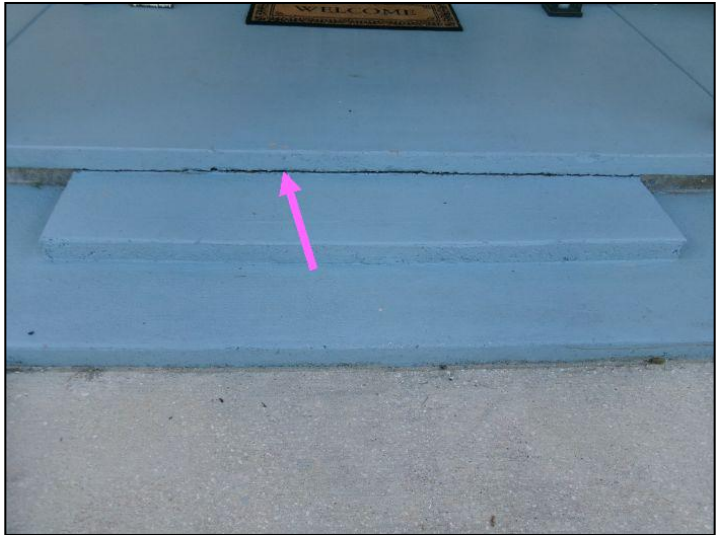
2.1. Typical cracking was observed at the concrete surfaces. Recommend sealing the cracks to prolong the life of the concrete.

Cracks need sealing

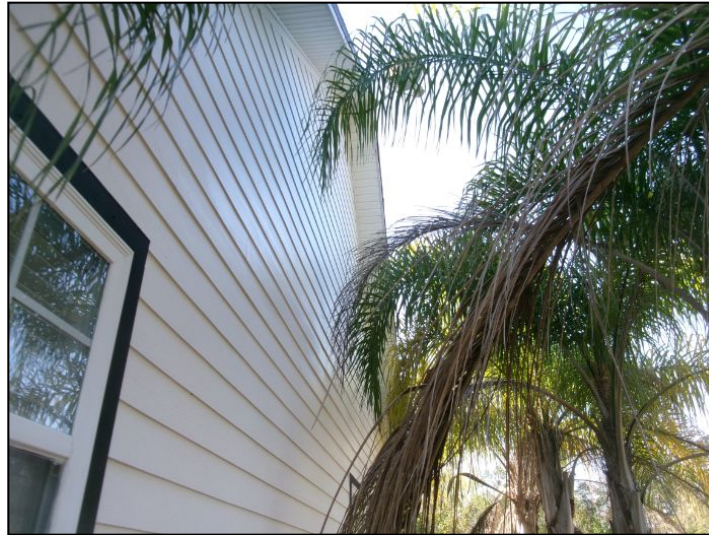
Trees need trimming

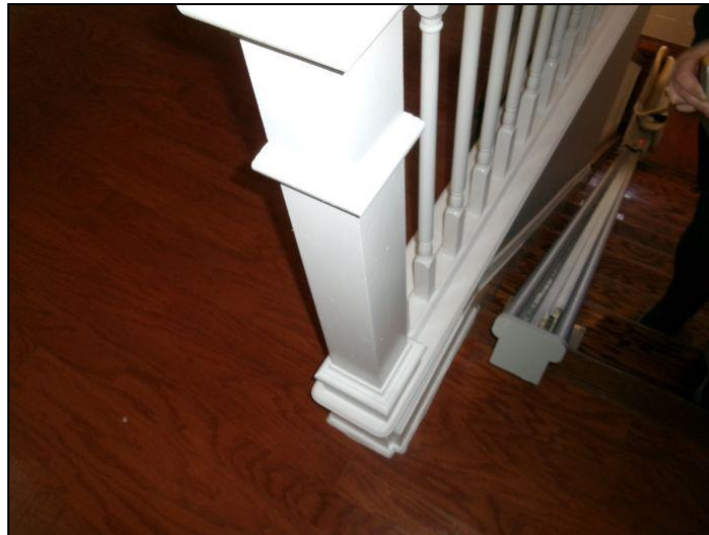
5.1. Handrail and baluster assembly is loose. Recommend additional fasteners be installed as to further stabilize the assembly.

Ballaster loose

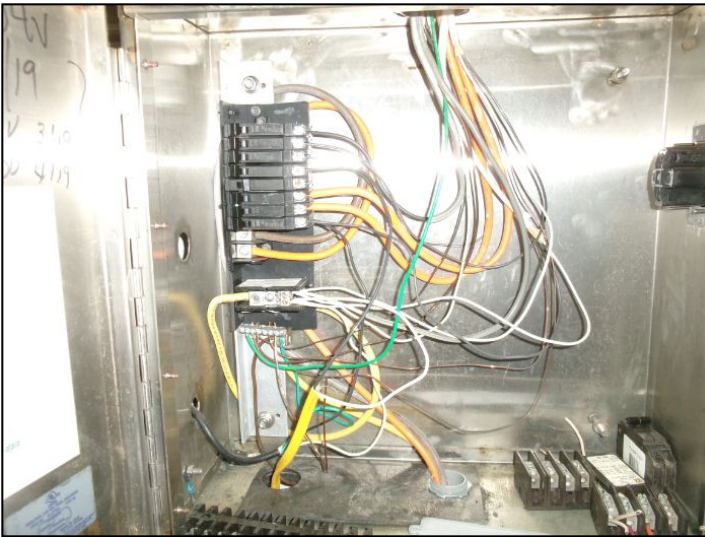
- 5.1. Panel was a hand made panel and not UL rated, recommend evaluation by a licensed electrical contractor.
- 5.2. Outlets in the building were not GFCI protected. We recommend these be replaced with GFCI outlets as to avoid a shock/short hazard.
- 5.3. Wiring entering the panel did not have proper protection. We recommend a grommet/bushing be installed as to prevent a shock/fire hazard.
- 5.4. Multi lugged neutrals inside panel box (more than one electrical conductor attached). This is not standard practice, and may cause overheating or even an electrical fire. Recommend evaluation by a licensed electrical contractor.

Panel not UL listed

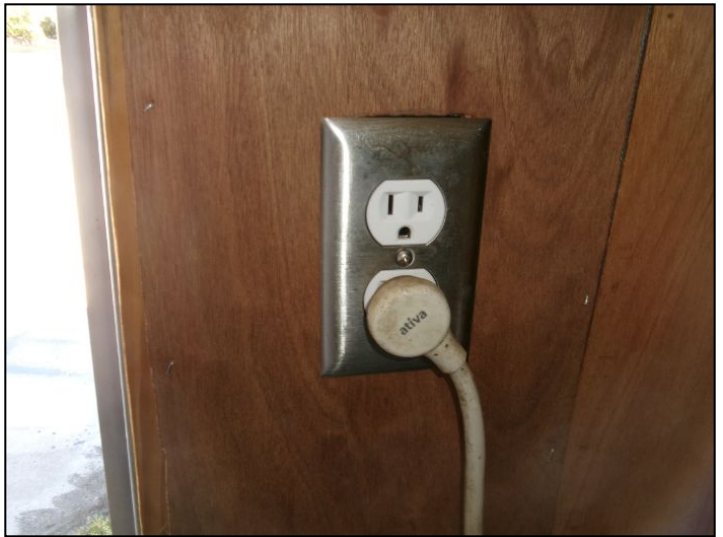
Outlets not GFCI protected

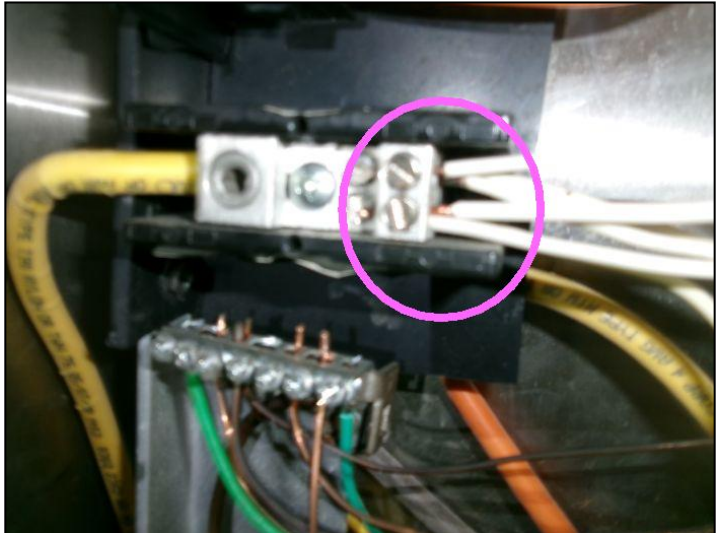
Multi lugged neutrals.

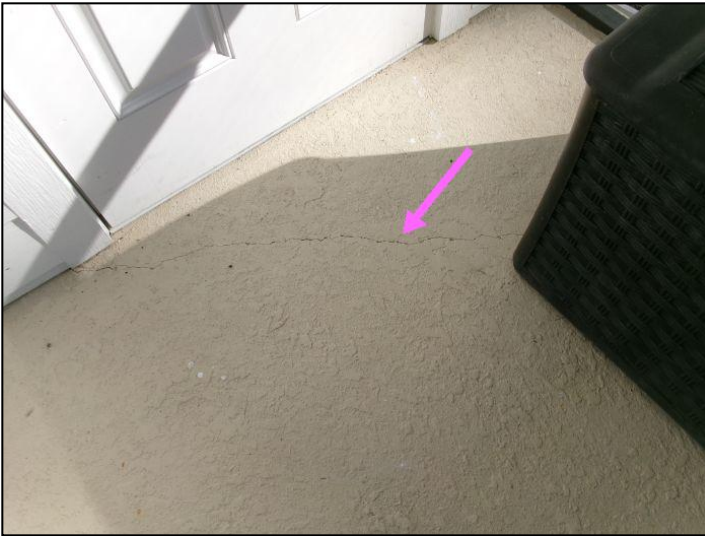
Cracks need sealing

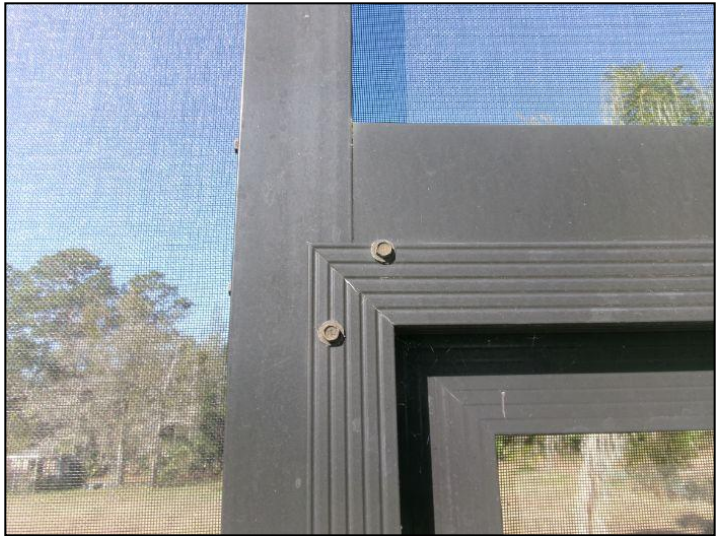
2.5. We noted minor corrosion on the pool cage screws, recommend painting or replacement to prevent staining and to maintain structural integrity.

Corrosion on screws
