# PROPERTY INSPECTION REPORT

**1234 Beach Blvd**  
**Inspection Prepared For: John Doe**  
**Agent: Janette Ledea - Remax Tri-City**

**Date of Inspection: 3/12/2026**  
**Age of House: 1924 102 yrs old Size: 1362 SqFt**  
**Weather: Sunny & Hot**

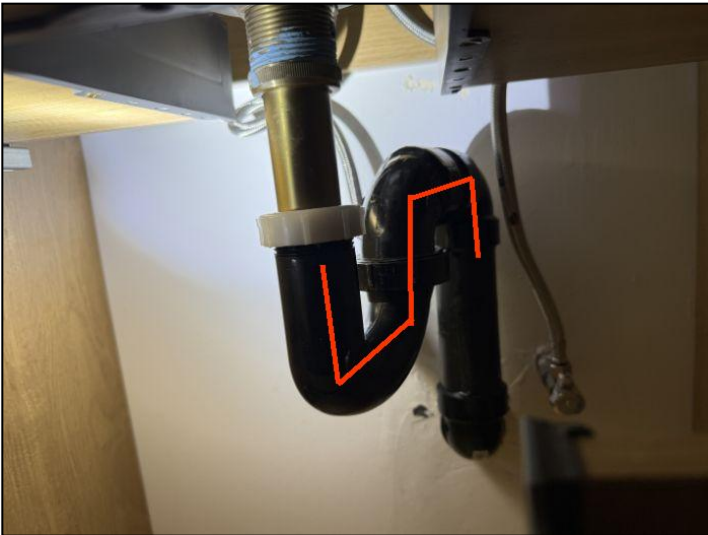
S-Trap primary

- Improper "S" trap noted. This trap configuration may cause the trap to siphon dry, allowing sewer gas and odour to enter the dwelling. This situation may be rectified by the installation of an anti siphon device (cheater vent). Suggest repair by a qualified professional. In the alternative, run a little bit of water into the sink to reseal the trap if odour is detected.

| Interior Areas | | | |
|---|---|---|---|
| | Page 12 Item: 9 | Plumbing | • Improper "S" trap noted. This trap configuration may cause the trap to siphon dry, allowing sewer gas and odour to enter the dwelling. This situation may be rectified by the installation of an anti siphon device (cheater vent). Suggest repair by a qualified professional. In the alternative, run a little bit of water into the sink to reseal the trap if odour is detected. |

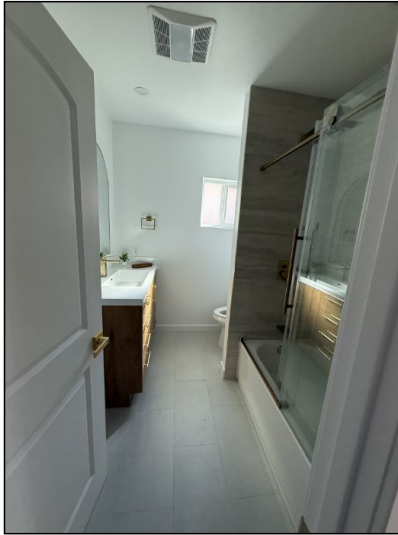
- No discrepancies except where noted at time of inspection.
- Wall adjacent to toilet showed signs of a repair and needs painting.

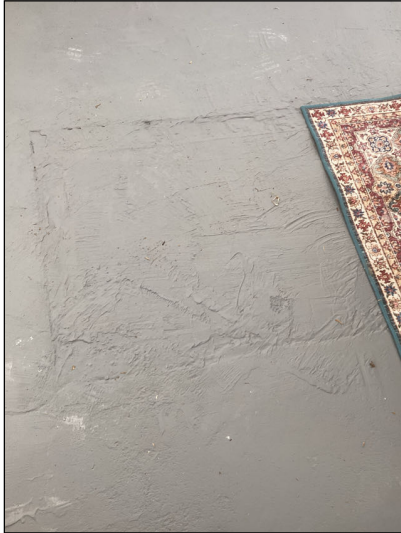
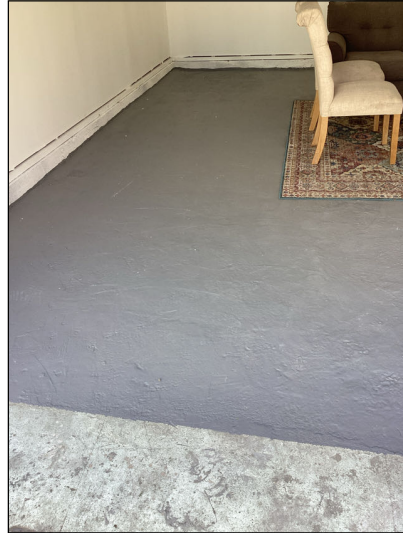
- Evidence of repairs observed, unable to determine the effectiveness of these repairs.
- Could not fully inspect garage floor due personal belongings covering.

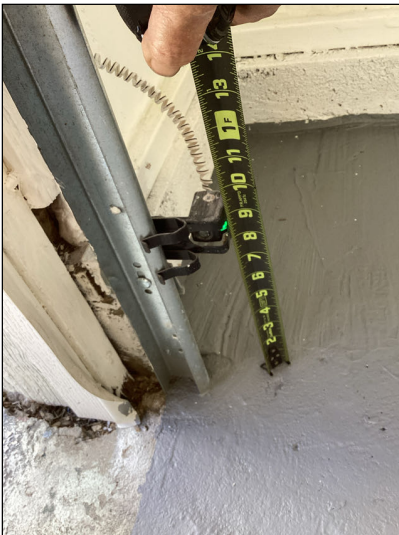
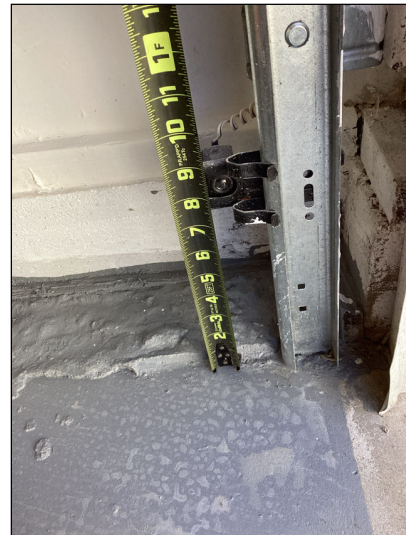
• The vertical distance between the photo-eye beam and the floor should be no more than 6 inches. The current height is 7 1/2 - 9 inches; for safety reasons it is recommended relocating the eye beams.

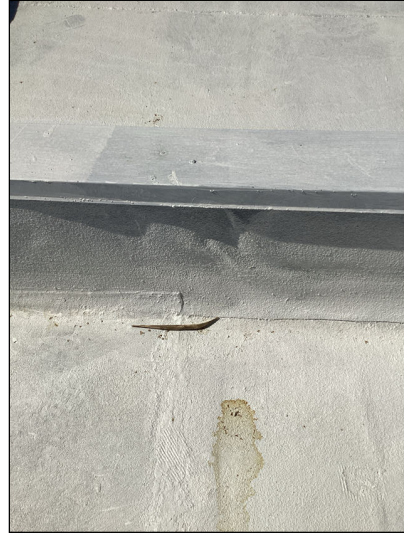
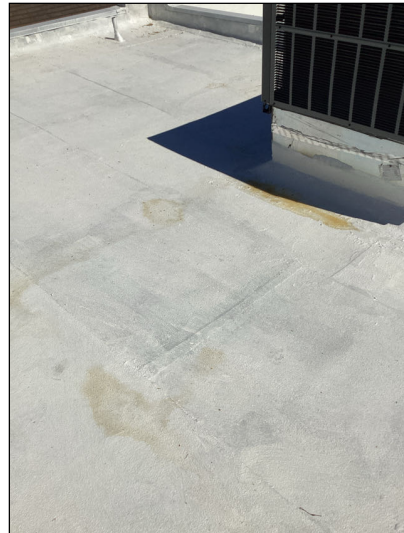
- No major system safety or function concerns at time of inspection.
- Condensation noted near package unit.

Standing water (Condensation)

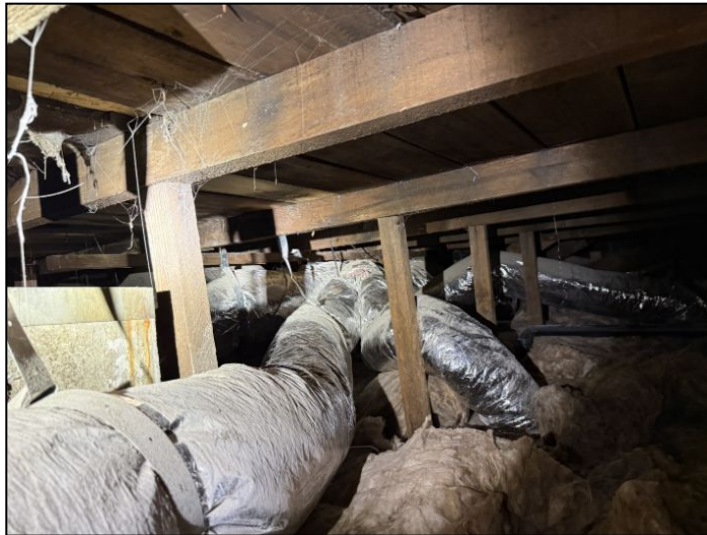
- Ducts were loose in areas; advise securing.

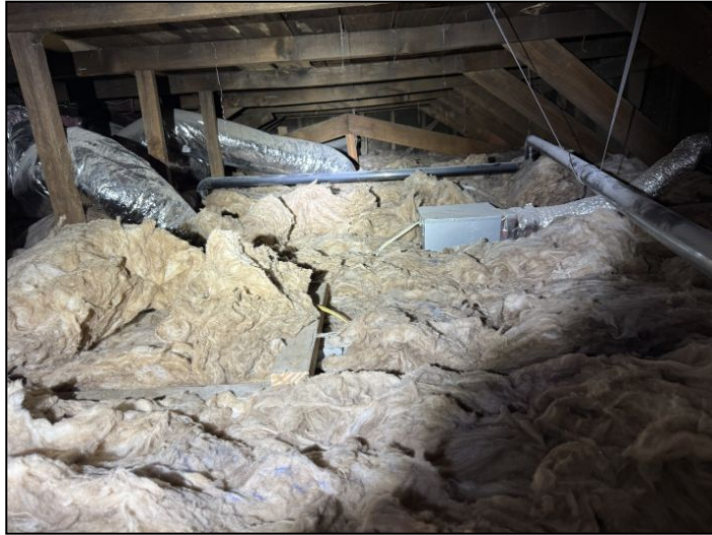
- No insulation over attic hatch; recommend installation, then sealing hatch with caulk to minimize heat loss.

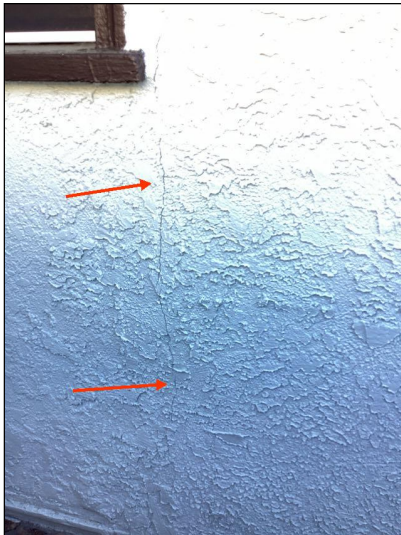
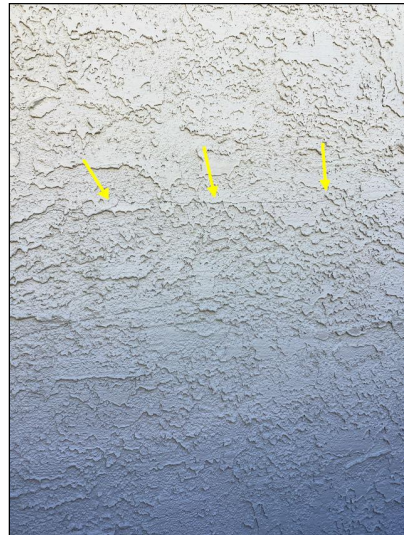
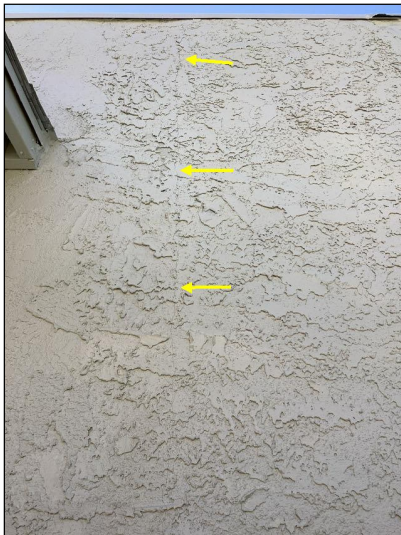
- Appeared in satisfactory condition at time of inspection.
- Cracks noted in stucco. Recommend sealing to prevent moisture intrusion and monitor.

Crack

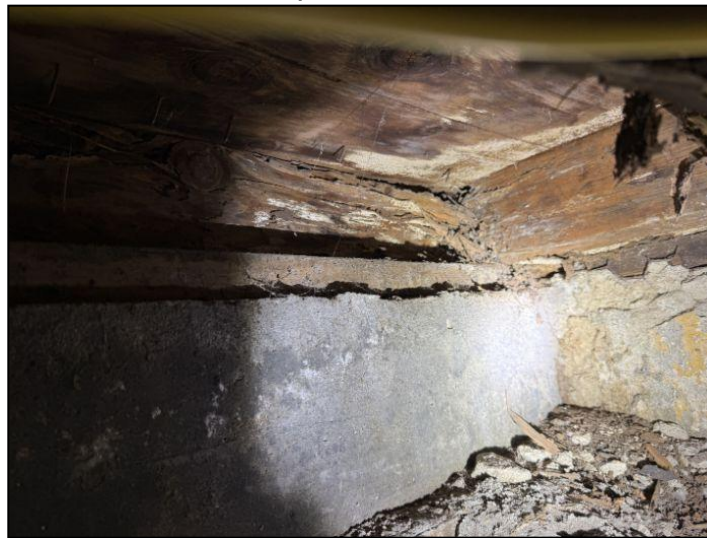
- Active leaks observed at the time of inspection.

Termite eaten

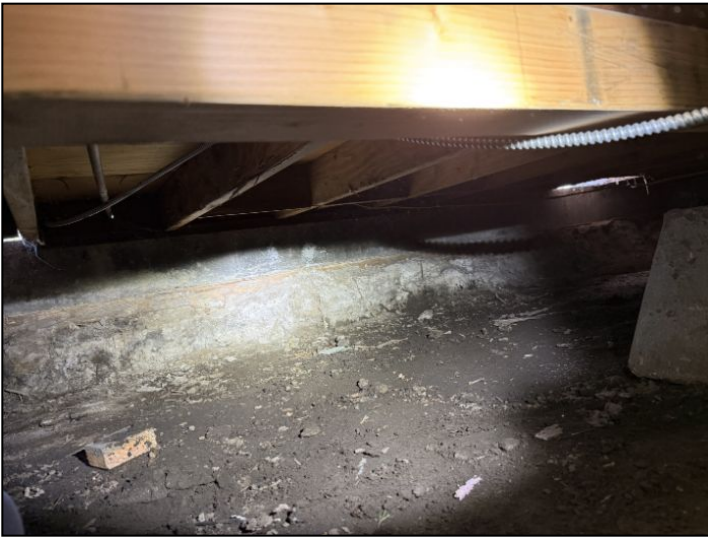
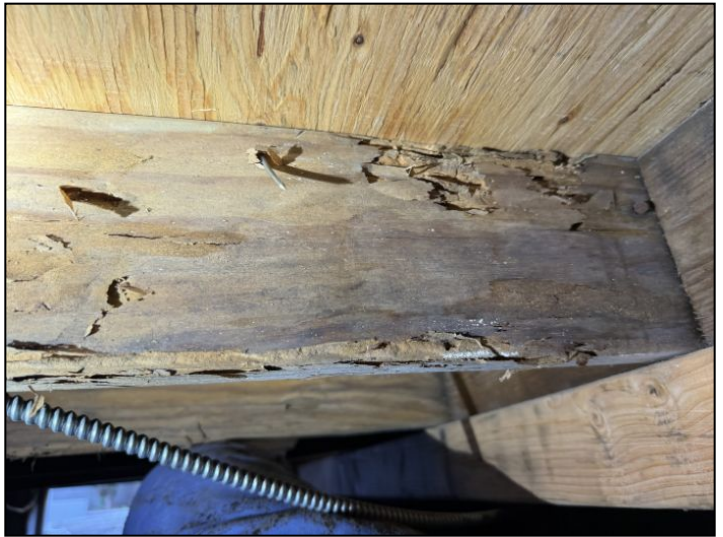
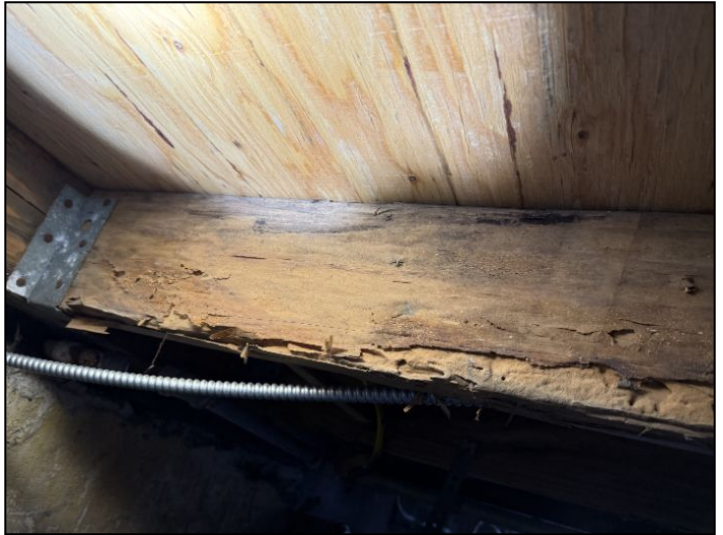
- Plywood sheathing sub floor.
- Dimensional lumber wood Joists
- Evidence of what appears to be consistent with termite damage was noted at one or more locations, recommend further review by a qualified Wood Destroying Organism Contractor to assure that no current infestation is present.

Termite eaten

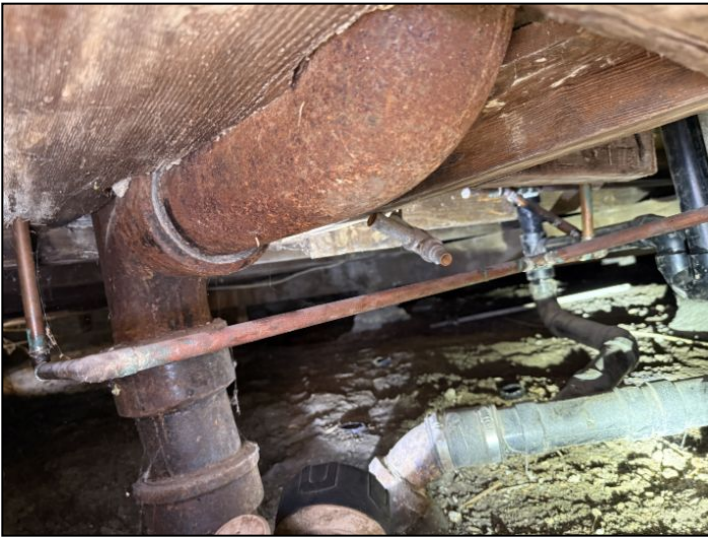
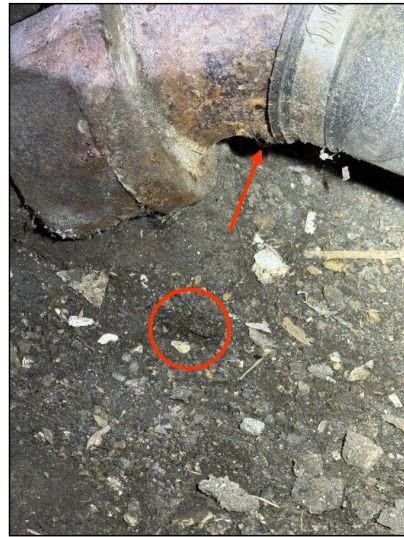
- Acrylonitrile-Butadiene-Styrene "ABS" waste and vent pipes noted.
- Cast iron waste and vent pipe noted.
- Cast iron drain lines have a life expectancy of 30-50 years. Recommend budgeting for replacement in the near future at areas where rust cysts are visible, BEFORE leaks occur.
- Evidence of leakage detected and requires review and repair by a qualified plumbing contractor.

Leaking

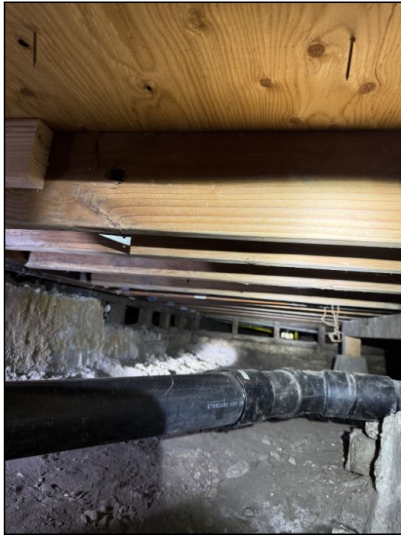
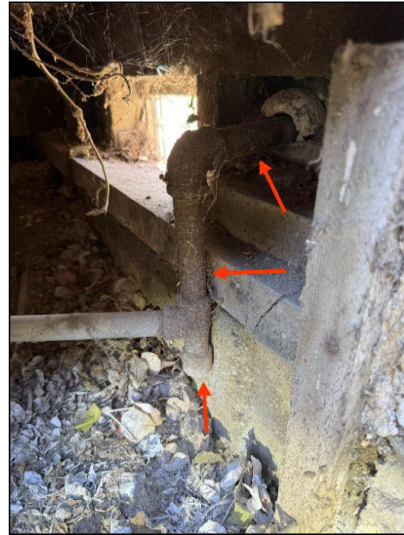
Rusted gas line

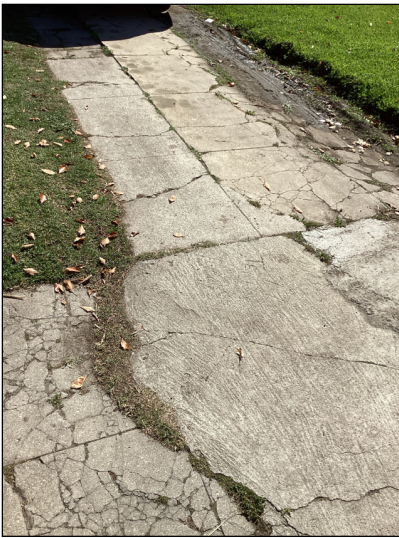
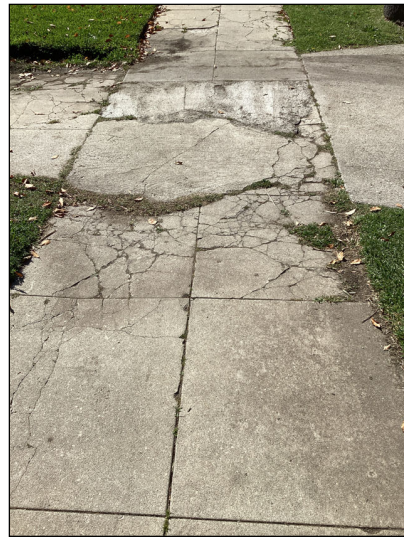
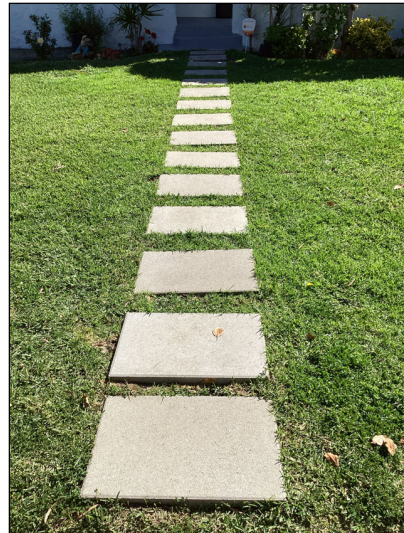
• There are numerous areas of damaged concrete surfaces. Concrete replacement is expensive. Recommend a concrete specialist provide an estimate for repair and or replacing.

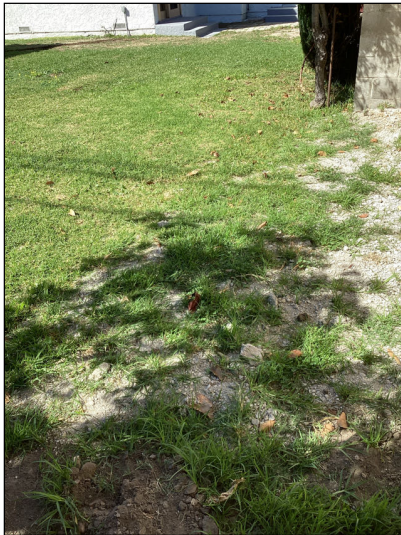
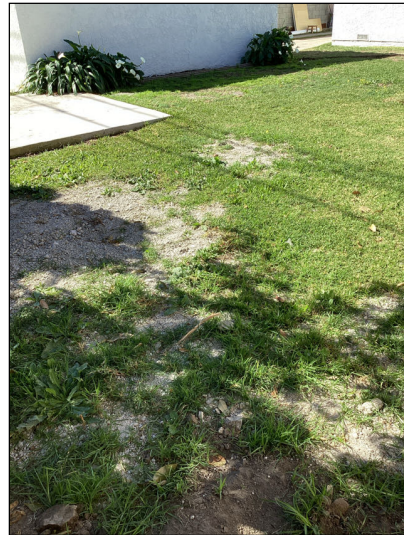
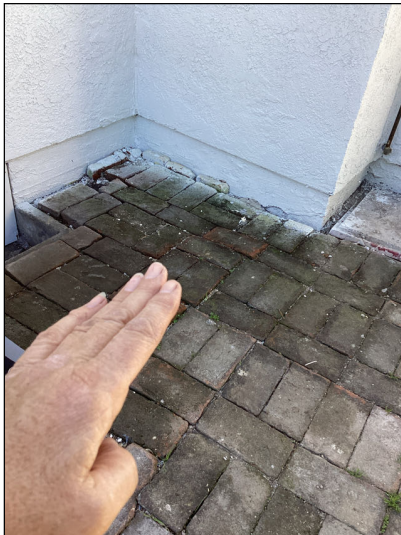
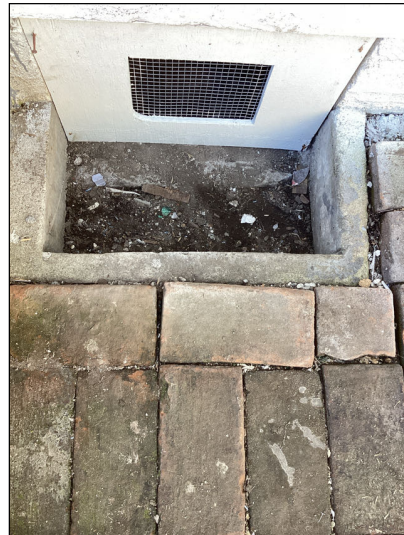
- The rear exterior grading by the back door is improperly sloped towards the foundation. Water can intrude into the interior. Recommend creating the proper slope away from the foundation to allow for proper drainage.

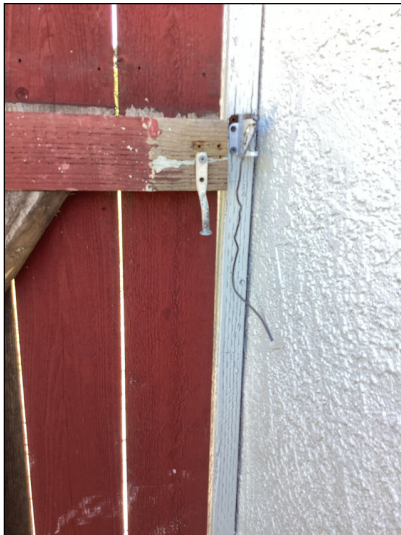
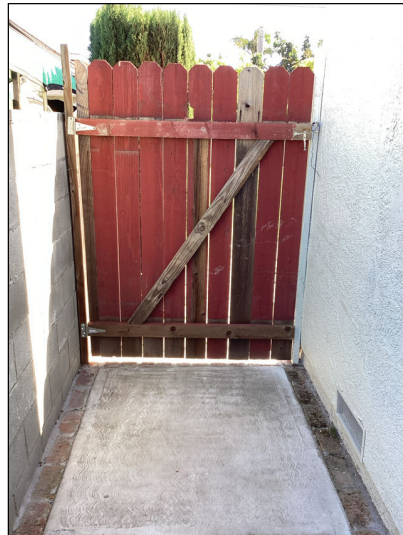
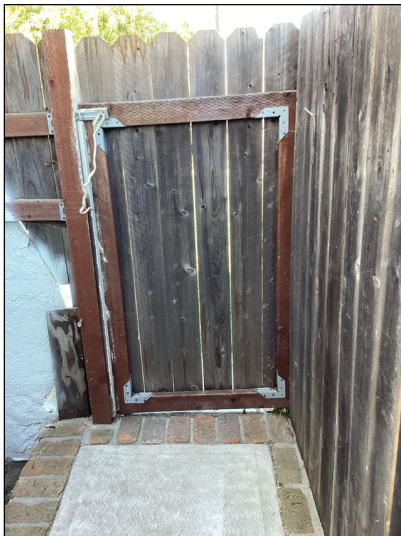
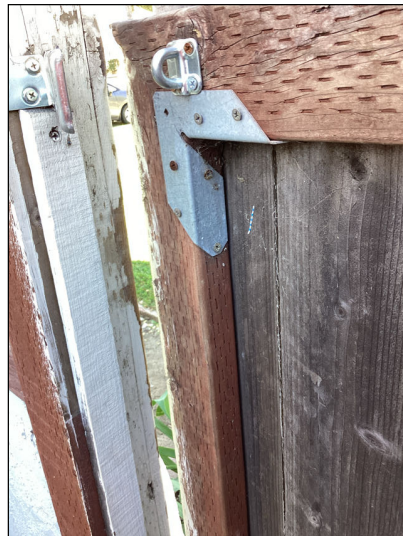
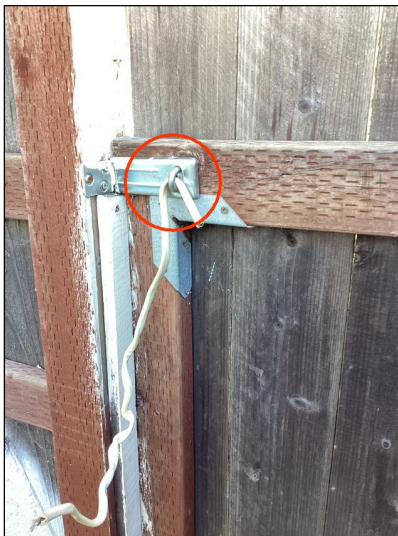
- Gate rubs.
- Gate hardware missing or damaged; gate will not secure.

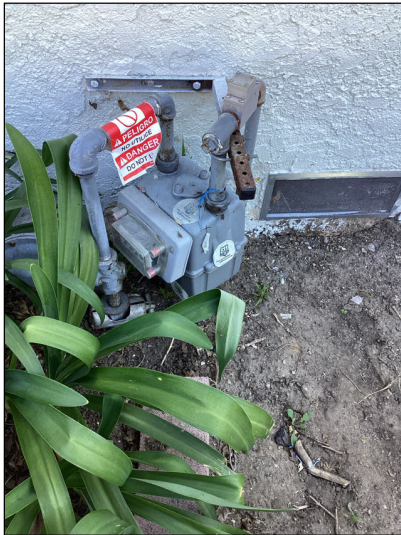
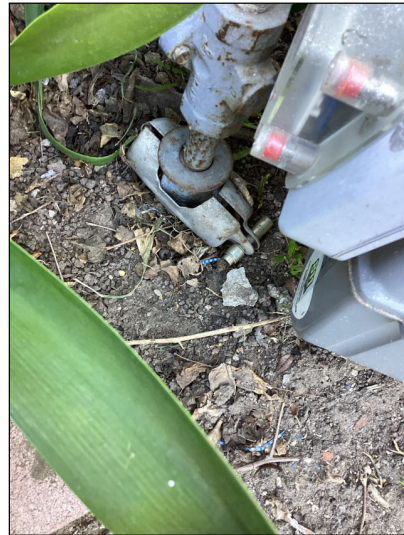
- Gas shut off locked. No gas to the house. Gas company came to turn on however, shut it off again due to an unknown leak.

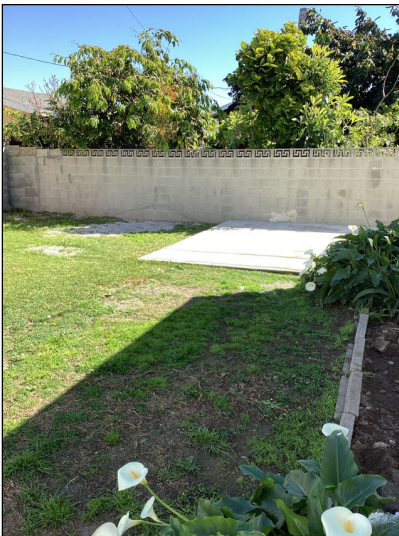
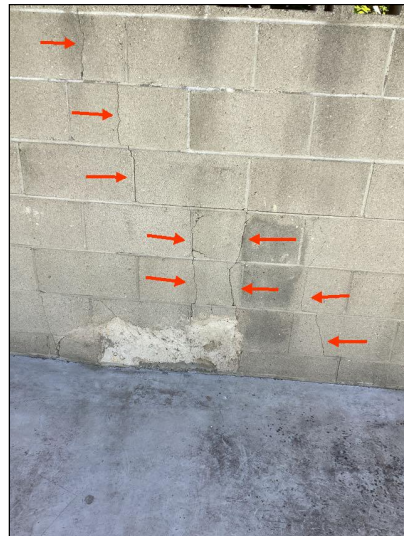
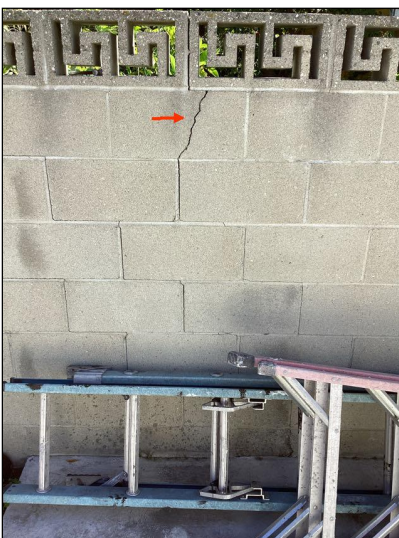
- Stress crack in block wall. Recommend monitoring.
- Appeared serviceable at time of inspection.
- Loose top blocks observed. This is a safety concern. Suggest maintenance/repairs as needed to ensure safety.

Crack

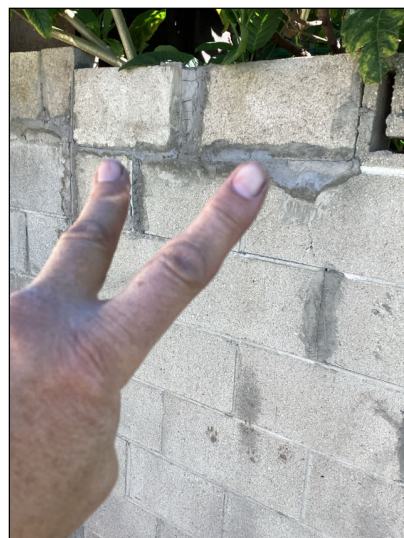
Loose top blocks

| Foundation | | | |
|---|---|---|---|
| | Page 55 Item: 12 | Fence Condition | <ul style="list-style-type: none"><li>• Loose top blocks observed. This is a safety concern. Suggest maintenance/repairs as needed to ensure safety.</li></ul> |
