***"1st Class Service,
Provided by
1st Rate Inspections!"***

Property Inspection Report

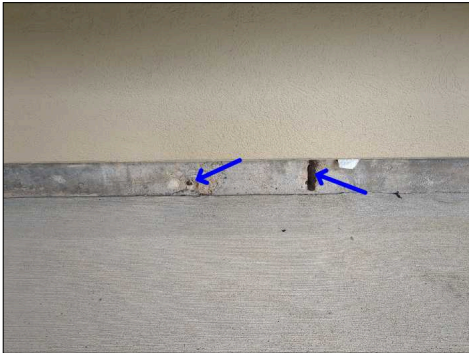
One or more of the post tension cables were noted to be exposed, recommend using a rust inhibitor to all rusting cables and sealing all exposed post tension cables noted around the foundation of the house to help prevent premature deterioration of the post tension cables.

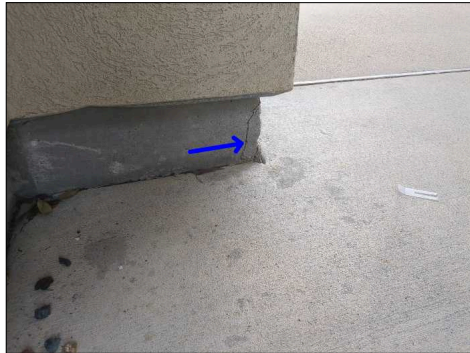
Corner pops were noted on one or more corners of the foundation, these are usually considered cosmetic nature unless other movement is noted. Recommend sealing all cracks to help prevent further deterioration.

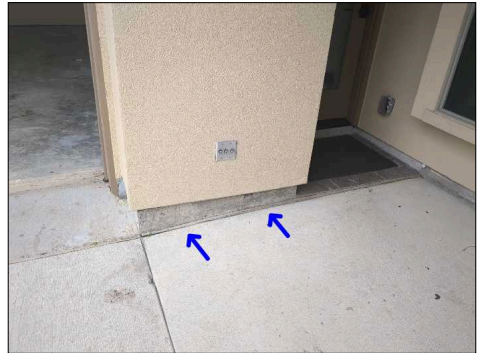
There are form boards noted at the slab, it is recommended that all form boards be removed from around the slab to help prevent conducive conditions for wood destroying insects as deteriorating wood is a conducive condition for wood destroying insects. Mainly at - main house

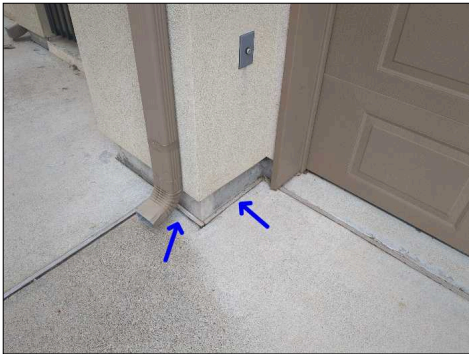
There are form boards noted at the slab, it is recommended that all form boards be removed from around the slab to help prevent conducive conditions for wood destroying insects as deteriorating wood is a conducive condition for wood destroying insects. Mainly at - guest house

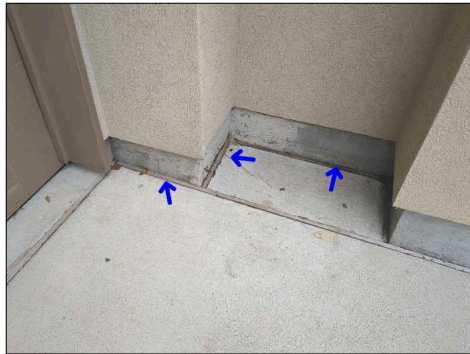
There are form boards noted at the slab, it is recommended that all form boards be removed from around the slab to help prevent conducive conditions for wood destroying insects as deteriorating wood is a conducive condition for wood destroying insects. Mainly at - guest house

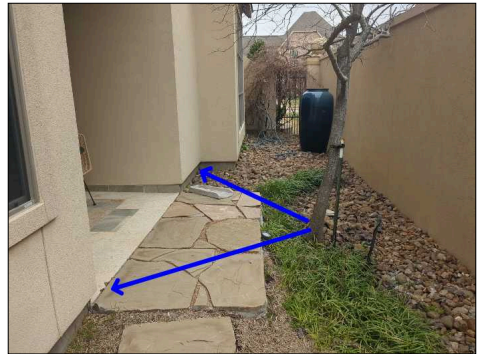
All trees should be located no closer than 15' from structure to help prevent foundation movement. You may want to keep larger trees trimmed to help slow further root growth and future foundation movement as removing older trees may cause voids under the slab from dying root systems.

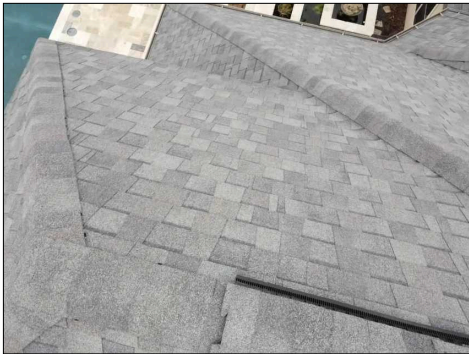
C.9. The downspout is missing the 90 degree elbow to direct water away from foundation. Mainly at - main house rear left

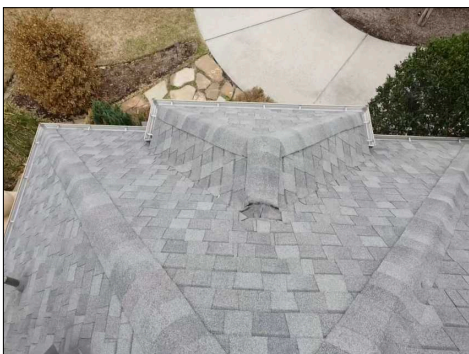
I	NI	NP	D
---	----	----	---

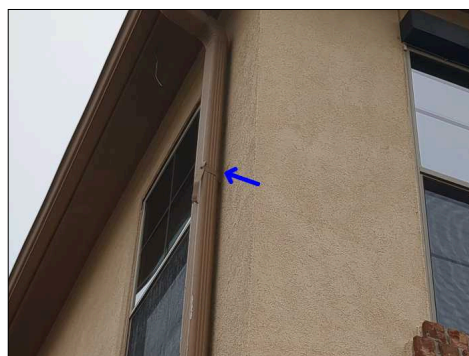
The gutter strap is damaged. Mainly at - left side

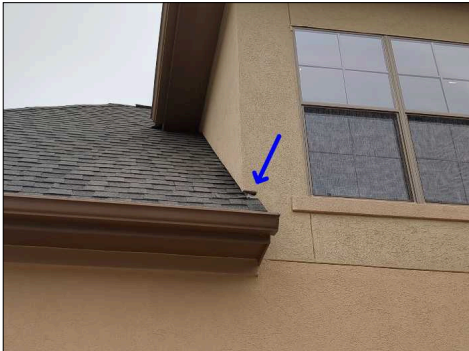
The roof is missing the kick out flashing at the end of the roof to sidewall connection. This is to help prevent water from running down or in the wall causing possible water penetration and deterioration. This is extremely important at stucco sidewall connections to help prevent water from penetrating behind the wall. Mainly at - right side main house

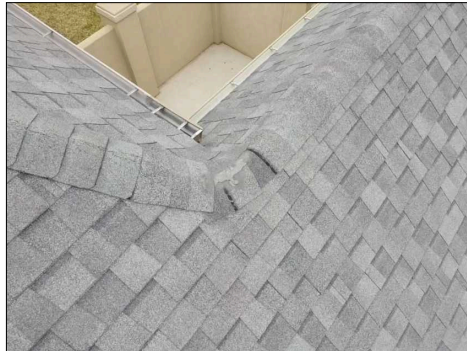
There are damaged or missing ridge shingles on the roof, recommend repairs or replacement of damaged ridge shingles.

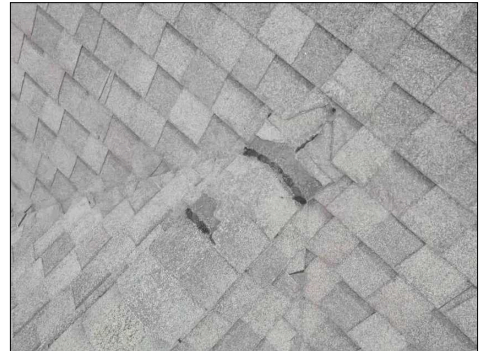
There are damaged or missing ridge shingles on the roof, recommend repairs or replacement of damaged ridge shingles.

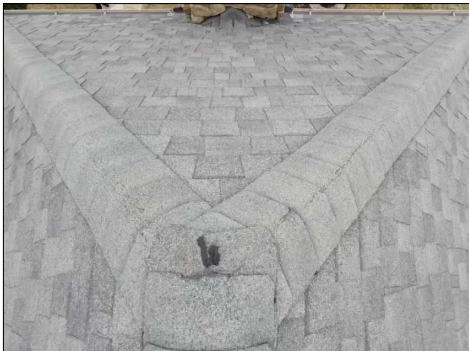
There are damaged or missing ridge shingles on the roof, recommend repairs or replacement of damaged ridge shingles.

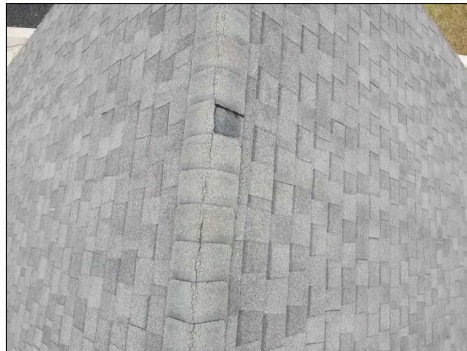
There are damaged or missing ridge shingles on the roof, recommend repairs or replacement of damaged ridge shingles.

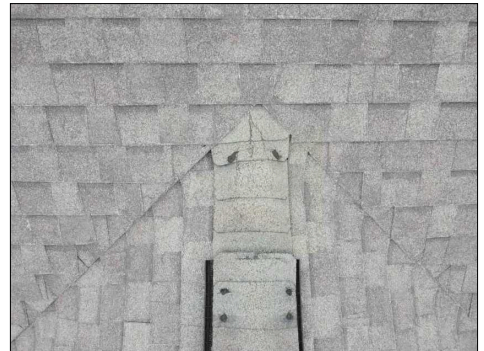
There are damaged or missing ridge shingles on the roof, recommend repairs or replacement of damaged ridge shingles.

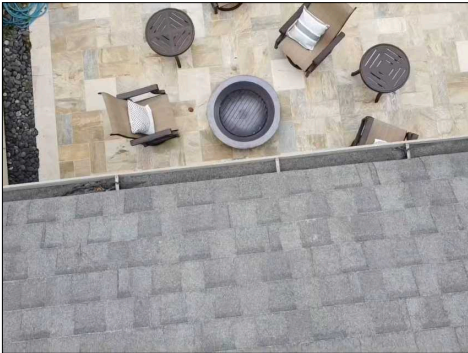
Due to the excessive granular loss on the roof covering the roof may age prematurely. We recommend further review of the roof system for a better understanding of the present condition.

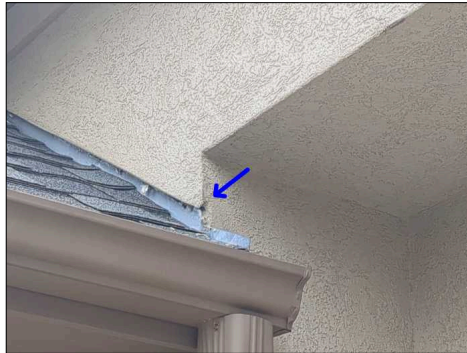
The improper kick-out / roof terminations need to have a proper flashing installed or the current flashing modified or replaced and sealed to prevent water intrusion through the system at these areas. During the installation of any flashing the immediate area can be inspected for wood rot or damage. Any other roof flashing in the area should also be checked as they sometimes can be a contributing cause. We suggest that the sidewall flashings of the roof be set in roof cement in the areas of kickouts as a preventative measure. Mainly at - left rear of guest house

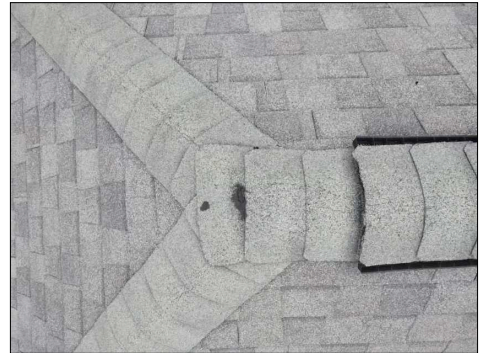
There are damaged or missing ridge shingles on the roof, recommend repairs or replacement of damaged ridge shingles.

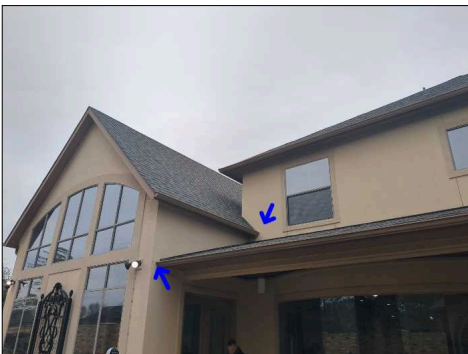
The roof is missing the kick out flashing at the end of the roof to sidewall connection. This is to help prevent water from running down or in the wall causing possible water penetration and deterioration. This is extremely important at stucco sidewall connections to help prevent water from penetrating behind the wall. Mainly at - patio of main house

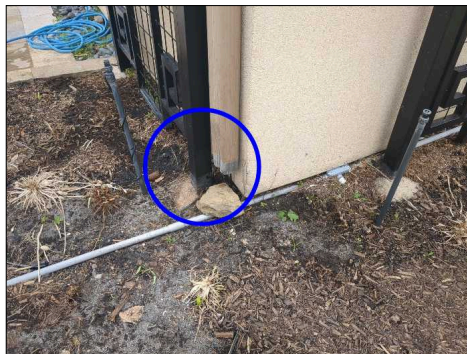
The downspout is missing the 90 degree elbow to direct water away from foundation. Mainly at - main house rear left

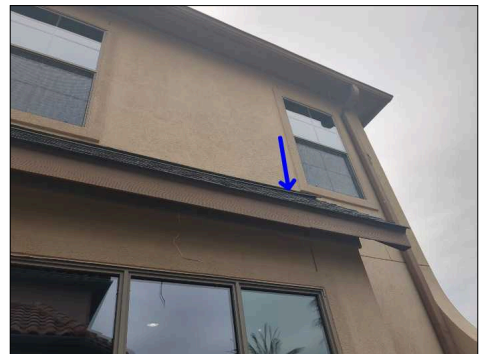
The roof flashing is lifted. Recommend securing all loose or lifted flashing and sealing nails to help prevent water penetration. Mainly at - left side of main house

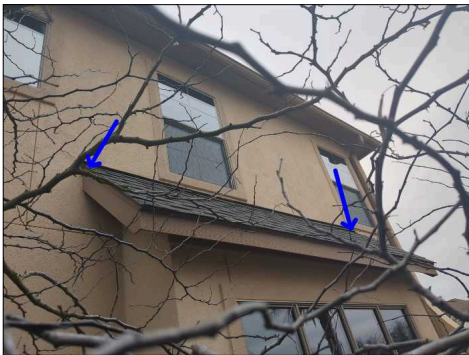
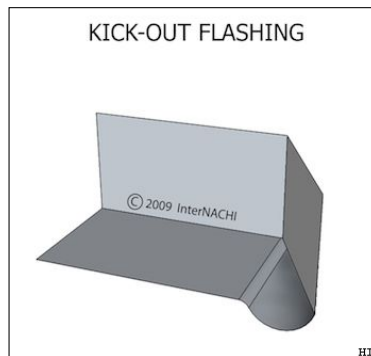
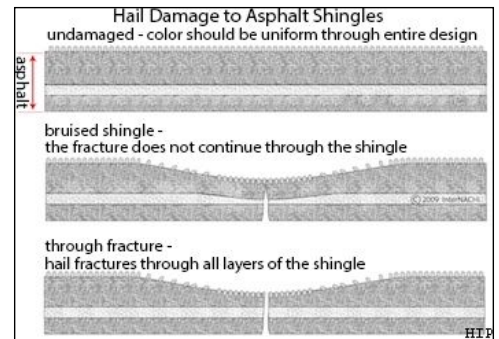
The roof is missing the kick out flashing at the end of the roof to sidewall connection. This is to help prevent water from running down or in the wall causing possible water penetration and deterioration. This is extremely important at stucco sidewall connections to help prevent water from penetrating behind the wall. Mainly at - left side main house

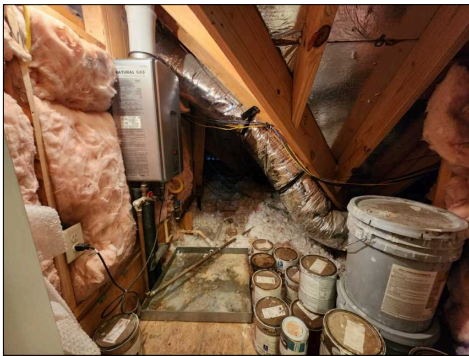
Overview of Attic. (Guest house)

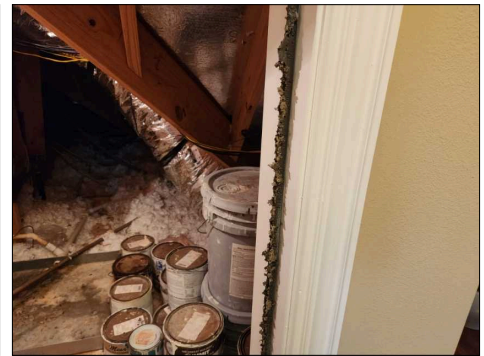
Weather stripping is damaged. Recommend repair or replacement. weather stripping should be installed around the edge of the door on the attic stairway to help prevent attic air from entering the home or conditioned air from entering the attic and to help slow the spread of fire. Mainly at- guest house

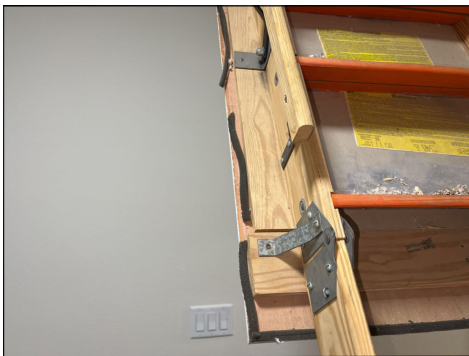
Weather stripping is damaged. Recommend repair or replacement. weather stripping should be installed around the edge of the door on the attic stairway to help prevent attic air from entering the home or conditioned air from entering the attic and to help slow the spread of fire. Mainly at- Main house access on 2nd floor

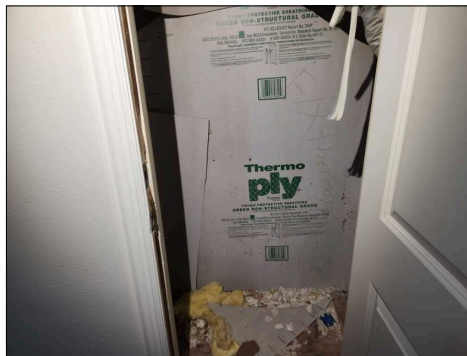
Overview of Attic. Upstairs Right Rear (Main House)

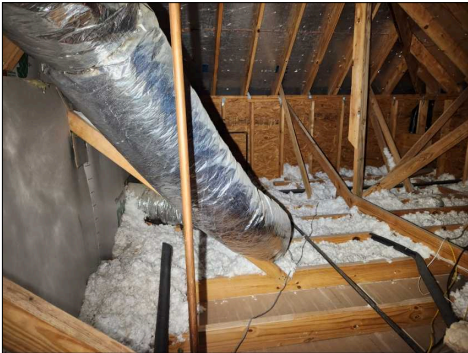
Overview of Attic. Upstairs Right Rear (Main House)

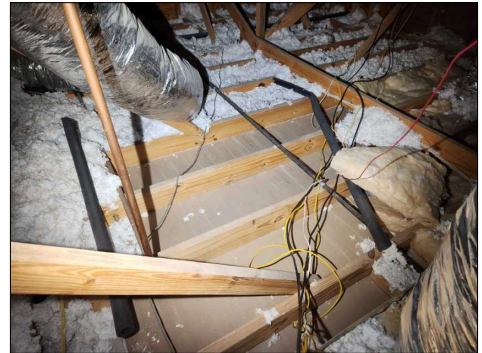
The insulation is missing in some areas of the attic, recommend replacing missing insulation for proper energy efficiency. Mainly at - Upstairs Right Rear (Main House)

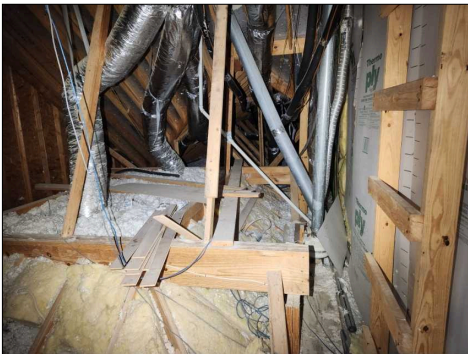
Overview of Attic. Upstairs Left Rear (Main House)

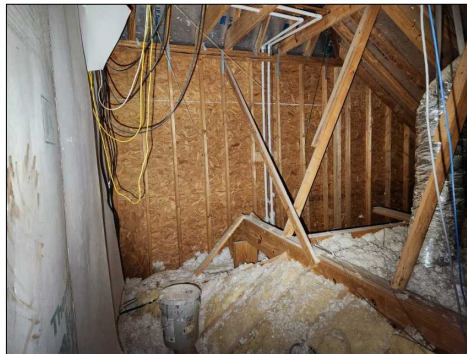
The insulation for the exterior wall is missing. Recommend replacing missing insulation for proper energy efficiency. Mainly at- Upstairs Left Rear (Main House)

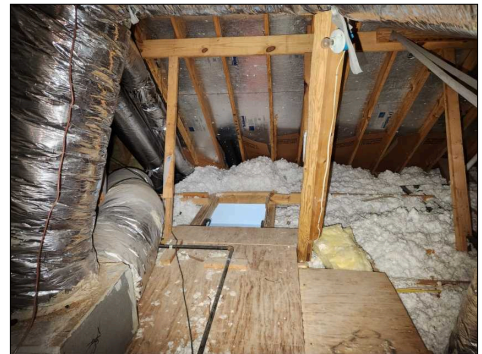
Overview of Main Attic. (Main House)

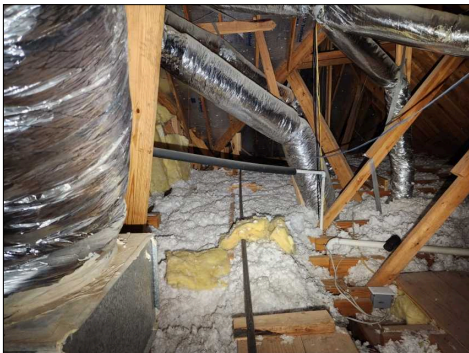
Overview of Main Attic. (Main House)

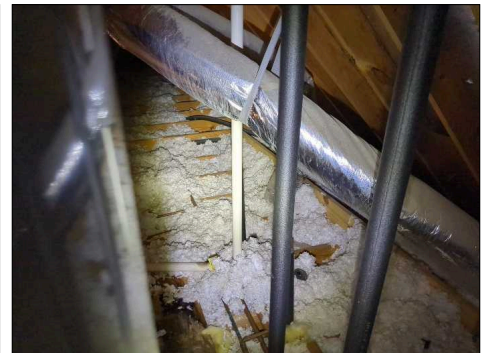
Insulation has been misplaced in one or more areas of the attic, recommend all displaced insulation be replaced to restore to proper energy efficiency. Mainly at - Main House (All Attics)

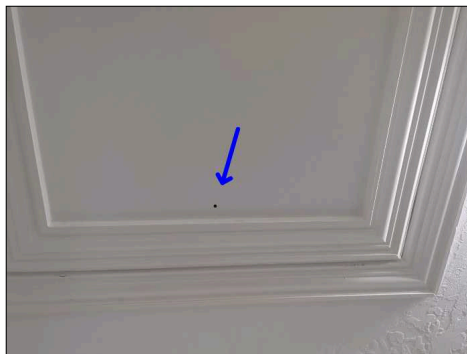
The pull down attic ladder is missing the pull string. Recommend installing a new pull string or an eye hook for access to the attic. Mainly at - Main Attic (Main House)

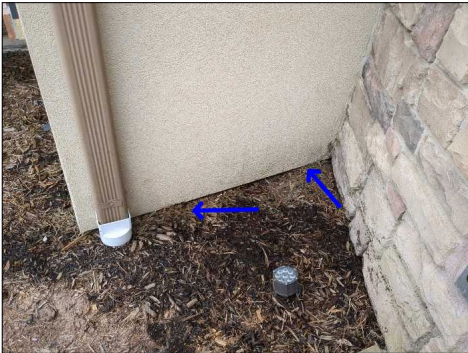
Recommend having a 4 to 6 inch gap between the stucco and grade to help prevent the system from wicking moisture up and causing possible feature damage.

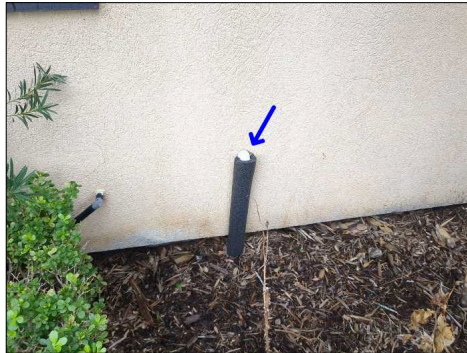
Recommend sealing gaps & holes in stucco to help prevent water penetration. Mainly at - front right of main house

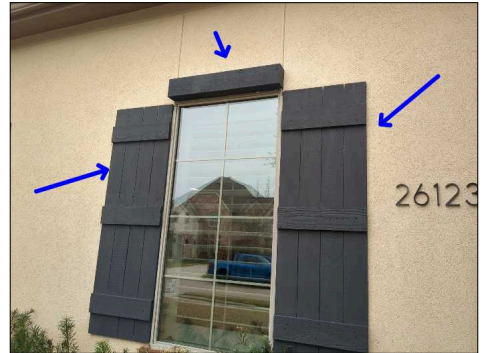
Recommend sealing gaps & holes in stucco to help prevent water penetration. Mainly at - front right of main house

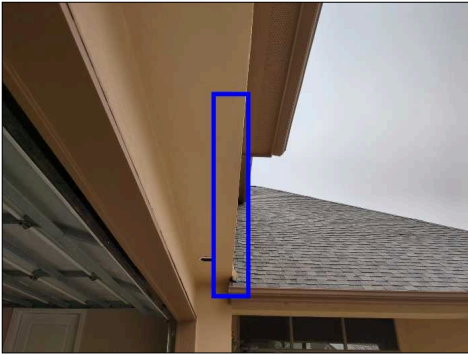
The stucco wall is missing the weepscreen at the bottom of the wall. It is recommended that water have a way to exit from behind the wall to help prevent deterioration of the substrate behind the stucco.

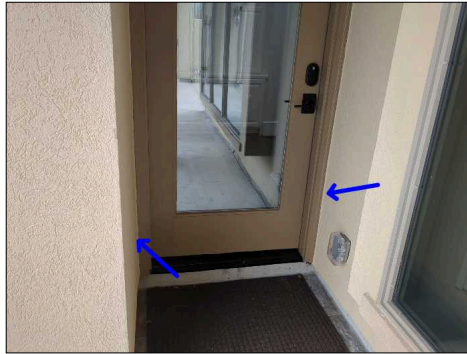
Recommend sealing between the trim and stucco to help prevent water penetration. Mainly at - main house right side door

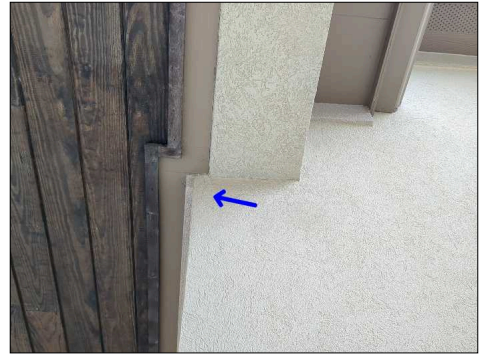
Minor cracks in stucco, recommend sealing with an acrylic paint. Mainly at - breezeway between homes

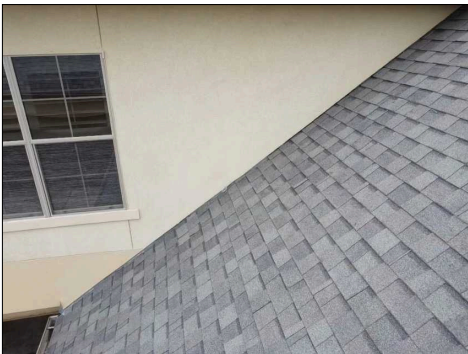
The stucco terminates onto the shingles or near the roof covering which is improper. There are differences of opinions as to whether this poses a problem requiring repairs. We recommend a stucco manufacturer be consulted for their requirements, if any, for this condition. Mainly at - main house right

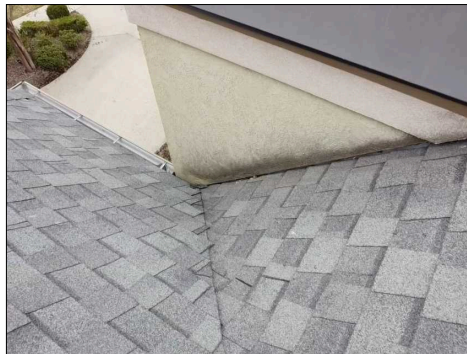
The stucco siding on the home is stained. Mainly at - front

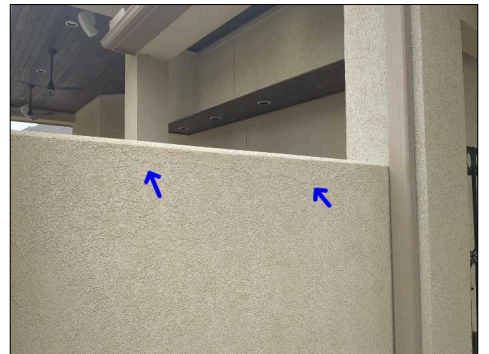
Minor cracks in stucco, recommend sealing with an acrylic paint. Mainly at - right side of driveway

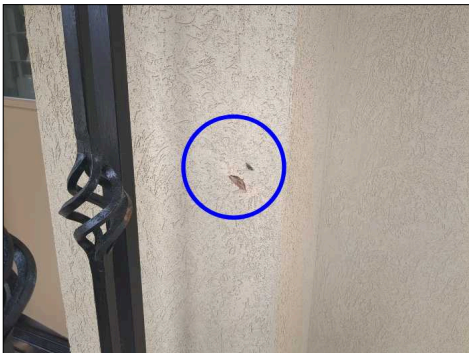
Recommend sealing chips in stucco to help prevent water penetration. Mainly at - right side of driveway pool entrance

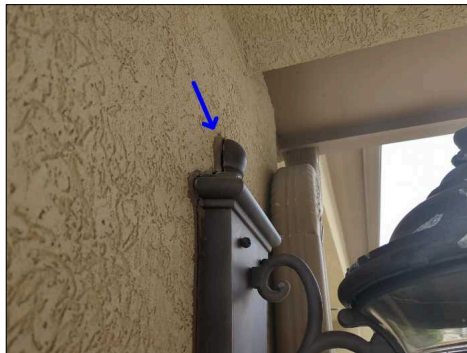
Seal all electrical lighting fixtures at wall connection to help prevent water penetration. It is a good idea to leave a small opening at the bottom to allow any water penetrating to escape.

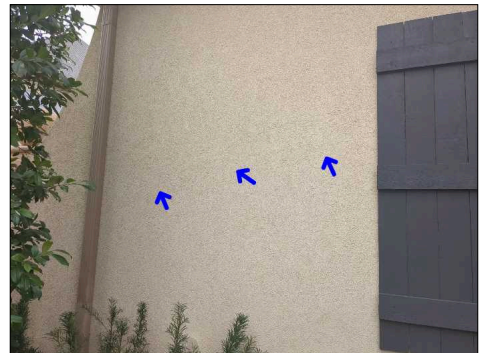
Minor cracks in stucco, recommend sealing with an acrylic paint. Mainly at - front left of guest house

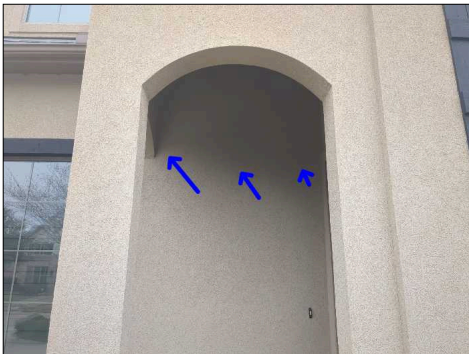
Minor cracks in stucco, recommend sealing with an acrylic paint. Mainly at - front entryway of guesthouse

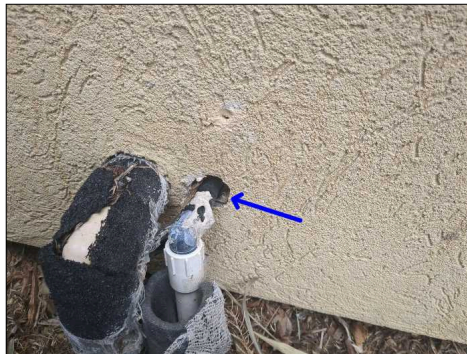
Recommend sealing gaps & holes in stucco to help prevent water penetration. Mainly at - front left of guest house

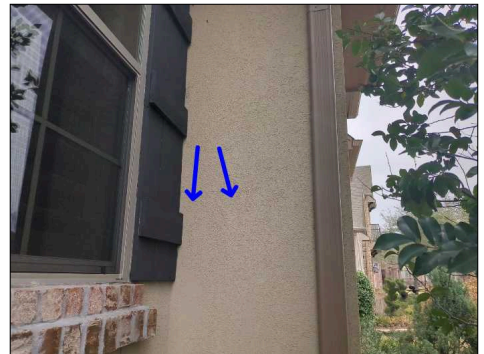
Minor cracks in stucco, recommend sealing with an acrylic paint. Mainly at - front of the guest house

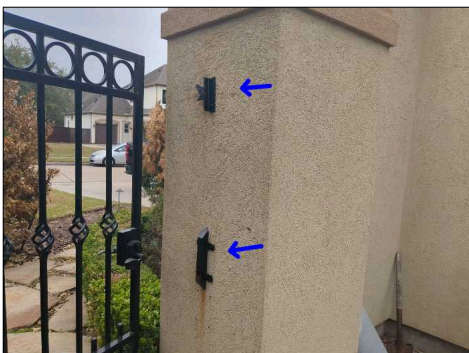
Recommend sealing gaps & holes in stucco to help prevent water penetration. Mainly at - guest house right side entry gate

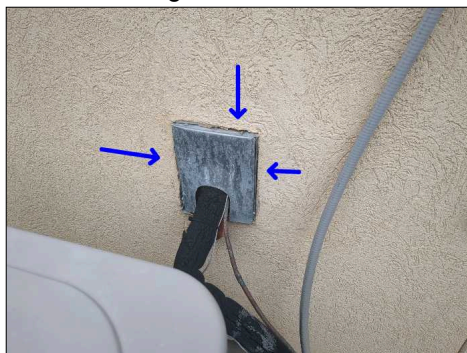
Recommend painting and sealing the A/C line entry cover at wall connection to help prevent deterioration and water penetration.

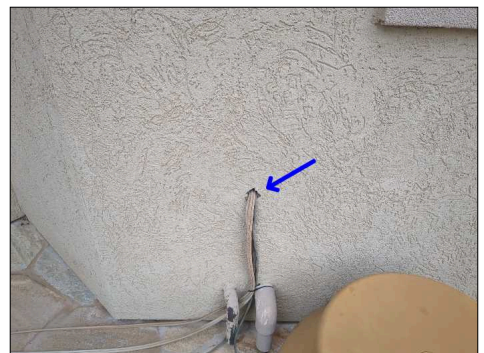
Recommend sealing gaps & holes in stucco to help prevent water penetration. Mainly at - rear of guest house

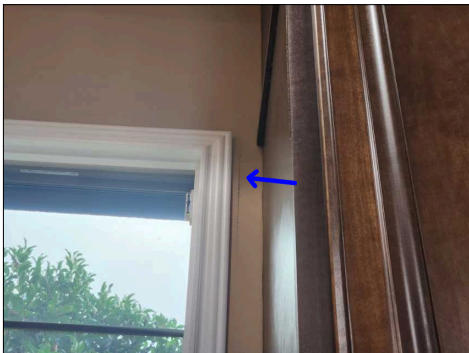
Settlement cracks were noted in the drywall. Mainly at - guest kitchen

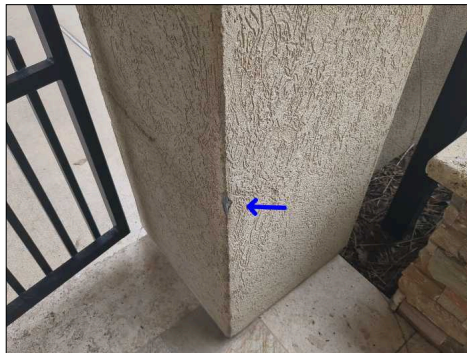
Recommend sealing chips in stucco to help prevent water penetration. Mainly at - right side of driveway pool entrance

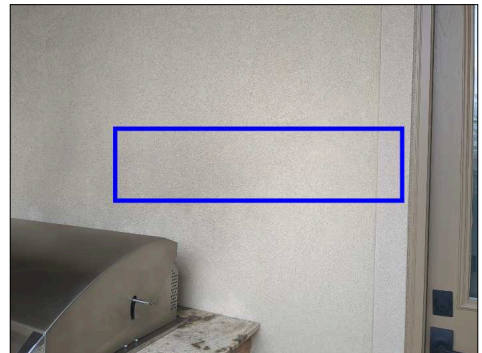
Minor cracks in stucco, recommend sealing with an acrylic paint. Mainly at - rear left of guest house

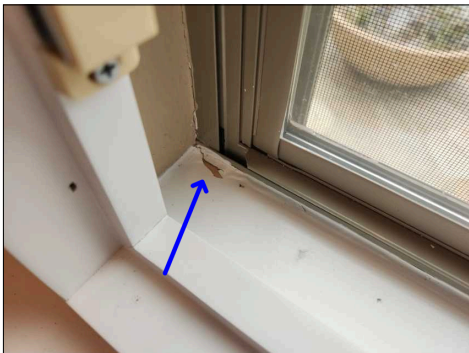
The window sill is peeling due to condensation moisture damage, recommend repairs to help prevent further deterioration. Mainly at - guest house living room

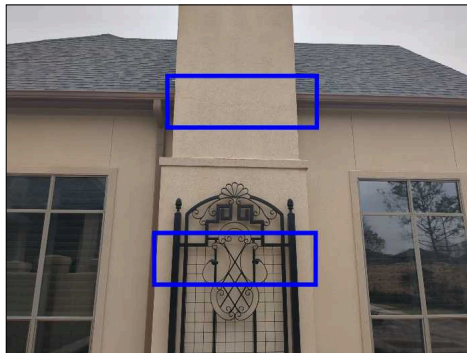
Minor cracks in stucco, recommend sealing with an acrylic paint. Mainly at - right side of main house

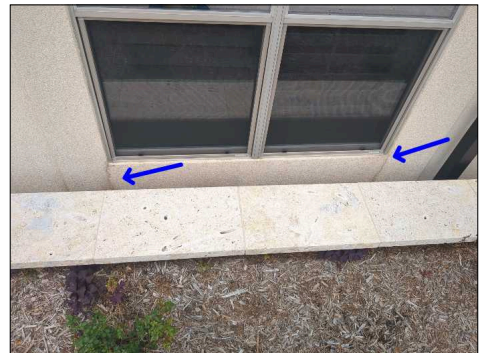
Minor cracks in stucco, recommend sealing with an acrylic paint. Mainly at - rear right of main house

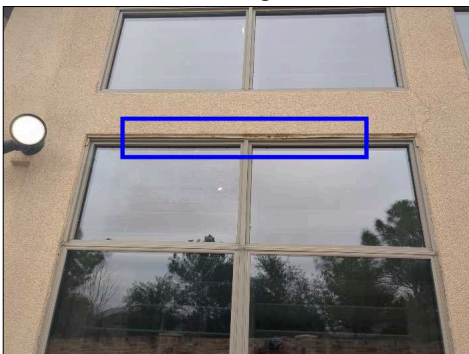
The flashing details are showing signs of rust / deterioration. This is often caused by excess moisture. Recommend repairs and or replacement as needed.

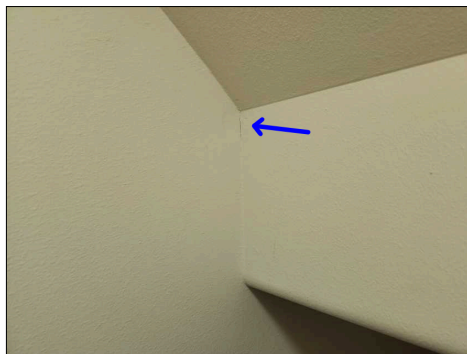
Settlement cracks were noted at the corner bead/tape joint in the drywall. Mainly at - guest house under stair storage

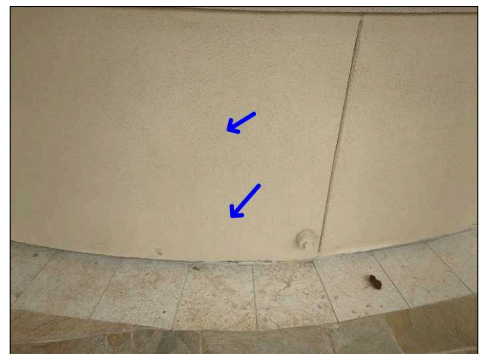
Minor cracks in stucco, recommend sealing with an acrylic paint. Mainly at - main house patio

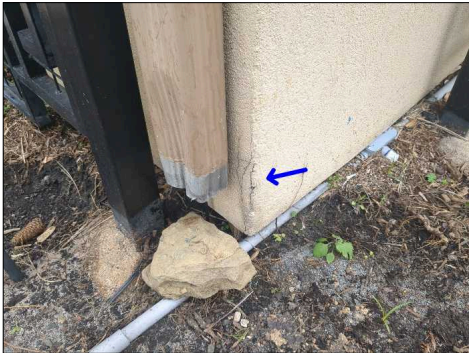
Stucco is damaged, recommend repairs to help prevent water penetration. Mainly at - rear left of main house

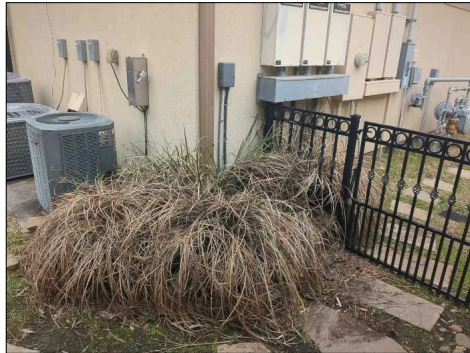
Recommend trimming vegetation so that it is not in contact with the house. Vegetation in contact with the structure can hold moisture against the structure and promote damage to building materials and conducive conditions for wood destroying insects.

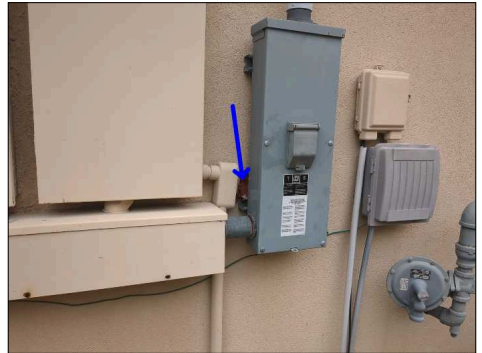
Recommend sealing gaps & holes in stucco to help prevent water penetration. Mainly at - left side rear of main house

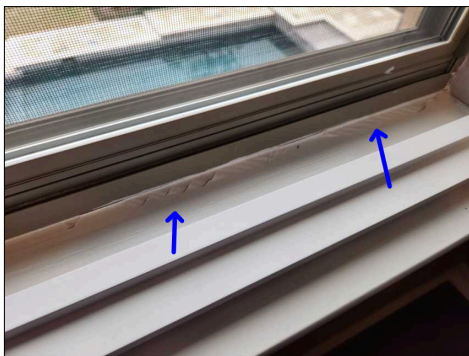
The window sill is peeling due to condensation moisture damage, recommend repairs to help prevent further deterioration. Mainly at - guest house 2nd floor bedroom

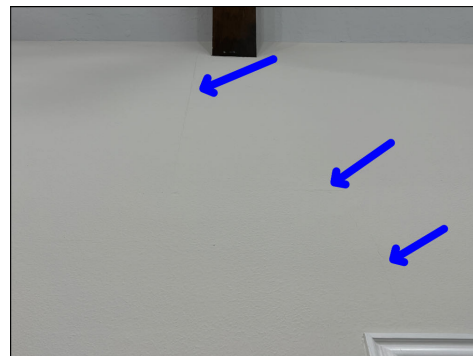
Settlement cracks were noted in the drywall. Mainly at - Den (Main House)

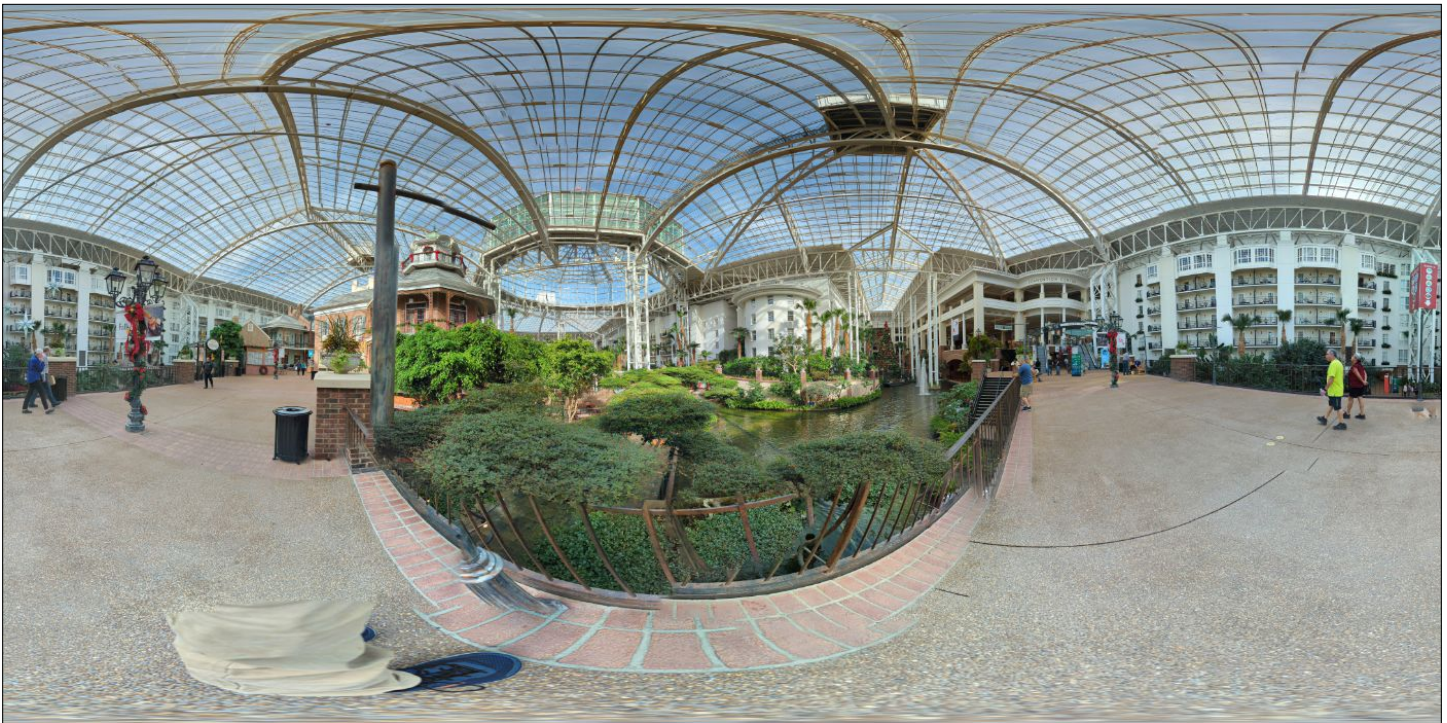
Signs of water intrusion into the structure.

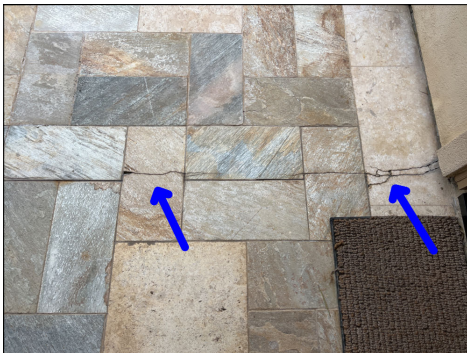
Cracks were noted in the tile, unable to determine the condition of the underlying surface. Mainly at - rear patio (main house)

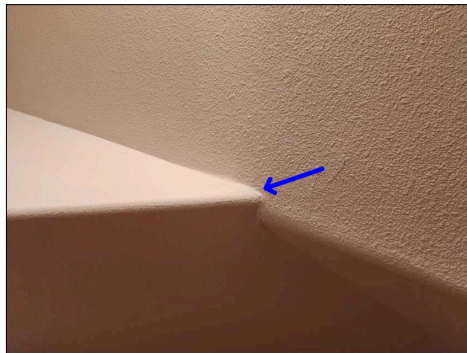
Settlement cracks were noted in the drywall. These are generally considered cosmetic only, unless otherwise noted. Mainly at - guest house gameroom

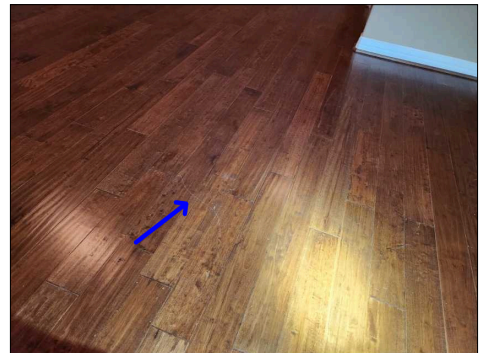
There are scratches noted in the wood flooring. Mainly at - guest house gameroom

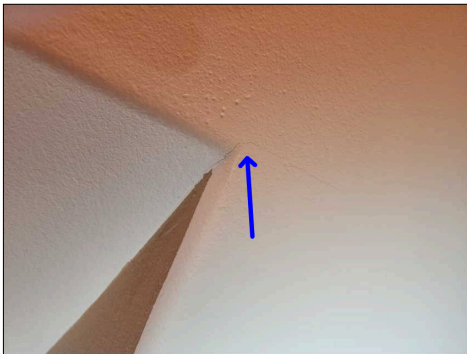
Settlement cracks were noted in the drywall. These are generally considered cosmetic only, unless otherwise noted. Mainly at - guest house gameroom

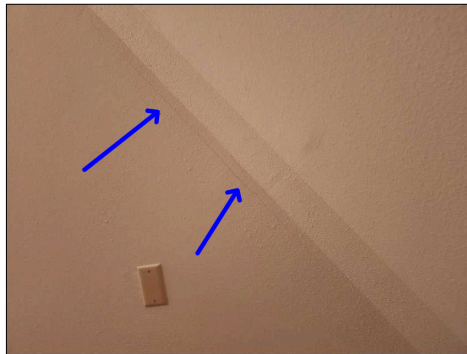
Settlement cracks were noted in the drywall. These are generally considered cosmetic only, unless otherwise noted. Mainly at - guest house gameroom

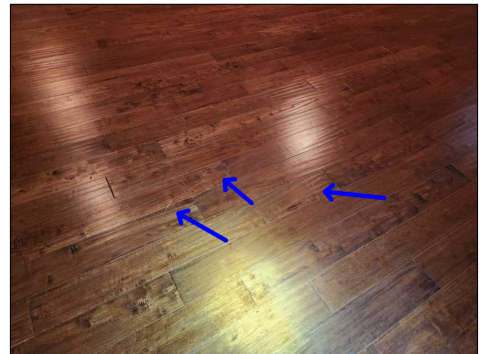
There are scratches noted in the wood flooring. Mainly at - guest house gameroom

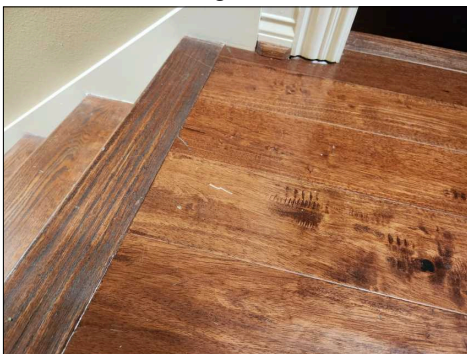
There are scratches noted in the wood flooring. Mainly at - guest house 2nd floor landing

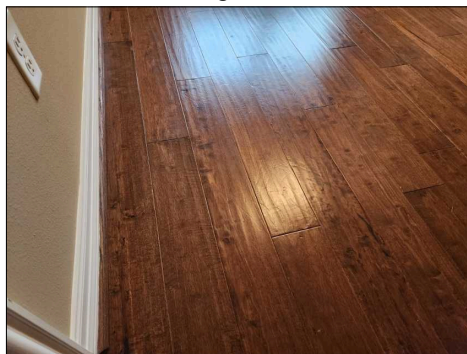
There are scratches noted in the wood flooring. Mainly at - guest house 2nd floor bedroom

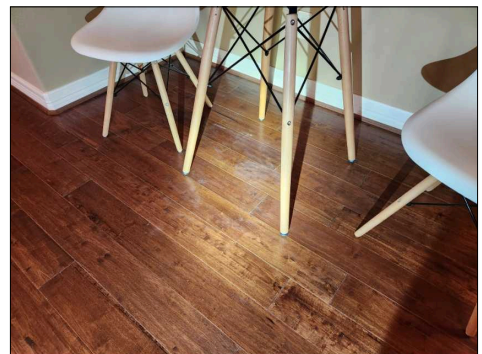
The finish is damaged on the flooring, recommend evaluation and repairs as needed. Mainly at - guest house 2nd floor living room

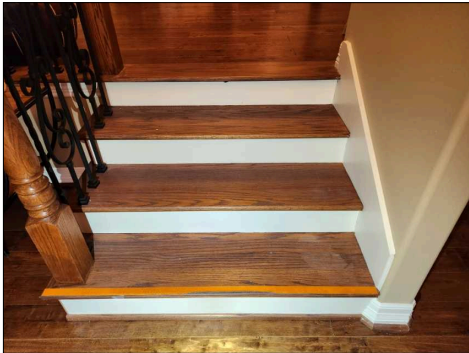
The finish is damaged on the flooring, recommend evaluation and repairs as needed. Mainly at - guest house 2nd floor living room

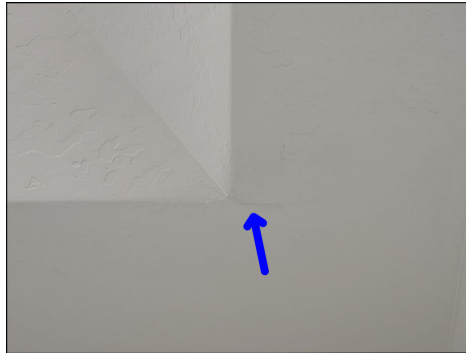
Settlement cracks were noted in the drywall. These are generally considered cosmetic only, unless otherwise noted. Mainly at - Master bedroom (Main House)

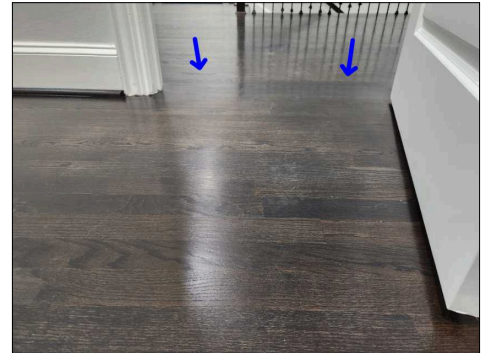
Uneven or sloping floors were noted. Some times in older homes minor slopes may be due to construction methods at that time, however if floors are sloping more than normal it is recommended that some follow up investigation be made. Sloping floors can be caused by foundation movement or from structural issues usually on upper floors. Floors were noted to be sloped. Mainly at - Upstairs Right Rear Bedroom (Main House)

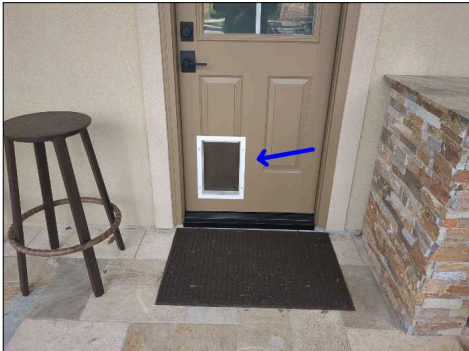
Doggie door is a security hazard If it can't be locked. Also, Doggie doors can lead to a rise in energy costs as this is a non insulated mechanism with no protection from the exterior environment. Things to consider with doggie doors would be elevated humidity, higher than normal energy costs, pest and pet intrusion. Recommend removal or replacement with an efficient self-closing and sealed doggie door. Guest house rear door

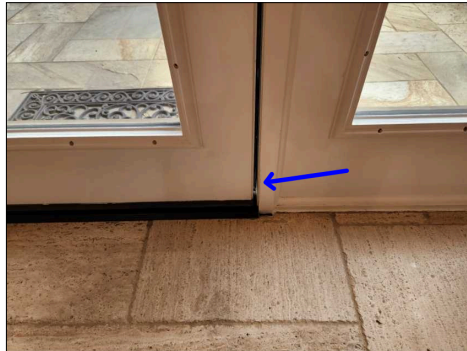
There is visible light noted around the door. Mainly at - guest house living room

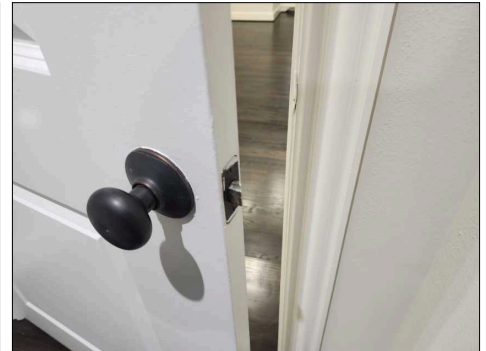
The door is not latching properly. Mainly at - Main House Upstairs Game Room

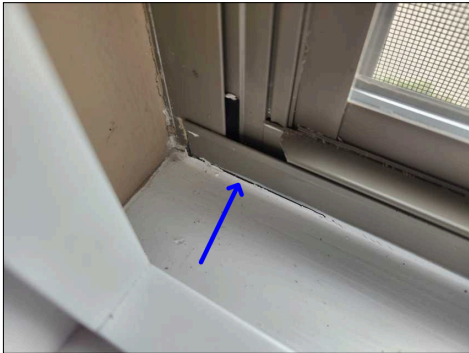
Sealant is needed around the interior of the windows between the window framing and the drywall to help prevent water penetration. Mainly at - Guest house front entryway

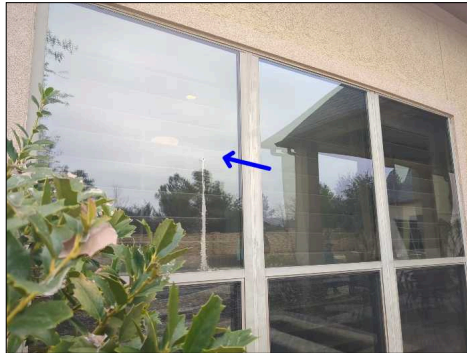
A hole was noted in a window pane. Mainly at - guest house rear

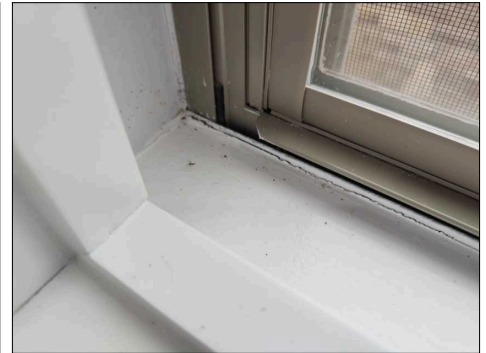
Sealant is needed around the interior of the windows between the window framing and the drywall to help prevent water penetration. Mainly at - Guest house master bedroom

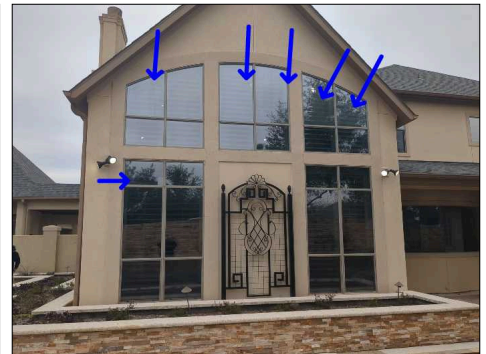
Window pane(s) have lost their thermal seal. Signs of lost seals in the thermal pane windows may appear and disappear as temperature and humidity changes. Recommend having a window contractor check all windows for lost thermal seals as all windows may not be noted. Mainly at - rear right side main house

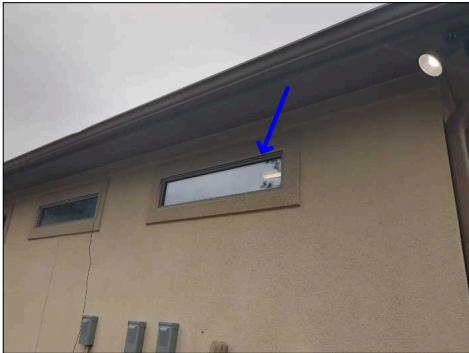
Window pane(s) have lost their thermal seal. Signs of lost seals in the thermal pane windows may appear and disappear as temperature and humidity changes. Recommend having a window contractor check all windows for lost thermal seals as all windows may not be noted. Mainly at - rear left of Maine house

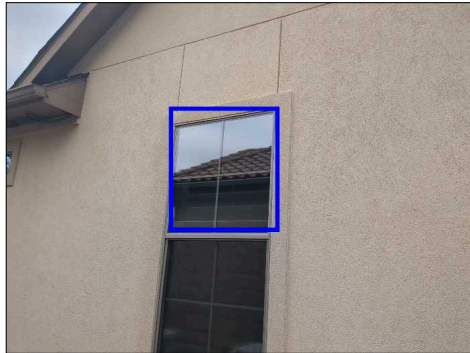
Window pane(s) have lost their thermal seal. Signs of lost seals in the thermal pane windows may appear and disappear as temperature and humidity changes. Recommend having a window contractor check all windows for lost thermal seals as all windows may not be noted. Mainly at - left side of main house

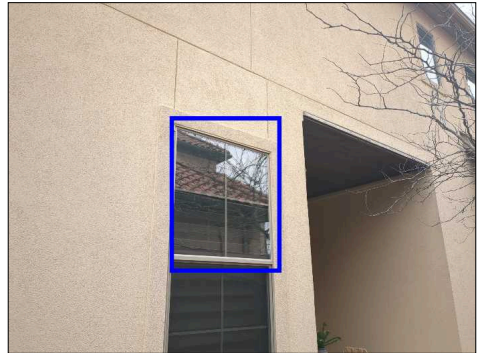
Window pane(s) have lost their thermal seal. Signs of lost seals in the thermal pane windows may appear and disappear as temperature and humidity changes. Recommend having a window contractor check all windows for lost thermal seals as all windows may not be noted. Mainly at - left side of main house

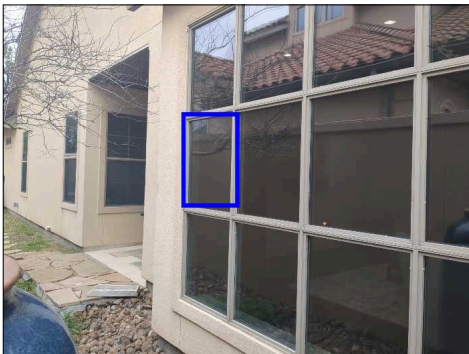
Window pane(s) have lost their thermal seal. Signs of lost seals in the thermal pane windows may appear and disappear as temperature and humidity changes. Recommend having a window contractor check all windows for lost thermal seals as all windows may not be noted. Mainly at - left side of main house

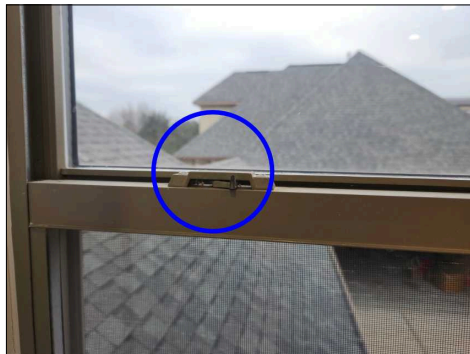
The window lock/latch is damaged. Mainly at - Upstairs Game Room (Main House)

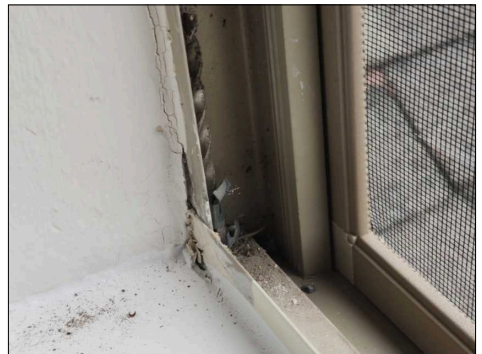
Springs were not attached or broken on window(s). Mainly at - Upstairs Game Room (Main House)

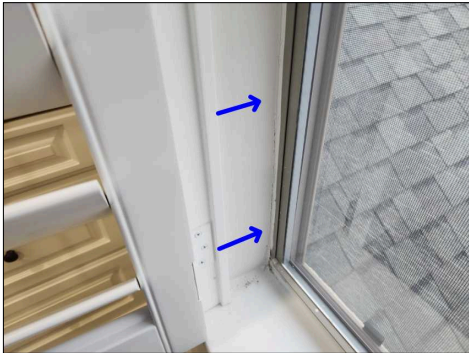
Sealant is needed around the interior of the windows between the window framing and the drywall to help prevent water penetration. Mainly at - main house upstairs game room

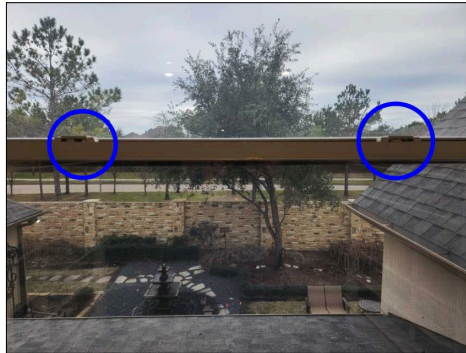
The window lock/latch is damaged. Mainly at - Upstairs Right Rear Bedroom (Main House)

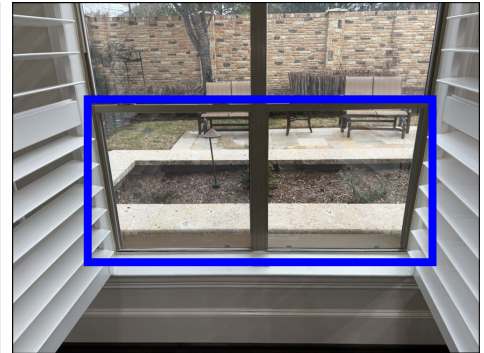
The window did not stay open when tested. Mainly at - Den (Main House)

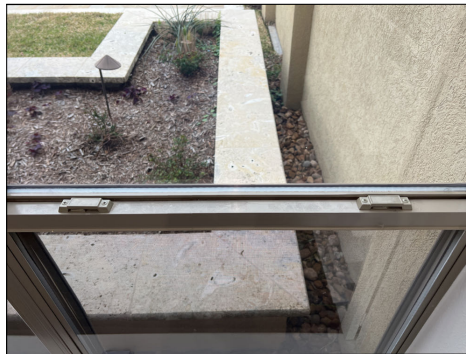
The window lock/latch is missing/broken. Mainly at - Den

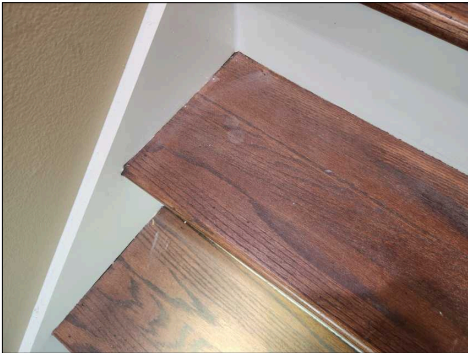
Wood staircase appears to be in need of refinishing. Mainly at- guest house

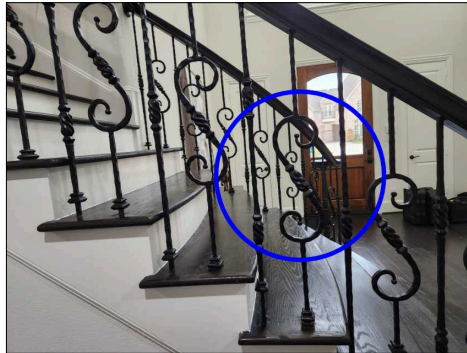
The rails on the stairway or balcony are climb able, this is a safety concern and it is recommended that all rails be installed in such a way that they cannot be climbed by children or pets.

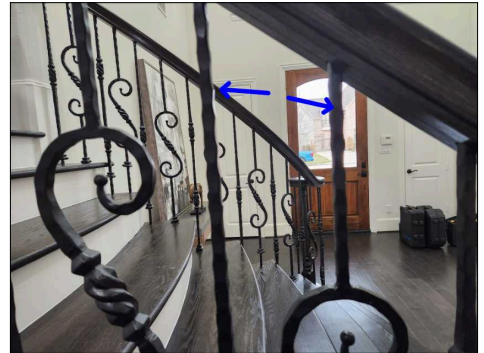
The baluster spacing of the stairs and or balcony is greater than the currently recommended four inches. This is a safety hazard as children or pets can get caught between or slip through the balusters. This may have been to code during construction, but may want to upgrade for additional safety.

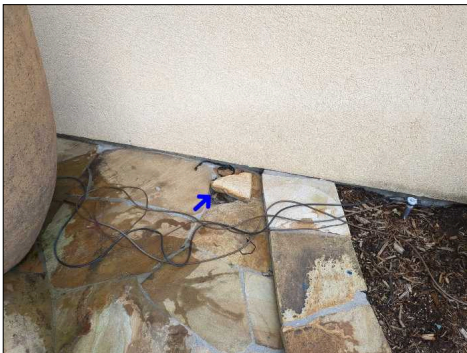
Damage was noted in the stonework. Recommend sealing to help prevent further deterioration. Mainly at - main house front entryway

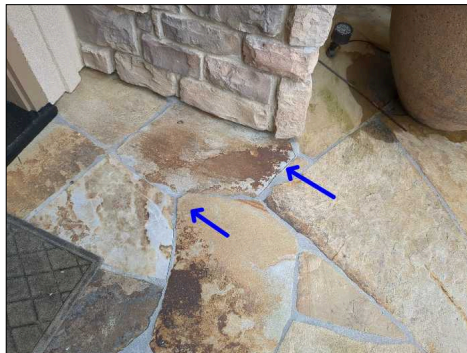
Minor settlement cracks are noted on the porch of main house

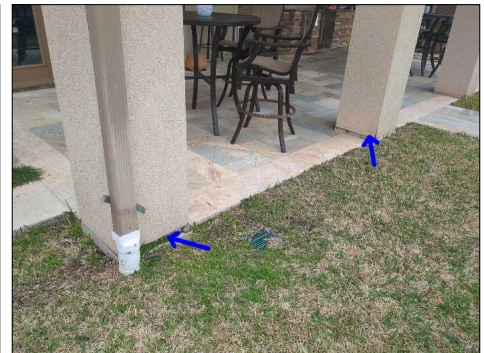
The patio post are showing signs of deterioration or damage recommend repairs or replacement to help prevent further deterioration.
