***"1st Class Service,
Provided by
1st Rate Inspections!"***

Property Inspection Report

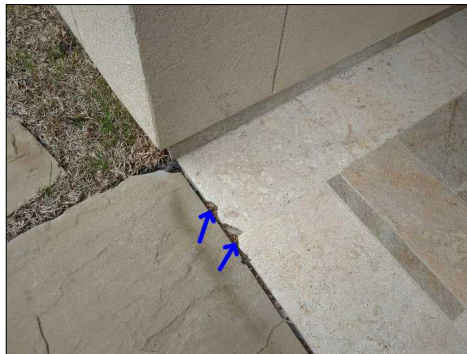
Damage was noted in the stonework. Recommend sealing to help prevent further deterioration. Mainly at - main house left side patio

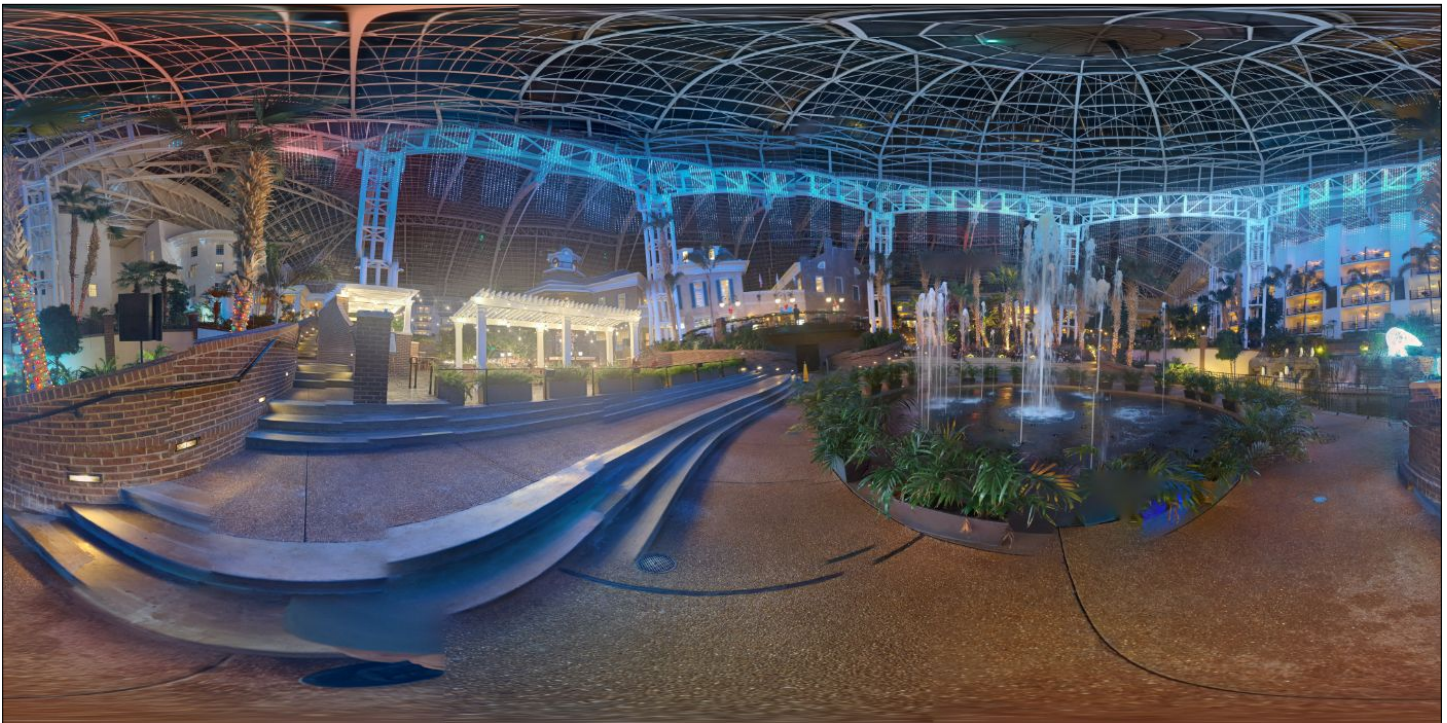
An expansive porch view.

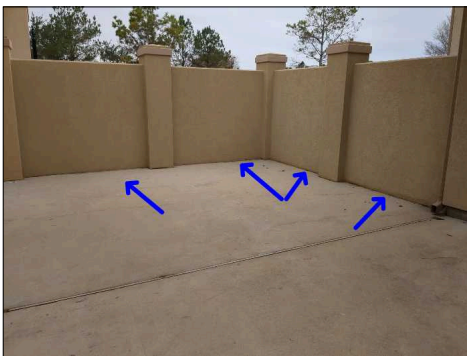
Recommend having a 4 to 6 inch gap between a stucco and grade to help prevent the system from wicking moisture up and causing possible feature damage.

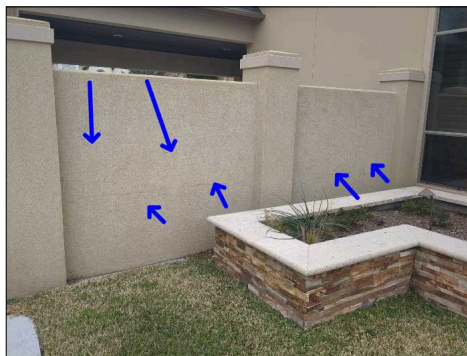
Minor cracks in stucco, recommend sealing with an acrylic paint. Mainly at - rear courtyard

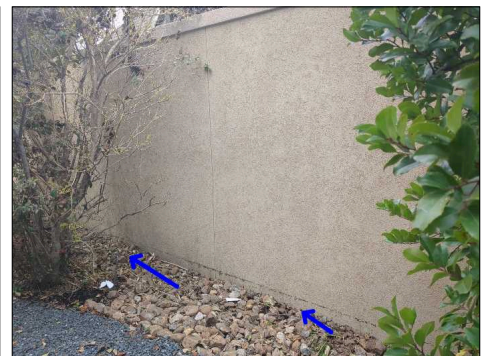
Recommend having a 4 to 6 inch gap between a stucco and grade to help prevent the system from wicking moisture up and causing possible feature damage. right side

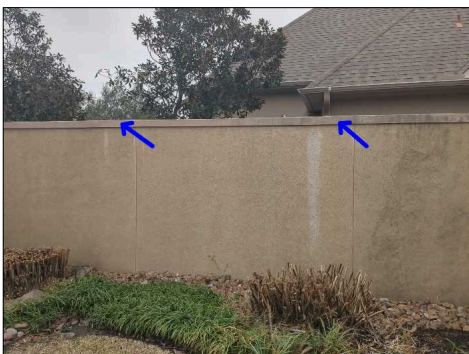
Although fences are not inspected it was noted that the stucco fence is showing some signs of damage or deterioration. right side

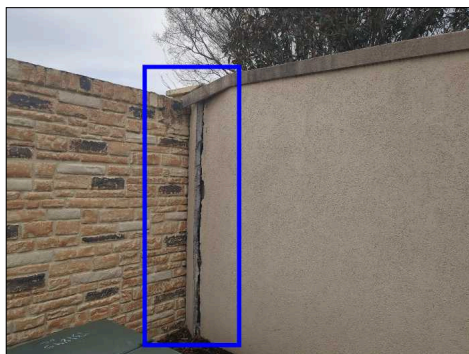
Although fences are not inspected it was noted that the stucco fence is showing some signs of damage or deterioration. right side

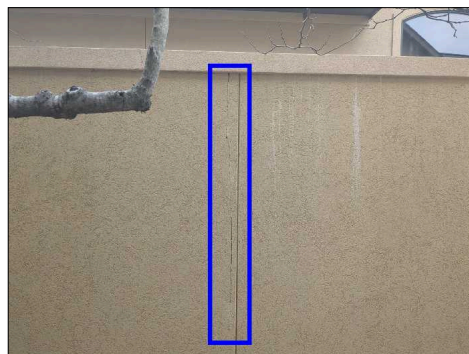
Although fences are not inspected it was noted that the stucco fence is showing some signs of damage or deterioration. left side

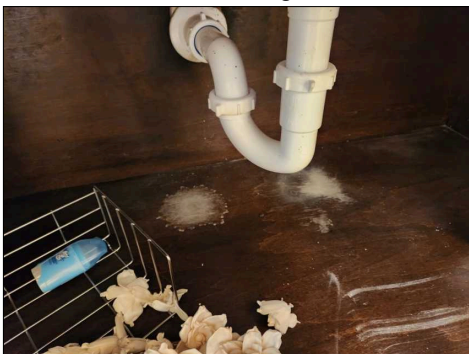
There are signs of water damage in the cabinet under sink. Mainly at - guest house 2nd floor bath

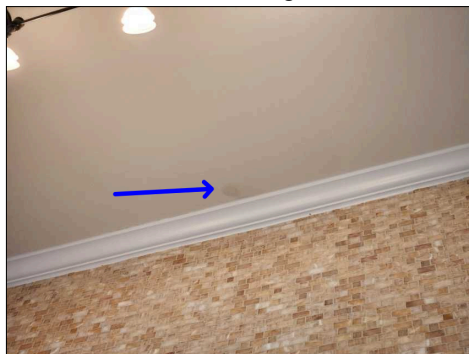
There are indications of water penetration to the ceiling evident mainly by staining. Unable to determine condition of the underlying materials. Mainly at - guest house 1st floor living room

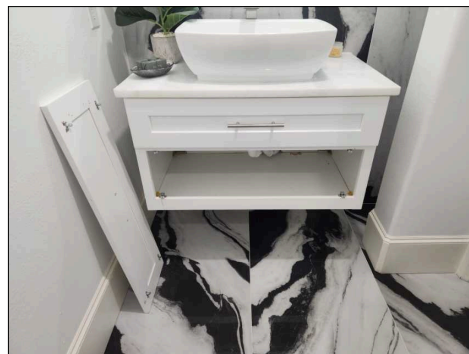
Although cabinets are not inspected it was noted that the cabinet door is not attached. Mainly at- main house 1st floor hall bath

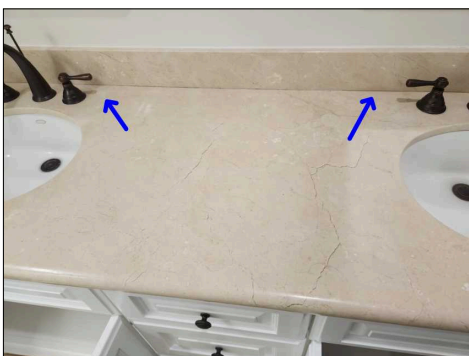
Seal countertop at wall connection. Mainly at - Upstairs Left Front Bath (Main House)

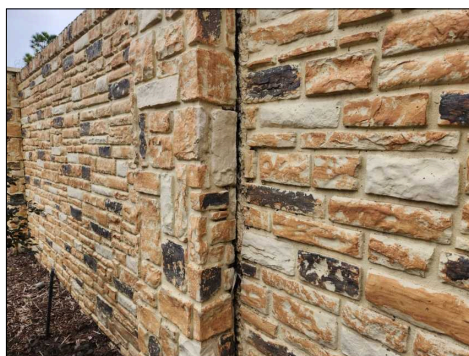
Although fences are not inspected it was noted that the stone fence is showing some signs of damage or deterioration.

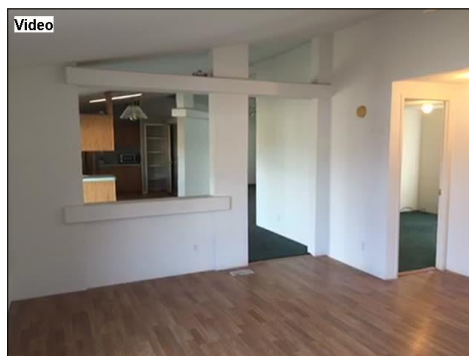
I=Inspected NI=Not Inspected NP=Not Present D=Deficient

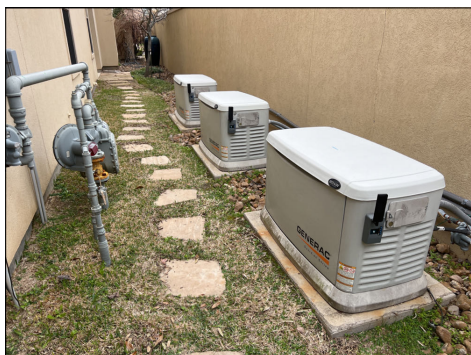
There are (3) backup generators installed on the property. Generators are not part of a normal home inspection therefore they were not inspected. Recommend contacting a licensed electrician for full evaluation of generator systems.

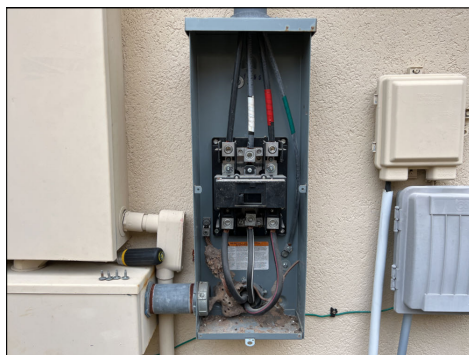
Overview of main disconnect

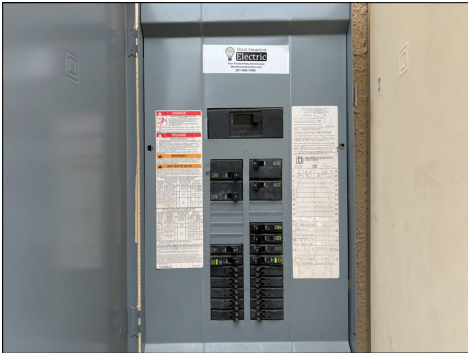
Overview of main electrical panel

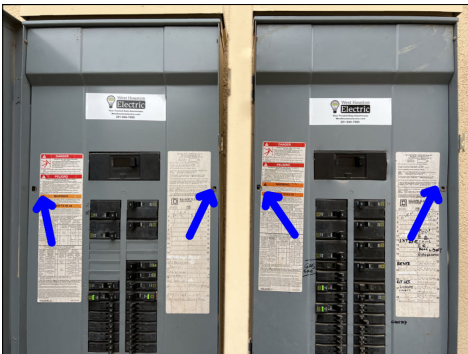
Panel cover is missing one or more screws.

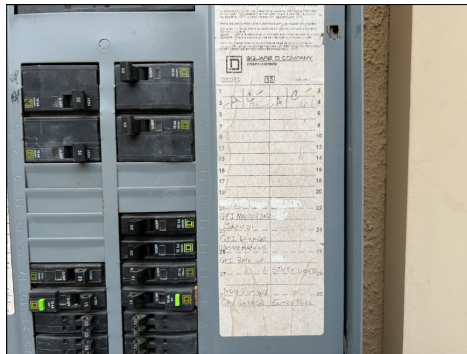
The breakers in the main electrical panel are partially labeled.

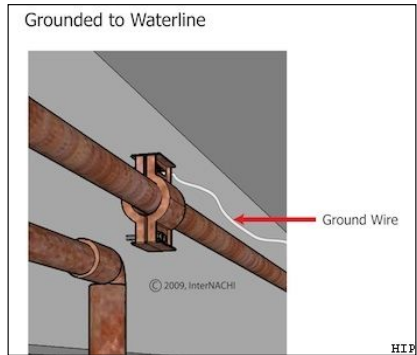
I=Inspected NI=Not Inspected NP=Not Present D=Deficient

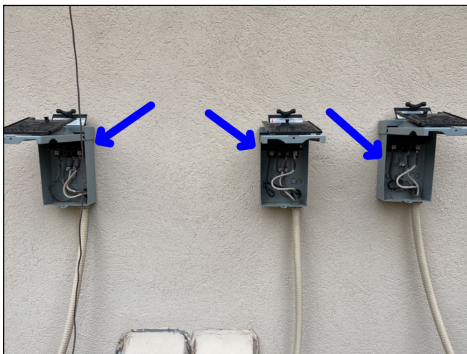
Line and loads wires are reversed on (3) A/C disconnects. (Behind Home)

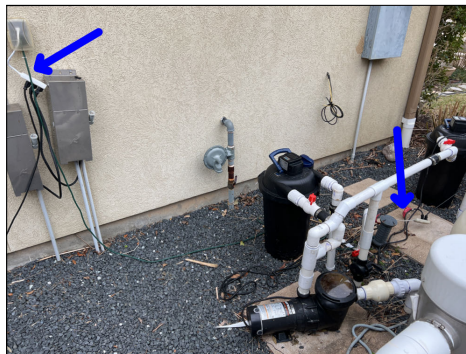
There is some extension cord type electrical wiring. Recommend wiring be replaced with permanent wiring. Mainly at - Pool Equipment

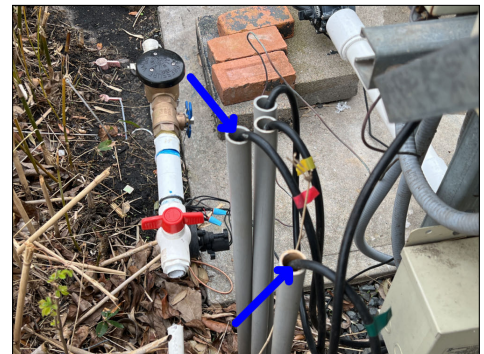
Silicone should be added to the conduit to help prevent water intrusion.

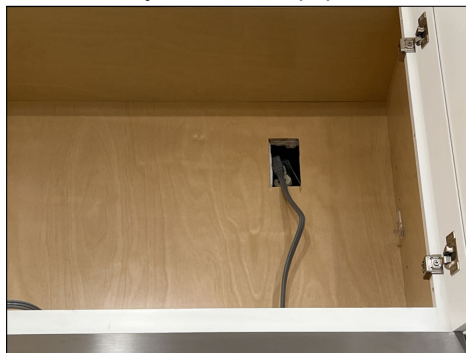
The electrical receptacle or box is loose, recommend securing and adding faceplate cover. Mainly at - Above vent hood in kitchen (Main House)

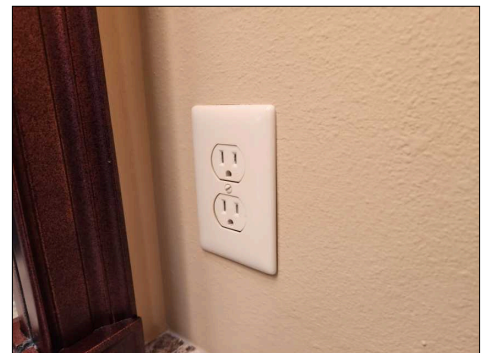
Switch plate is loose. Recommend securing to help prevent electrical shock. Mainly at - guest house 2nd floor bath

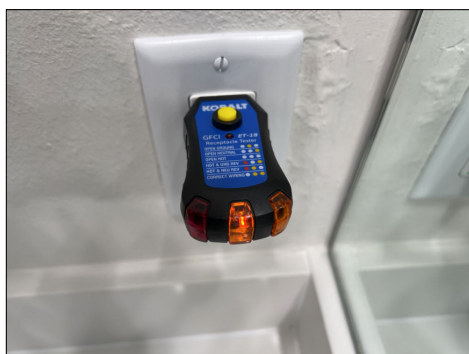
Electrical receptacle(s) are registering an open ground. Mainly at - Master bath (Main House)

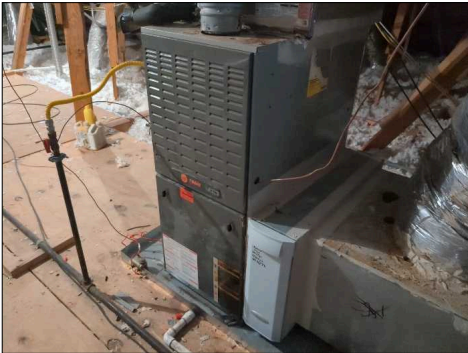
Overview of Furnace equipment unit #1. Trane

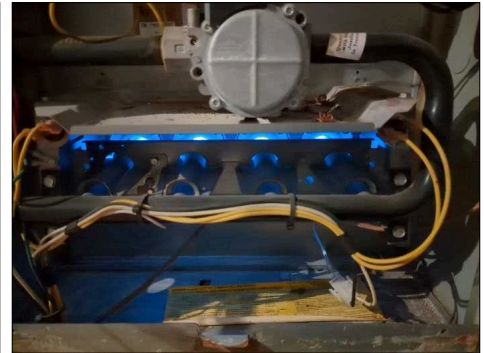
Overview of Furnace burner compartment unit #1

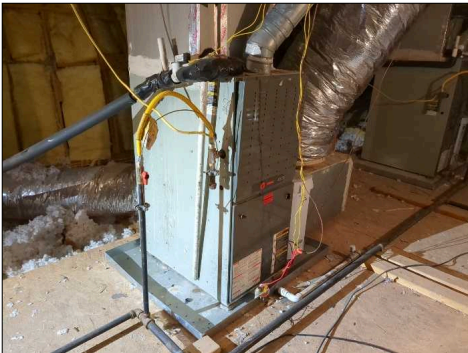
Overview of Furnace equipment unit #2. Trane

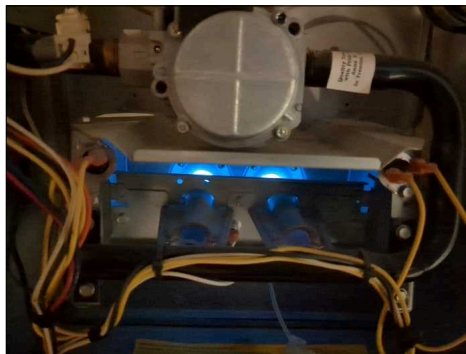
Overview of Furnace burner compartment unit #3

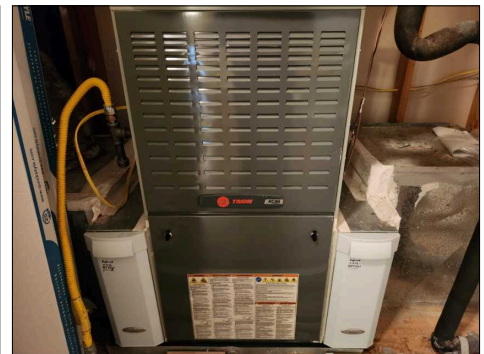
Overview of Furnace equipment (Unit #4)

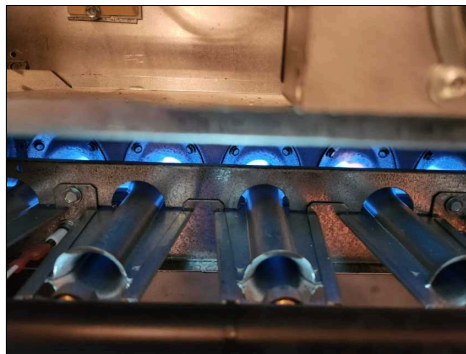
Overview of Furnace burner compartment. (Unit #4)

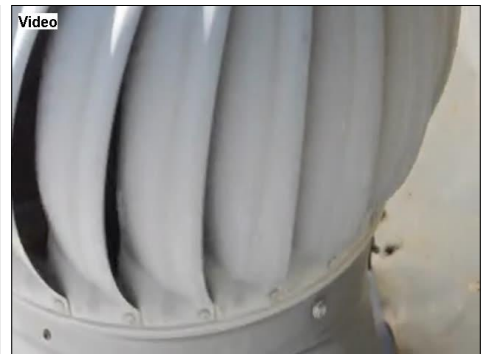
Vent hood in action.

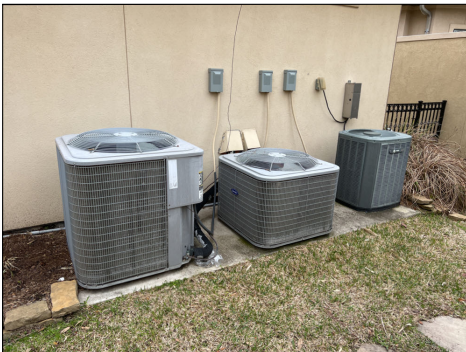
Overview of outside A/C units for the main house

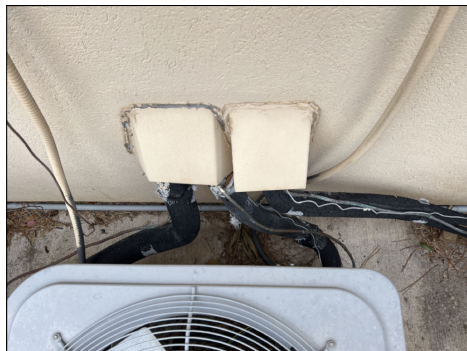
The insulation is missing or damaged on the A/C suction line at the condensing unit. Recommend repair or replacement to prevent cooling loss from exterior temperatures.

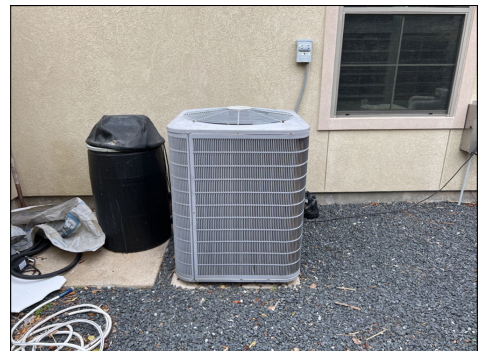
Overview of A/C Condenser (Guest House)

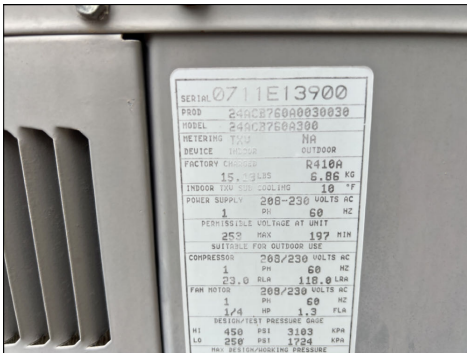
Overview of A/C Condenser Manufacturers Tag. (Unit #4) Carrier, Feb. 2011

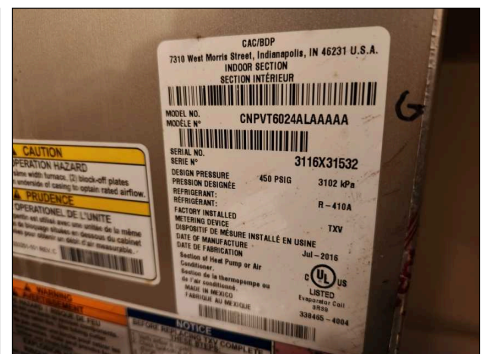
Overview of A/C Evaporator Manufacturers Tag (Unit #4) Trane, July 2016

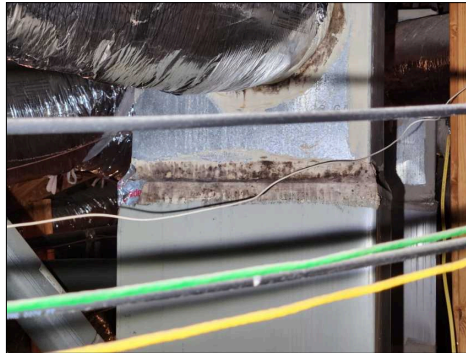
There is a growth at the plenum or evaporator. This is usually caused by conditioned air leaks around the area causing condensation and microbial growth, recommend sealing leaks and cleaning all affected surfaces.

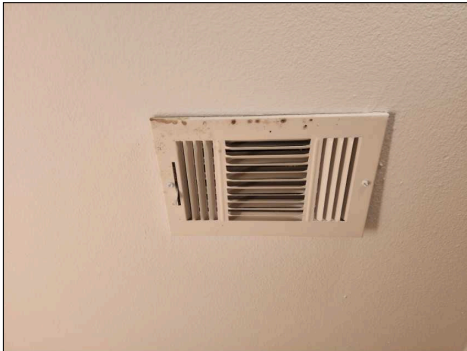
Registers are showing signs of growth, recommend cleaning vents and ducts as needed. Air sampling will most likely not identify microbial growth, however a swab or tape sample will determine if there is microbial growth.

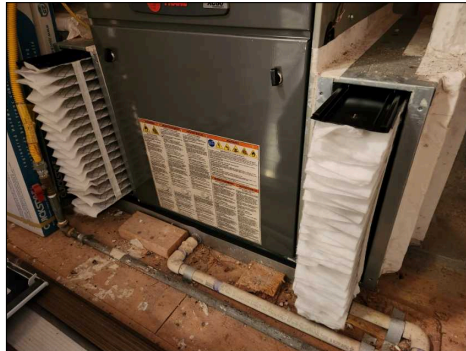
There is a media filter installed for the air conditioning unit. It is installed at the unit usually in the attic and should be changed approx. every six months to a year depending on use. On new construction it is recommended to change more often until construction dust in area subsides. (Guest house)

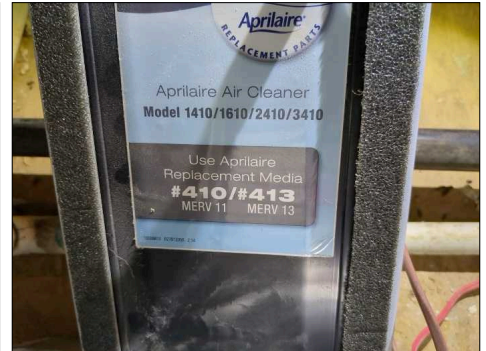
There is a media filter installed for the air conditioning unit. It is installed at the unit, usually in the attic, and should be changed approx. every 6 months to 1 year depending on use, on new construction it is recommended to change more often until construction dust in area subsides. Same size for all main house units

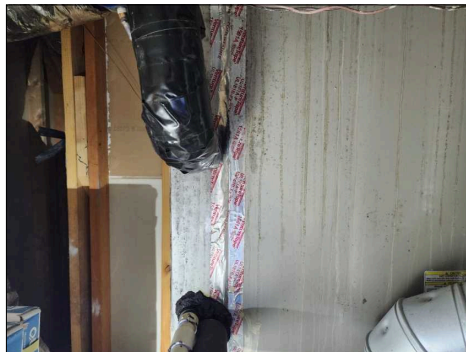
There is a microbial growth noted at the plenum, ductwork and/or evaporator. This is often caused by a conditioned air leak causing condensation and microbial growth, recommend sealing all air leaks and cleaning all surfaces.

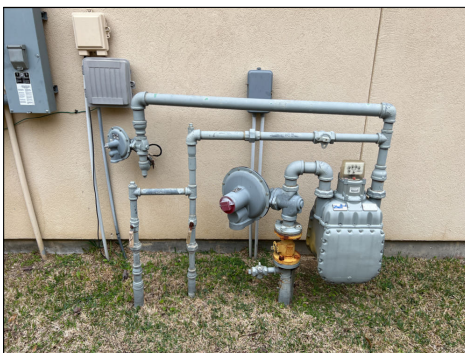
Overview of Gas delivery manifold.

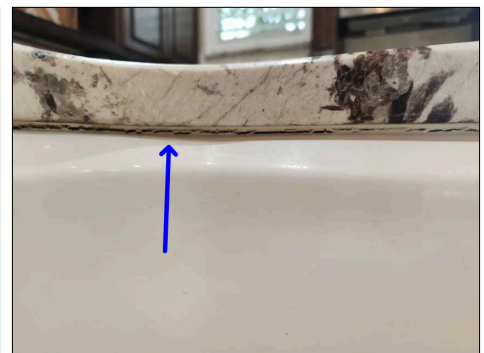
Undermounted sinks require sealant between the sink and counter top to help prevent water penetration to the surfaces below. Recommend sealing or repairing seal to help prevent water penetration and potential moisture damage to the underlying materials. Mainly at - guest house kitchen

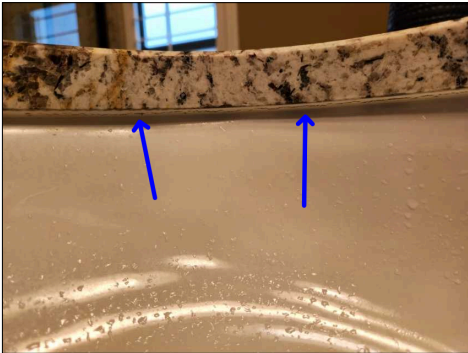
Undermounted sinks require sealant between the sink and counter top to help prevent water penetration to the surfaces below. Recommend sealing or repairing seal to help prevent water penetration and potential moisture damage to the underlying materials. Mainly at - guest house 2nd floor bath

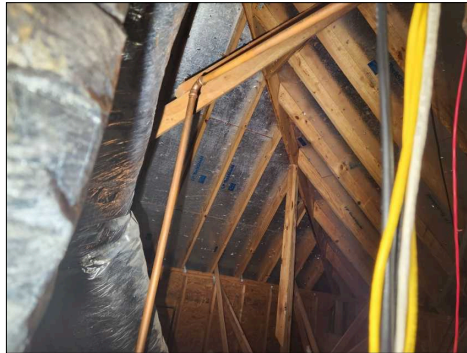
There are un-insulated water supply lines routed through the attic. Recommend these lines be properly insulated to help prevent damage to the pipes in freezing weather. Mainly at - Upstairs Right Rear (Main House)

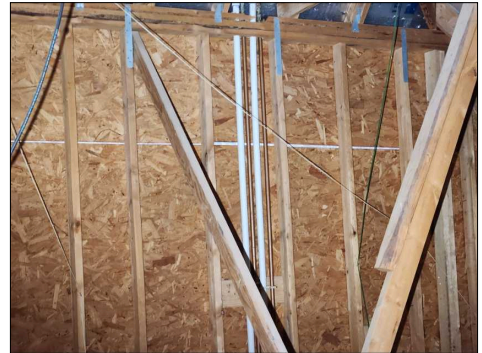
There are un-insulated water supply lines routed through the attic. Recommend these lines be properly insulated to help prevent damage to the pipes in freezing weather. Mainly at - Upstairs Left Rear (Main House)

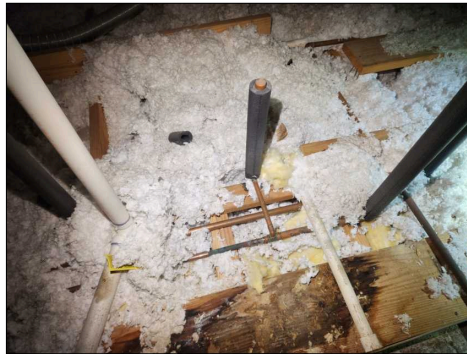
There are un-insulated water supply lines routed through the attic. Recommend these lines be properly insulated to help prevent damage to the pipes in freezing weather. Mainly at - Main Attic (Main House)

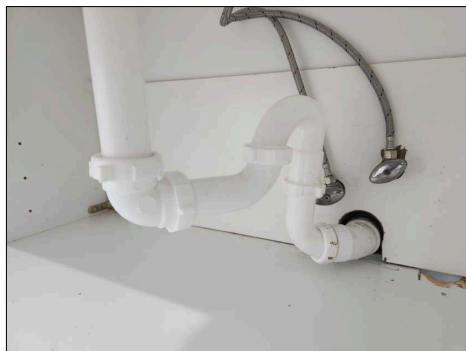
S-traps noted under sink. The "S" trap is prohibited under the Uniform Plumbing Code throughout the United States. This is because the "S" trap will siphon or suck water out from the trap which will end up releasing methane (sewer) gases into the home.

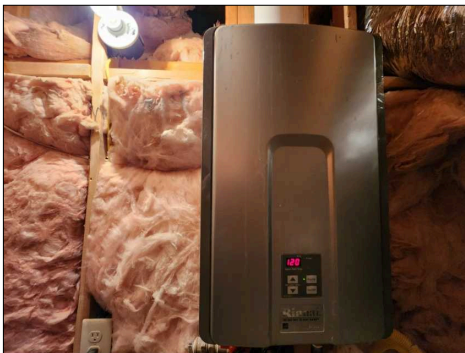
Overview of water heater (Guest house)

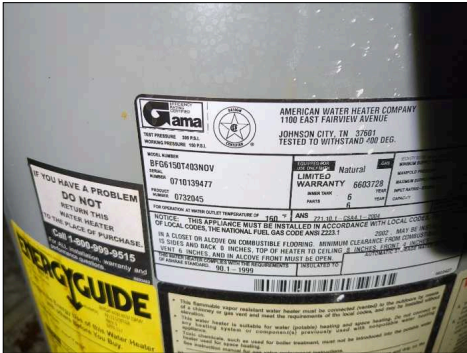
Overview of Water Heater Manufacturers Tag (Left Unit) American Water Heater Co. 10th Week of 2007

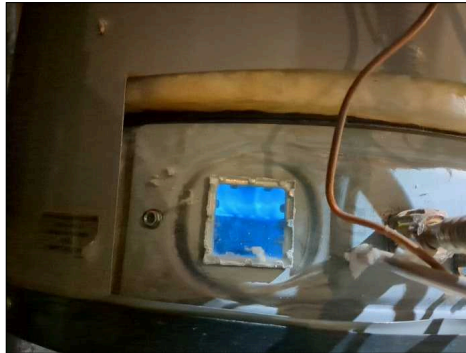
Overview of water heater burner compartment left side unit

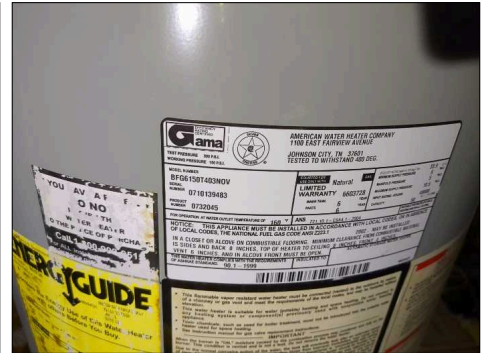
Overview of Water Heater Manufacturers Tag (Right Unit) American Water Heater Co. 10th Week of 2007

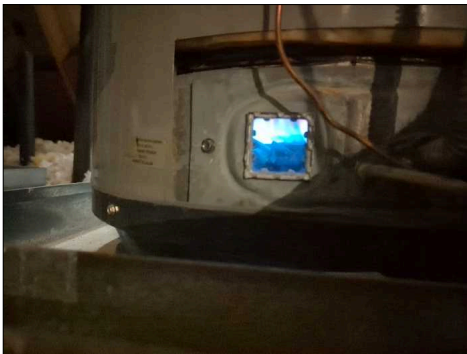
Overview of water heater burner compartment right side unit

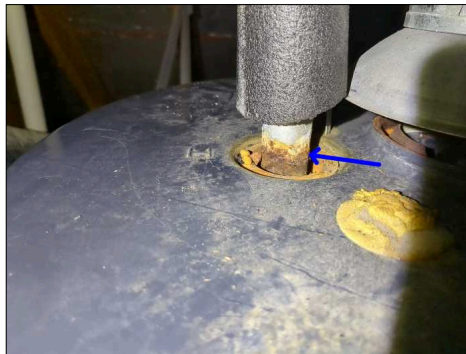
There are indications of electrolysis noted at the water heater supply fittings evident mainly by rust and corrosion. Left side unit

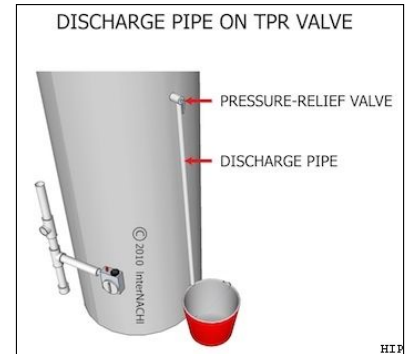
D. Hydro-Massage Therapy Equipment

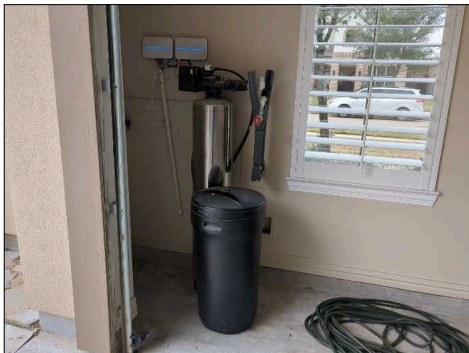
There is a water softener and or water filter installed on the property. Water softeners and water filters are not part of a normal home inspection, therefore we recommend a full evaluation of these systems by a licensed plumber. Main house

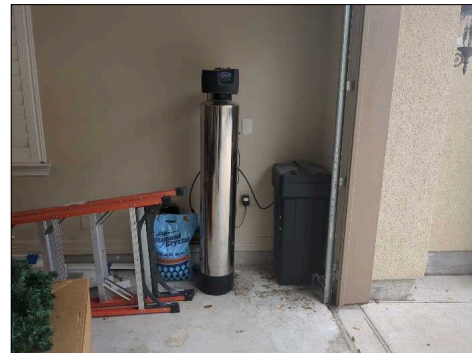
There is a water softener and or water filter installed on the property. Water softeners and water filters are not part of a normal home inspection, therefore we recommend a full evaluation of these systems by a licensed plumber. Guest house

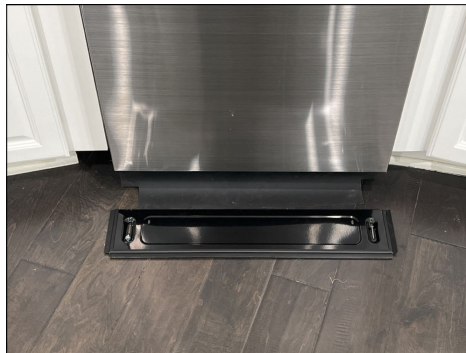
The kick plate is not installed on the dishwasher. (Main House)

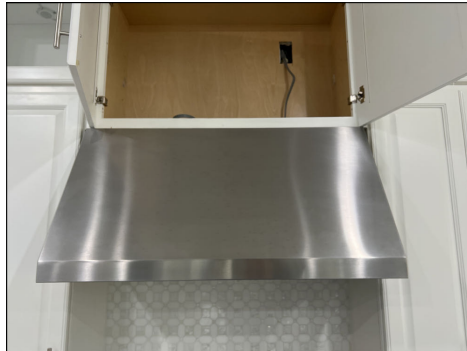
There is air leaking from between the cabinet and range hood or microwave vent. Indications are that the vent is not installed properly. (Main House)

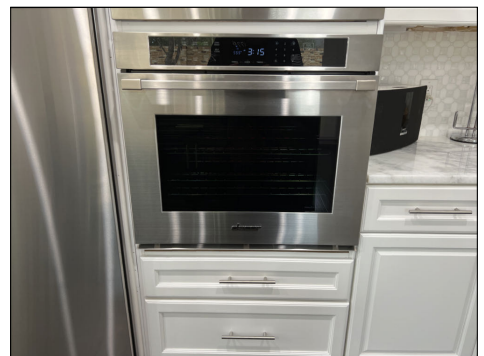
Overview of oven (Main House)

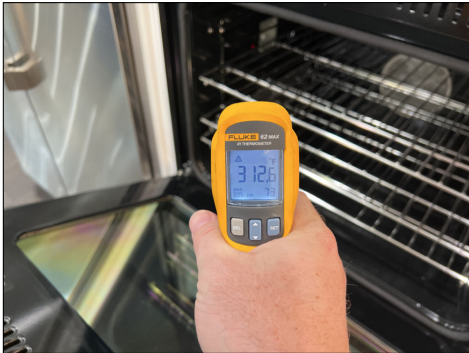
Cabinet oven Thermostat to Temperature Reading: 350F / 310-315 F

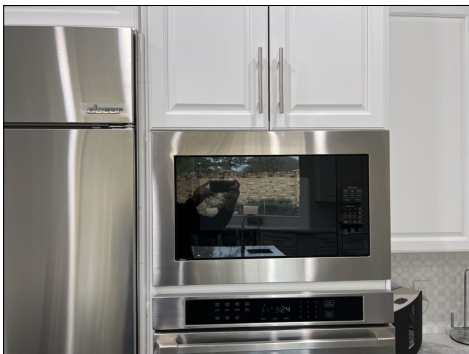
Overview of Microwave

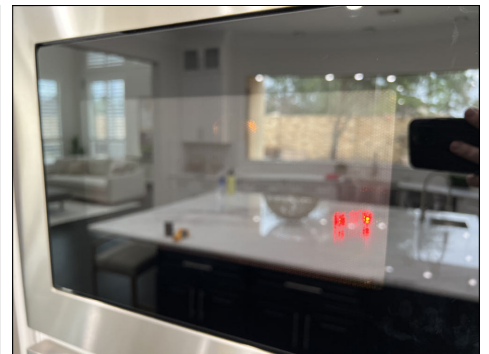
Overview of Microwave in operating

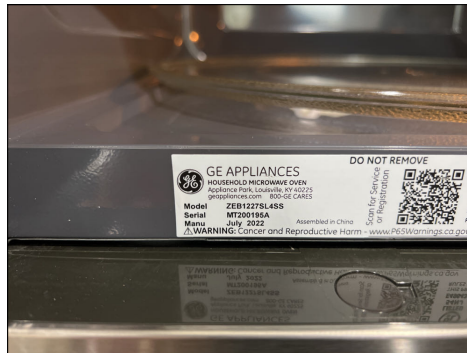
(Main House) Manufacturers Tag. Please visit the following website to find more information regarding the manufacturers date of appliances. Building-Center.org

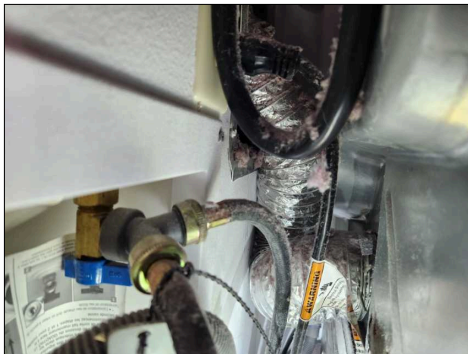
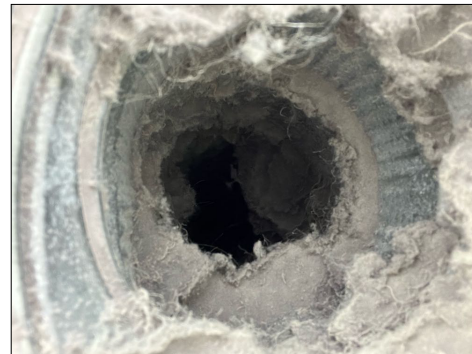
Recommend dryer vent cleaning to restore dryer duct to an operable condition. Dryer ducts becoming clogged can inhibit the dryer's performance as well as become a potential fire hazard in the home.

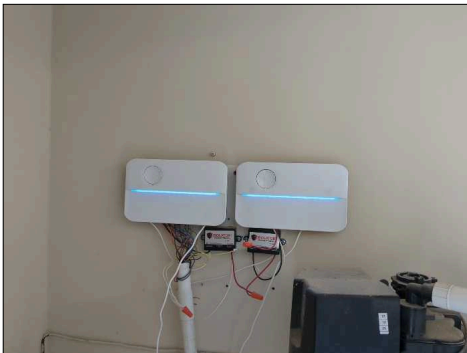
Overview of the Irrigation System Control Panel (Main House Garage)

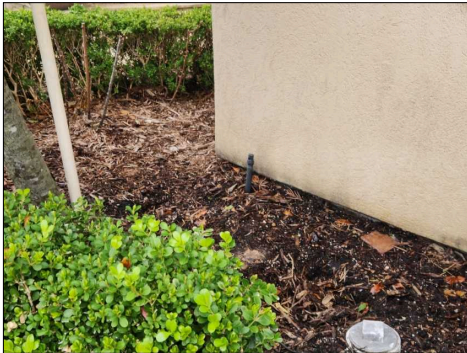
There is low pressure at the spray heads. Zone - 2

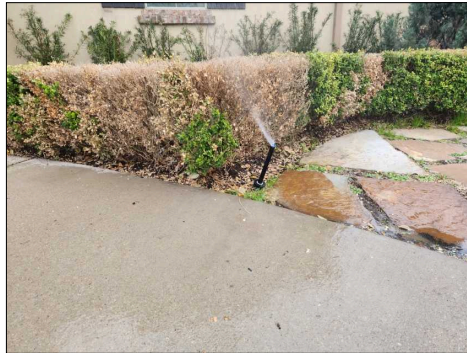
Head(s) is at an angle limiting its spray pattern, recommend straightening head to reestablish proper spray. Zone - 7

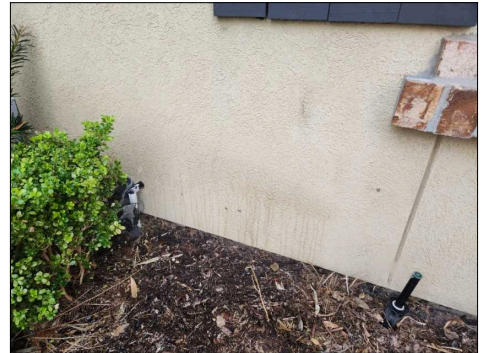
Recommend adjusting the sprinkler head by the home so that it does not spray the structure. Allowing the sprinkler to spray the home can cause water damage and/or penetration. Zone - 7

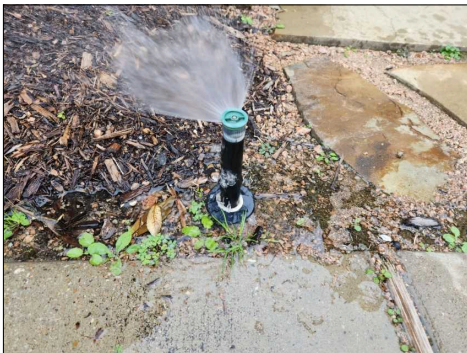
There is a broken sprinkler head. Zone - 7

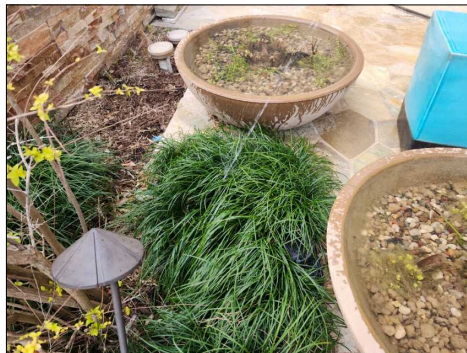
The heads or hoses of the drip system were exposed above grade. The drip system is intended to be buried as it is a direct source for watering a tree or shrubs root system. Recommend burying the components below the soil to help promote better watering and coverage. Zone - 8

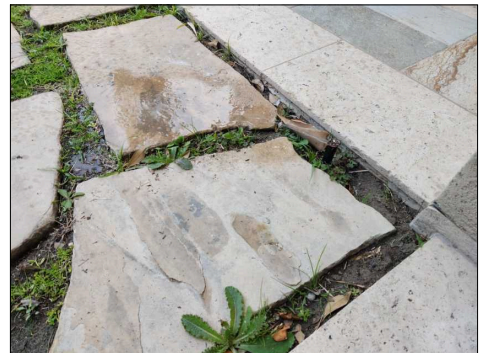
There is low pressure at the spray heads. Zone - 9

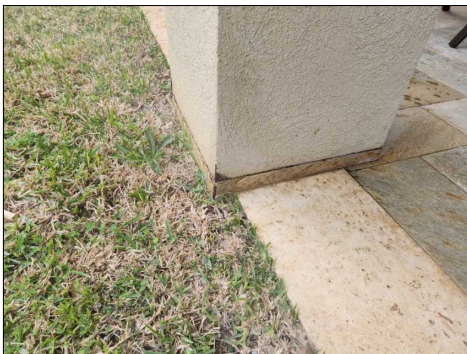
Recommend adjusting the sprinkler head by the home so that it does not spray the structure. Allowing the sprinkler to spray the home can cause water damage and/or penetration. Zone - 9

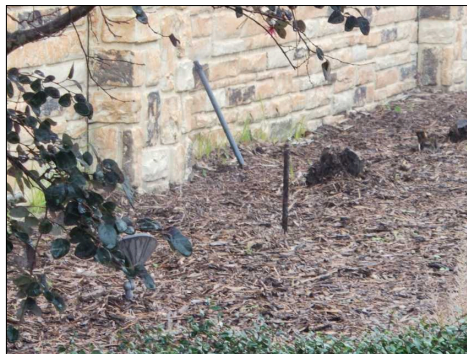
Head(s) is at an angle limiting its spray pattern, recommend straightening head to reestablish proper spray. Zone - 11

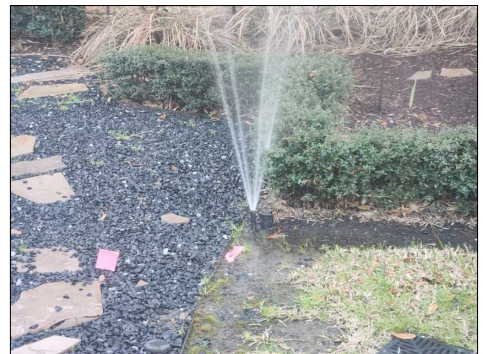
There is a broken sprinkler head. Zone - 12

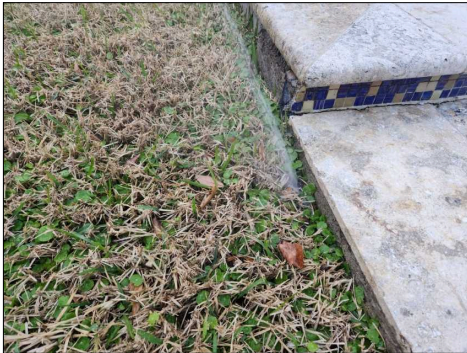
Head(s) are not popping up high enough to clear grass causing limited spray coverage. Zone - 12

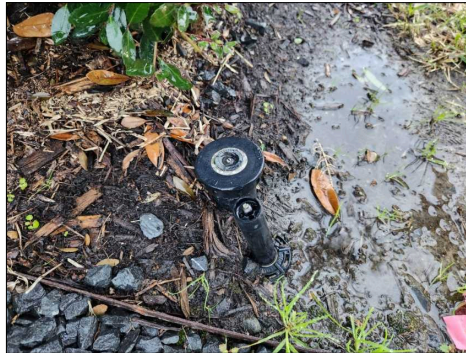
There is a broken sprinkler head. Zone - 12

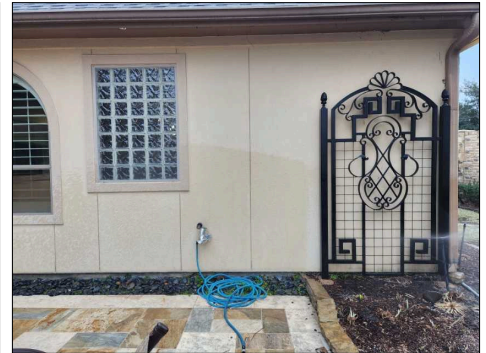
Recommend adjusting the sprinkler head by the home so that it does not spray the structure. Allowing the sprinkler to spray the home can cause water damage and/or penetration. Zone - 15

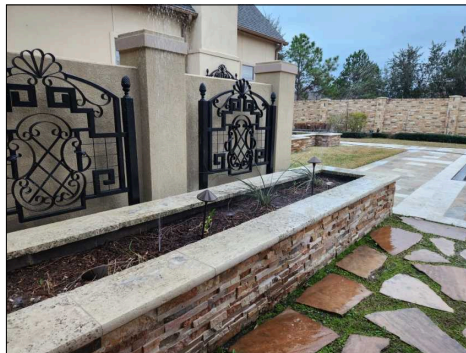
The heads or hoses of the drip system were exposed above grade. The drip system is intended to be buried as it is a direct source for watering a tree or shrubs root system. Recommend burying the components below the soil to help promote better watering and coverage. Zone - 17

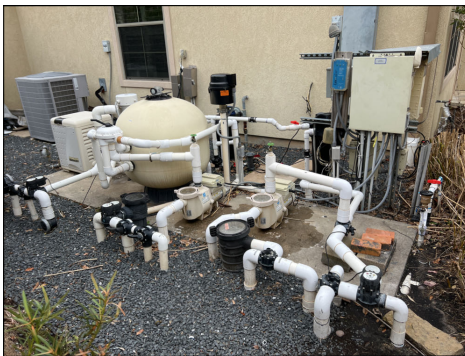
Overview of pool equipment

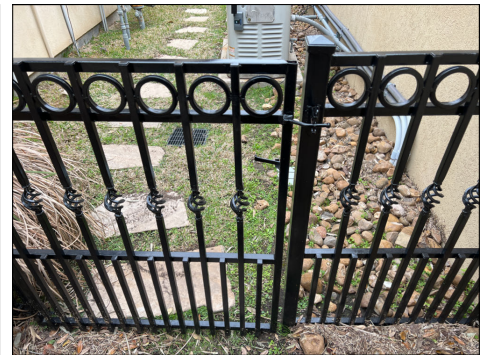
Improper gates to back yard pool area. The gates around the pool should be at least 48" tall, self closing, self latching, open outward, latch inside at least 3" below top of gate and can be locked with no opening over a 1/2" within 18" of the latch.

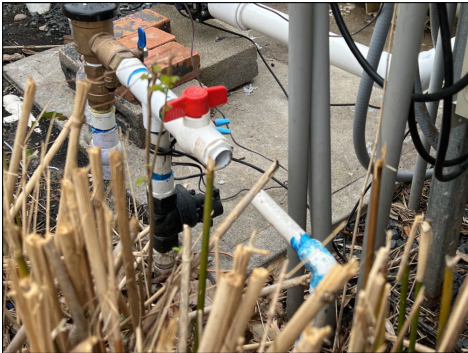
Water fill unit is disconnected.

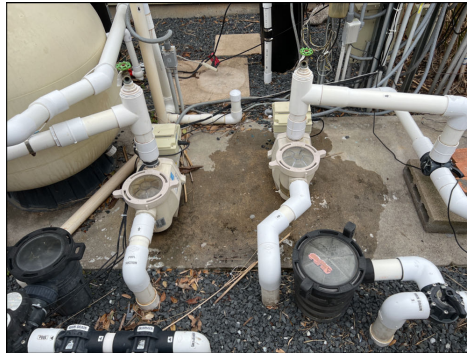
There is a water leak at the pool equipment. Mainly at - unable to determine location of leak

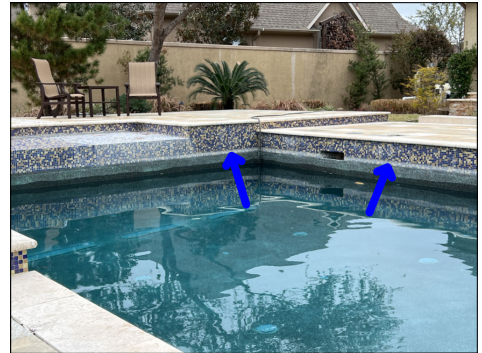
There are mineral stains on the pool walls and or surrounding equipment. Recommend a chemical analysis be performed on the pool water to verify safe water chemistry.

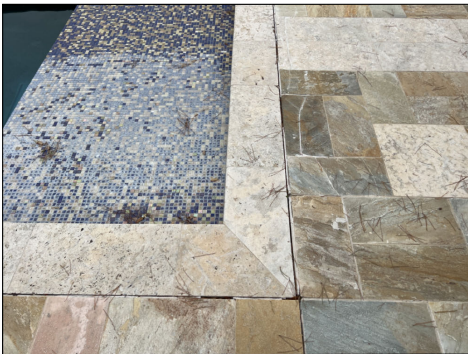
Recommend sealing between deck and coping to help prevent water penetration between causing soil to wash away and pavement to settle.

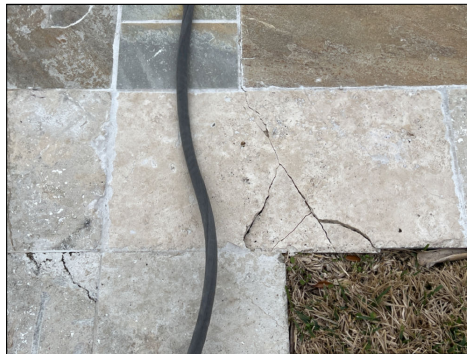
Tiles are chipped and/or cracked. Mainly at - throughout pool deck surround

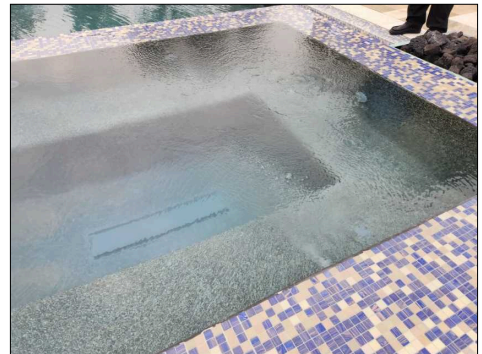
The pool equipment is sucking air, recommend sealing by applying grease to o-ring seals on the filter and strainers.

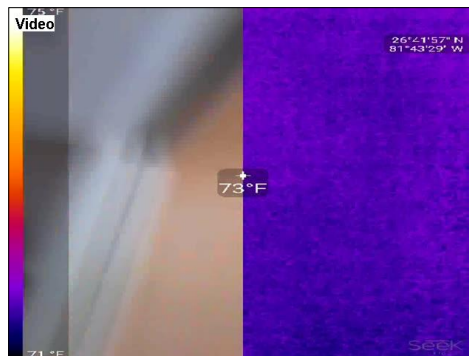
F. Sewer Scope Observations

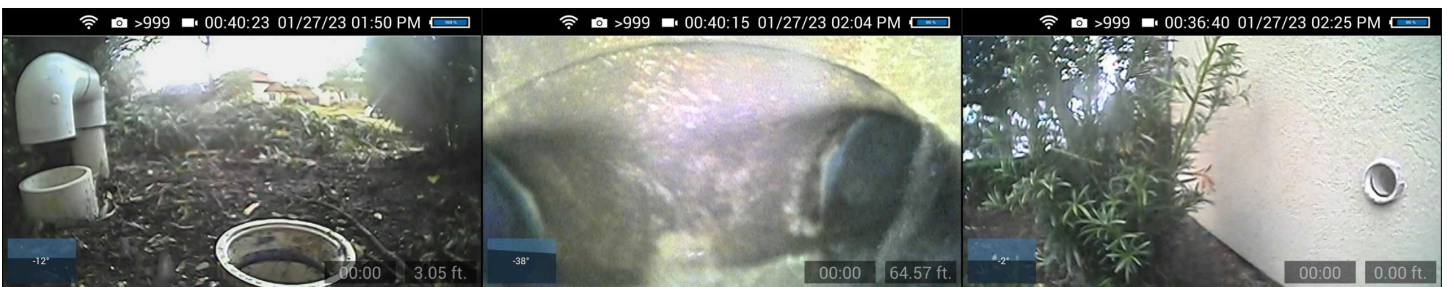
Overview of Sewer Scope Inspection Entry Point (Main House)

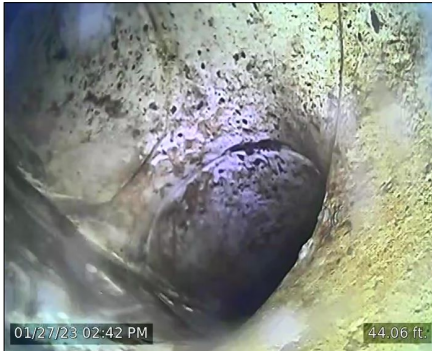
Sewer lateral connection from guest house to main house drain line @ 44 ft.

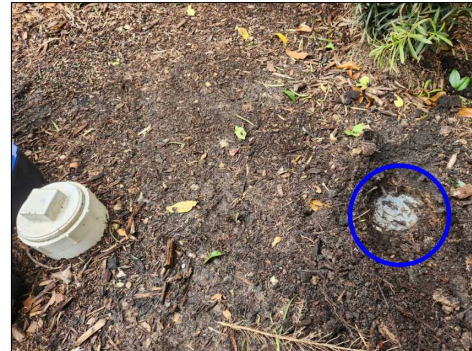
The height of the clean out is below the grade of the soil. It is recommended that the riser be elevated above grade to help identify entry points of the sewer line in the event that there is a need to gain access to the line to clear potential future blocks or obstructions. Mainly at - Guest House

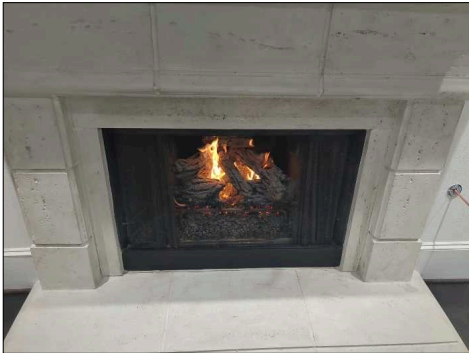
Overview of Office Fireplace

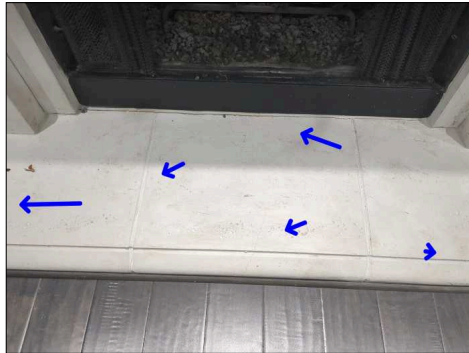
Settlement cracks are noted in the hearth, recommend sealing. Left front fireplace

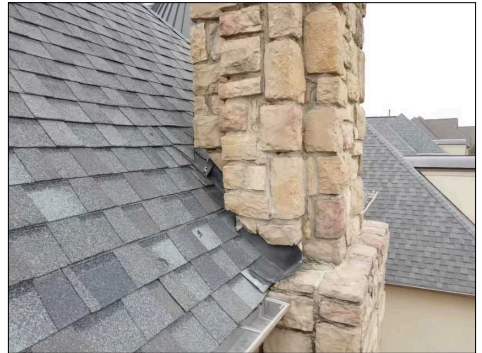
Overview of Office Chimney

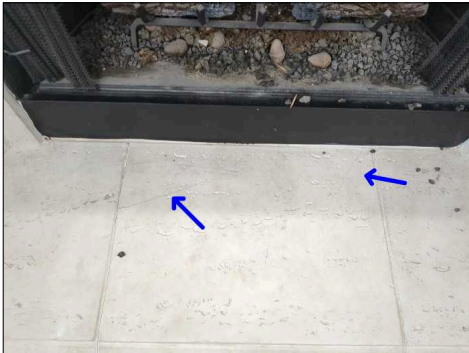
Settlement cracks are noted in the hearth, recommend sealing. Right rear fireplace

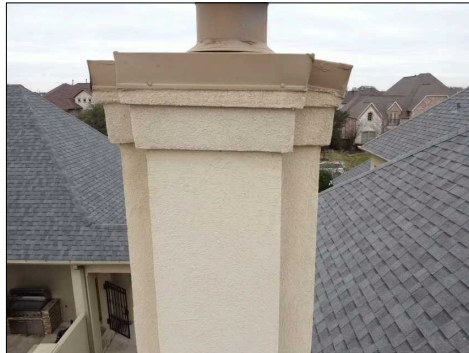
Overview of Living Room Chimney Cap
