Inspect, Inc.

INSPECTION REPORT

N/A, IL
Inspection prepared for: John Smith
Date of Inspection: 6/18/2015
Age of Home: 2005

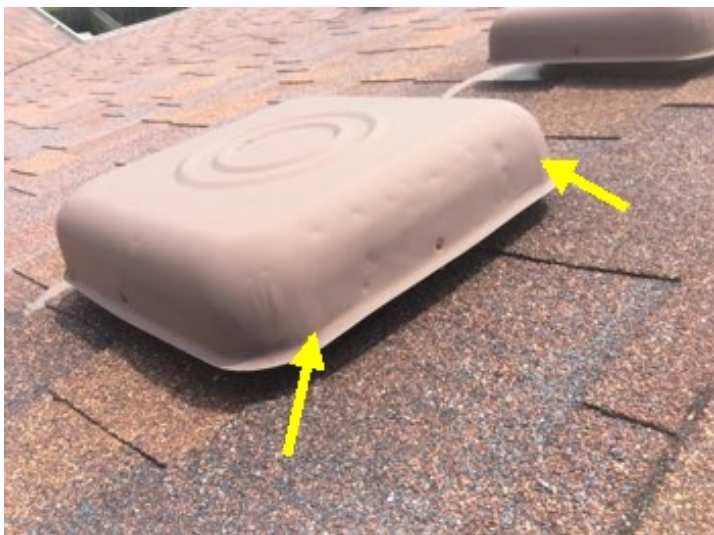
- The roof shows normal wear for its age and type.
- Evidence of granular loss.
- Evidence of nail pops visible.
- Evidence of moss, lichen and algae growth observed.
- Shingles are starting to lift and curl.
- Evidence of possible hail hits observed.
- Cracks visible in shingles.

Evidence of possible hail hits observed.

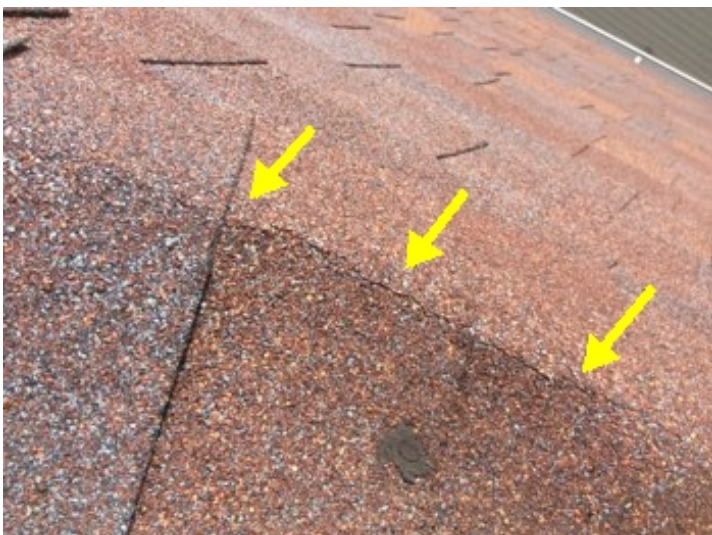
Cracks visible in shingles.

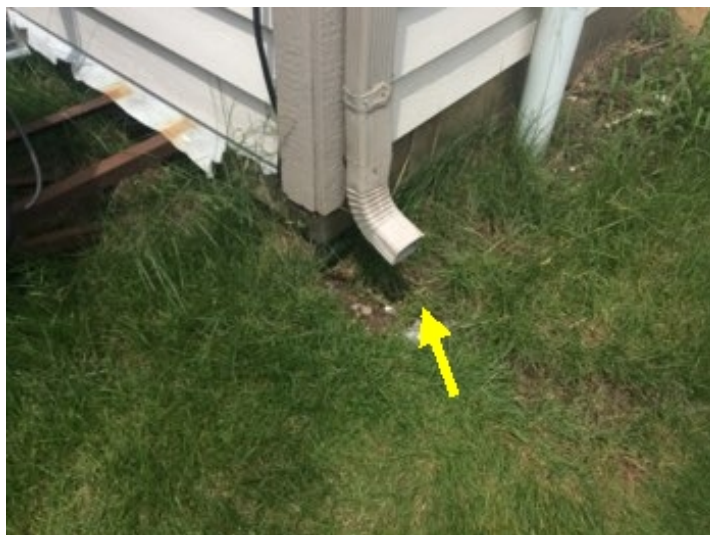
Downspout discharges water at foundation.

- Downspout discharges water at foundation.
- Recommend installation of gutter extensions to ensure proper drainage away from foundation.

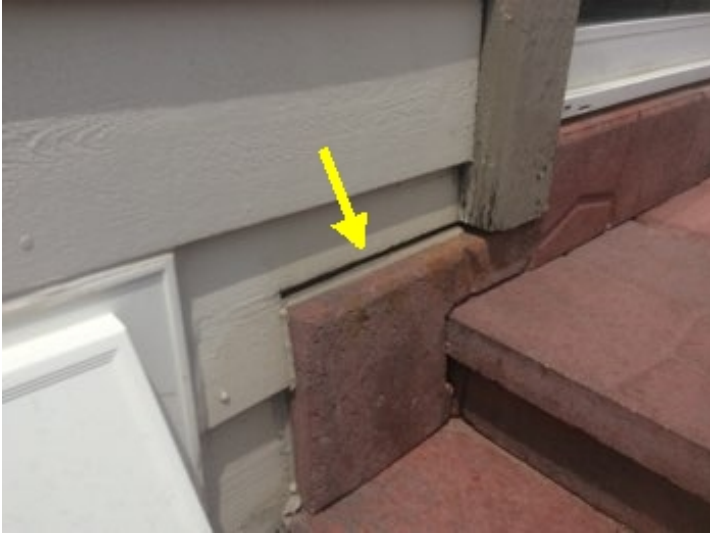
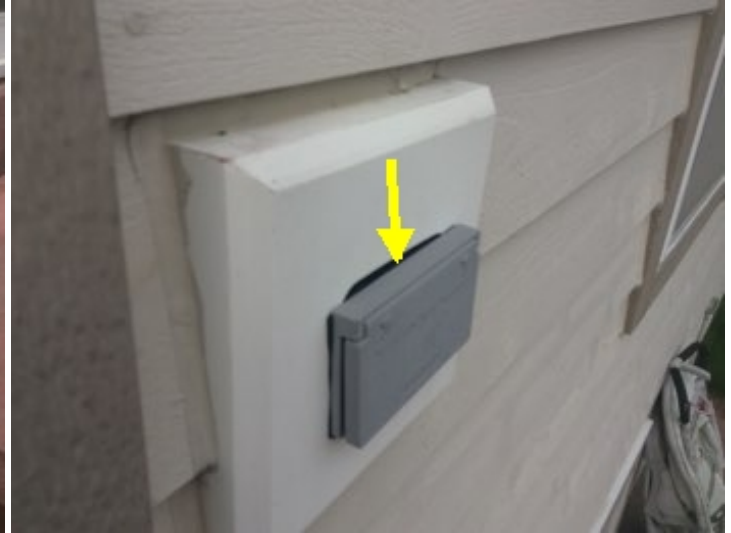
- Siding appears to be in serviceable condition for its age.
- Condition of the structure behind siding cannot be determined without removal of existing coverings and is outside the scope of this inspection.
- Peeling paint observed, suggest scraping and painting as necessary.
- Recommend caulking at open seams.
- Evidence of cracks, knots, and holes in cladding.
- Recommend repair or replacement as necessary.

Recommend caulking at open seams.

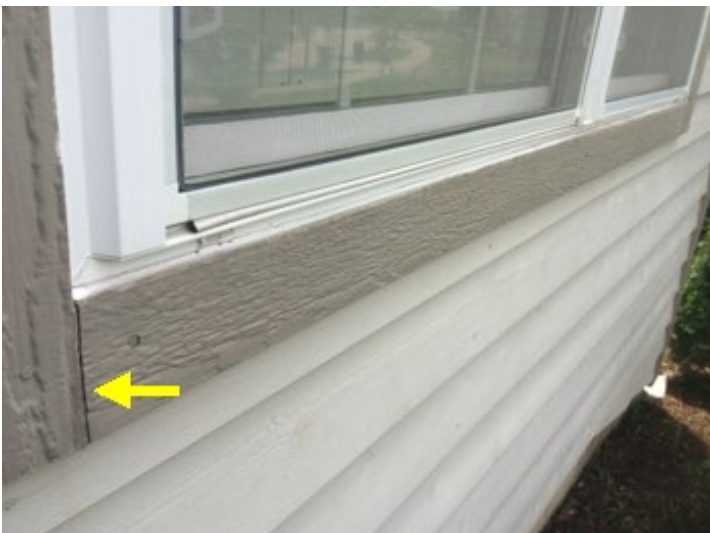
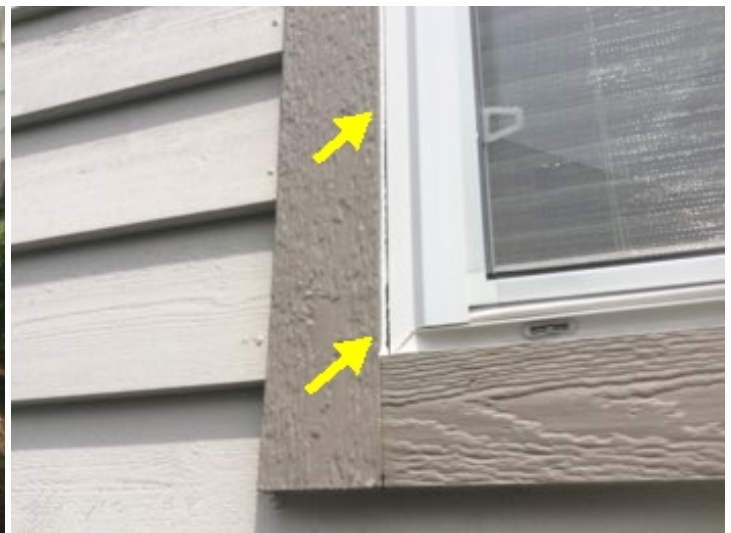
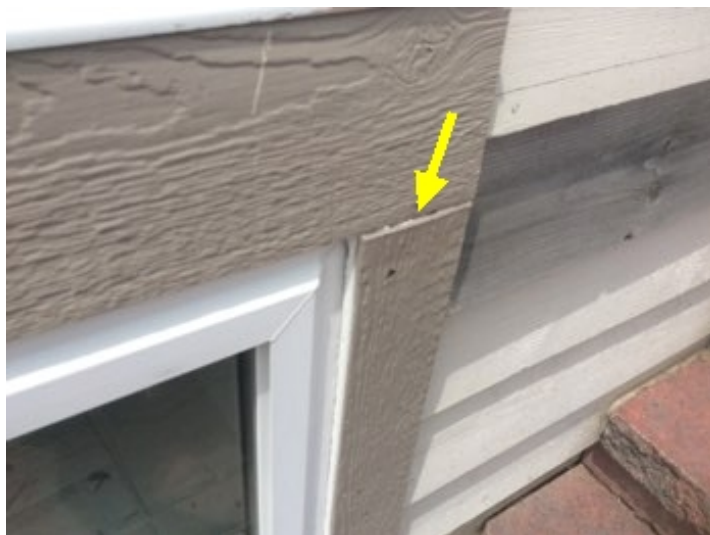
- Condition of the structure behind trim cannot be determined without removal of existing coverings and is outside the scope of this inspection.
- Recommend caulking open seams.

Recommend caulking open seams.

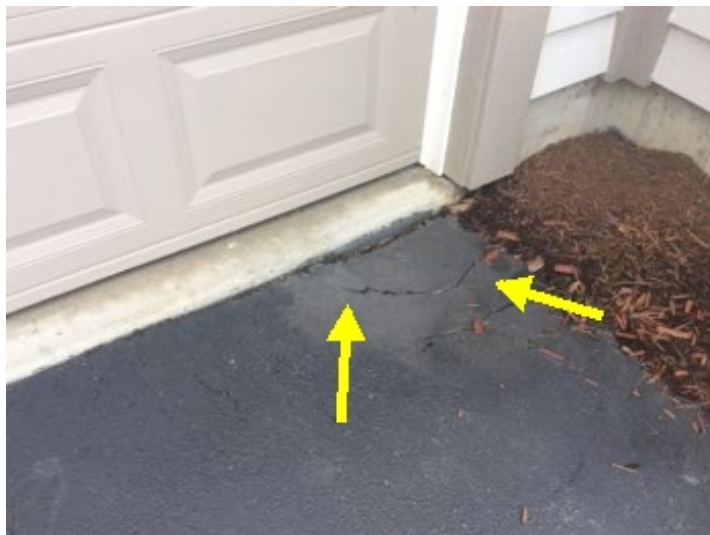
- Evidence of settlement and cracks in driveway.
- Evidence of possible trip hazards present.
- Recommend evaluation by a qualified contractor for repair or replacement as necessary.

Evidence of possible trip hazards present.

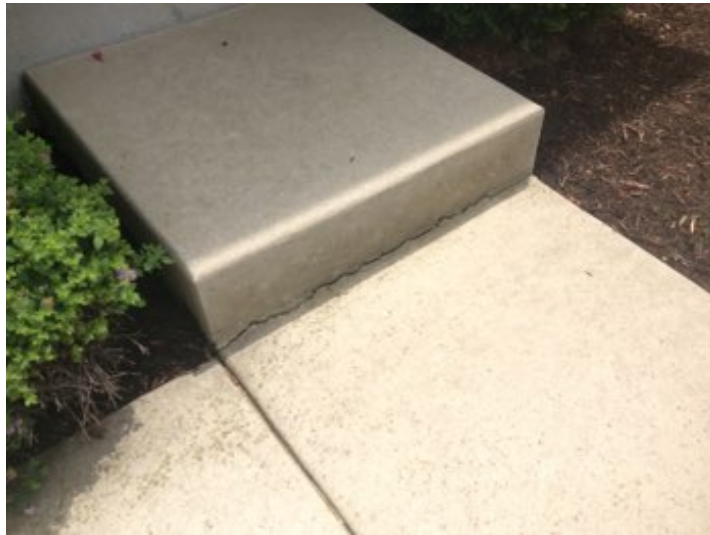
Evidence of settlement and cracks in walkways.

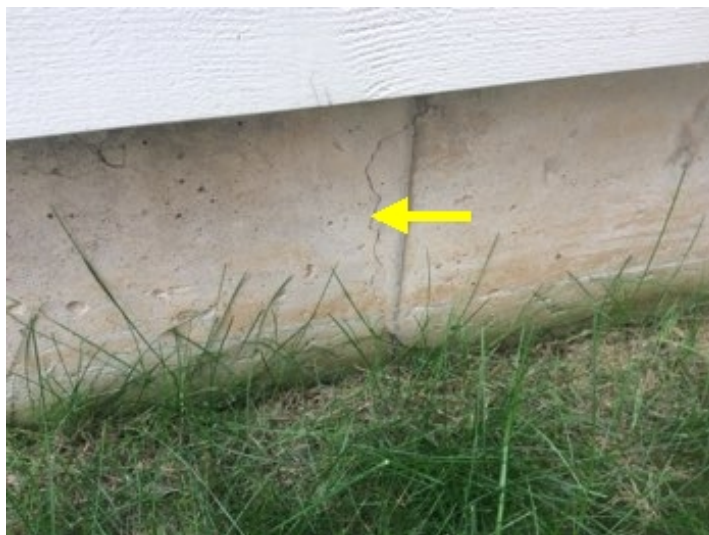
- Visible areas of the foundation appear to be structurally sound at time of inspection.
- Evidence of settlement cracks visible in foundation.
- Settlement and shrinkage cracks are very common and appear in almost all foundations. While these may not be structural in nature they can allow moisture infiltration. Recommend to monitor foundation cracks for seepage and repair if necessary. Foundation cracks can be professionally repaired by a qualified waterproofing contractor so that moisture will not enter the structure.

Evidence of settlement cracks visible in foundation.

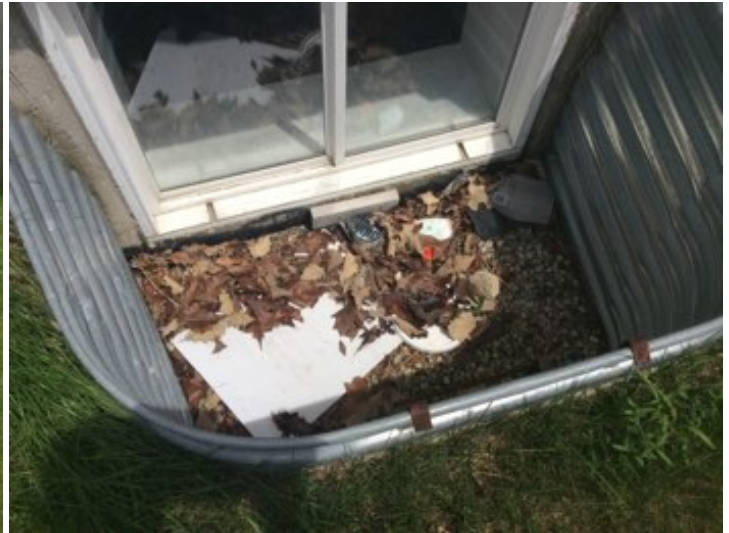
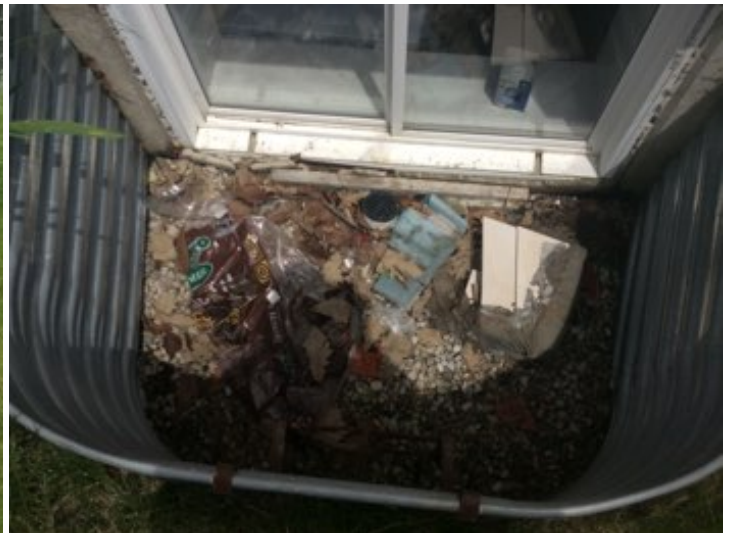
Window wells are full of debris and should be cleaned.

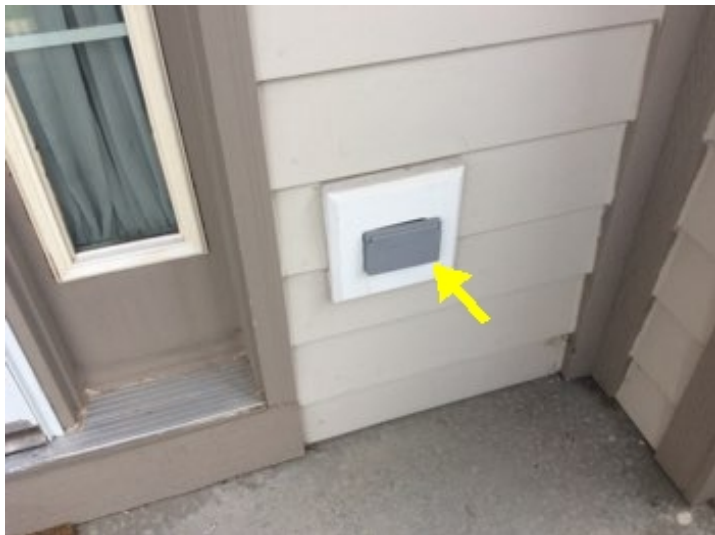
No power at outlet on front porch.

- Electrical outlets may be present in yard and may not have been tested. Surveying the yard for electrical system components is technically exhaustive and not part of this report.
- Buried electrical system components are not visible and are not part of this report.
- Low voltage lighting components are not inspected.
- **No power at outlets. Possible defective GFCIs**
- **Recommend evaluation for repair or replacement by a licensed electrician as necessary.**

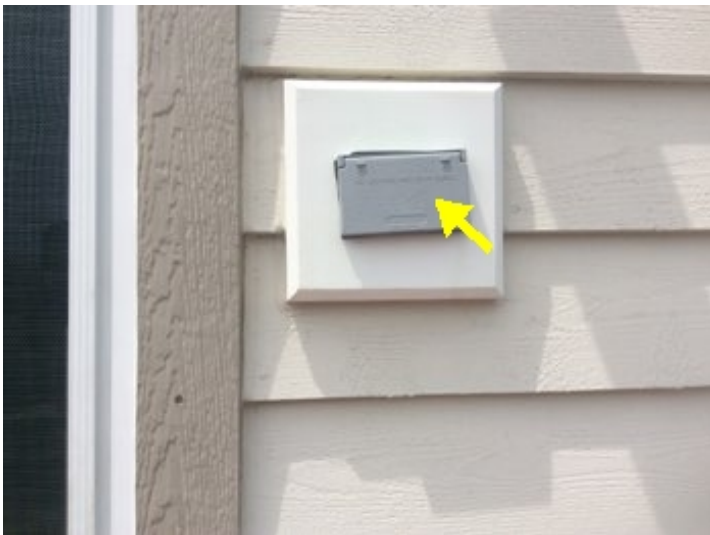
No power at outlet at rear steps. Possible defective GFCI

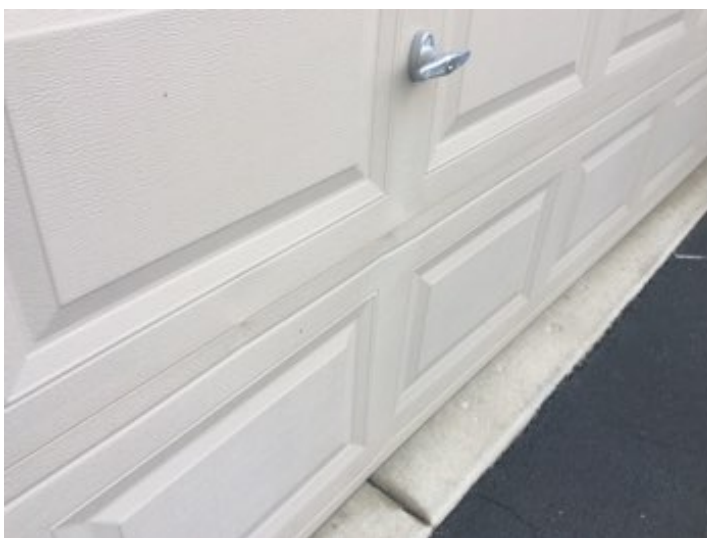
Dents in the overhead garage door visible.

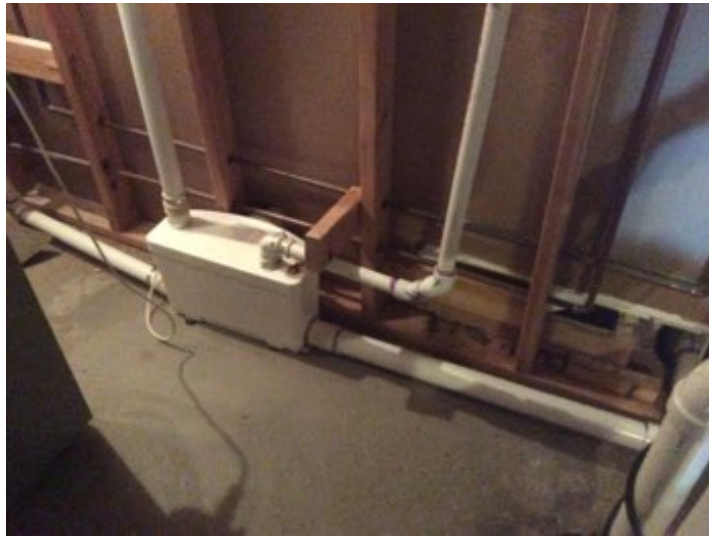
Waste piping does not appear to be professionally installed.

- Evidence of clean outs visible.
- Waste piping does not appear to be professionally installed.
- Recommend to have plumbing system evaluated for repair or replacement by a licensed plumbing contractor as necessary.

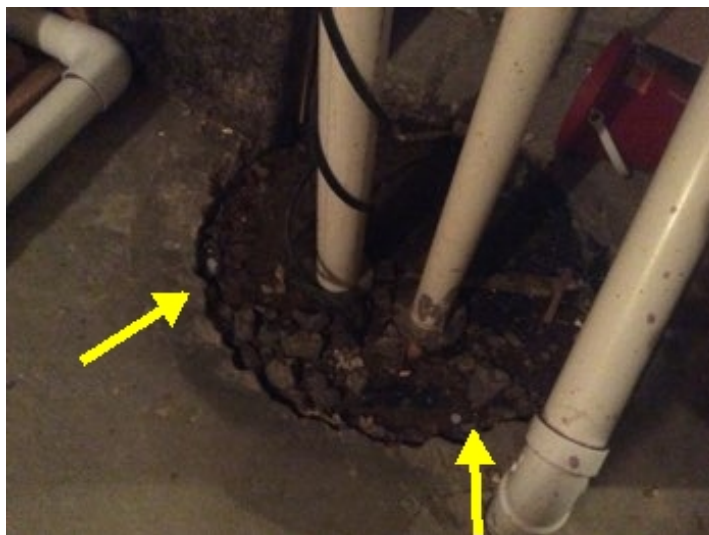
Evidence of standing water on ejector pit cover.

- Evidence of standing water on ejector pit cover.
- Recommend review by a licensed plumber for repair or replacement.

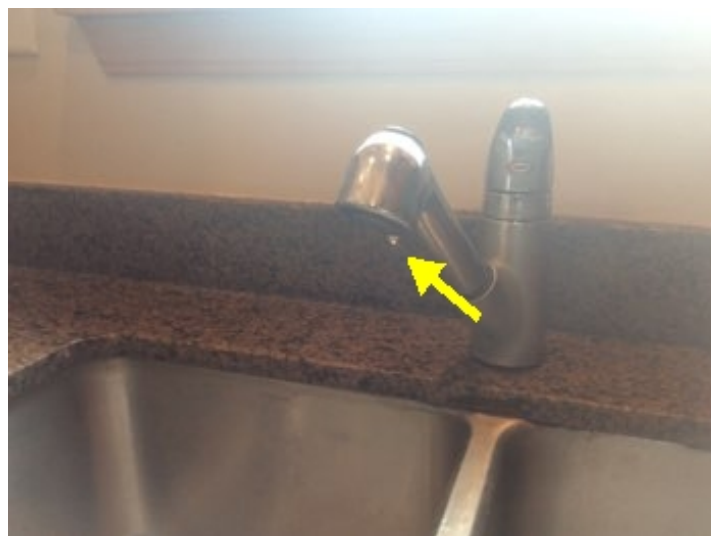
Faucet drips.

- Wear and tear of faucets is not reported.
- Faucet drips.
- Recommend review for repair or replacement as necessary.

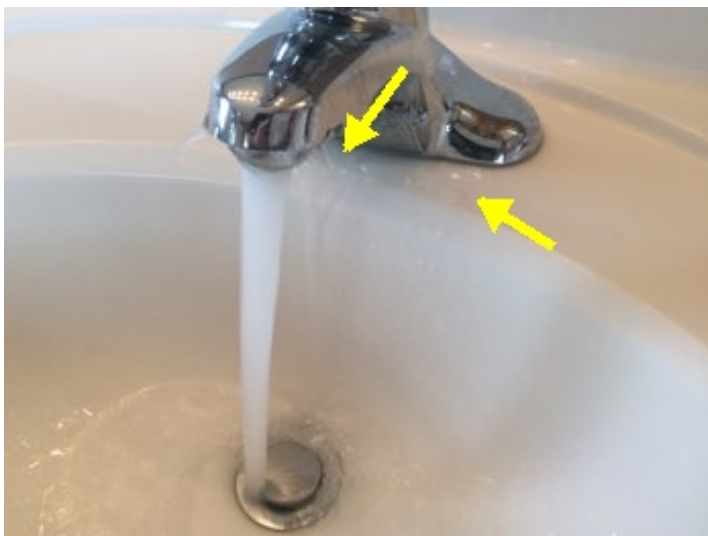
Sink faucet is leaking and needs repair.

- Sink faucet is leaking and needs repair.
- Recommend evaluation and repair/replacement as necessary.

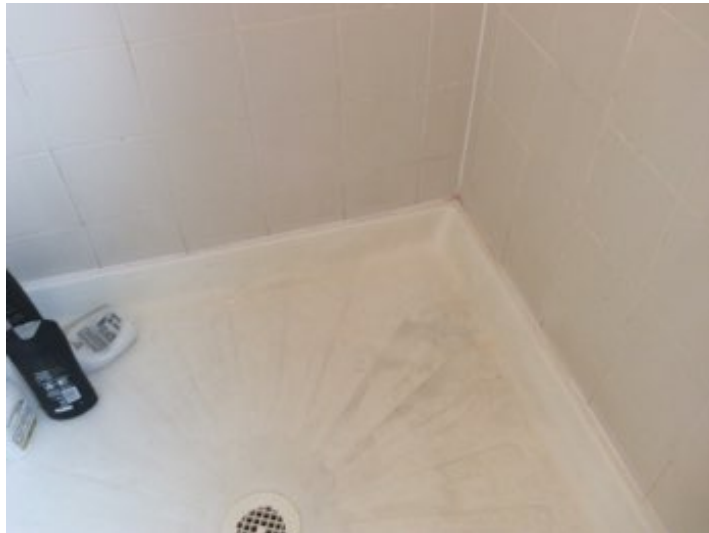
Grout and caulk are dirty and need to be cleaned.

- Grout and caulk are dirty and need to be cleaned.
- Recommend repair or replacement as necessary.

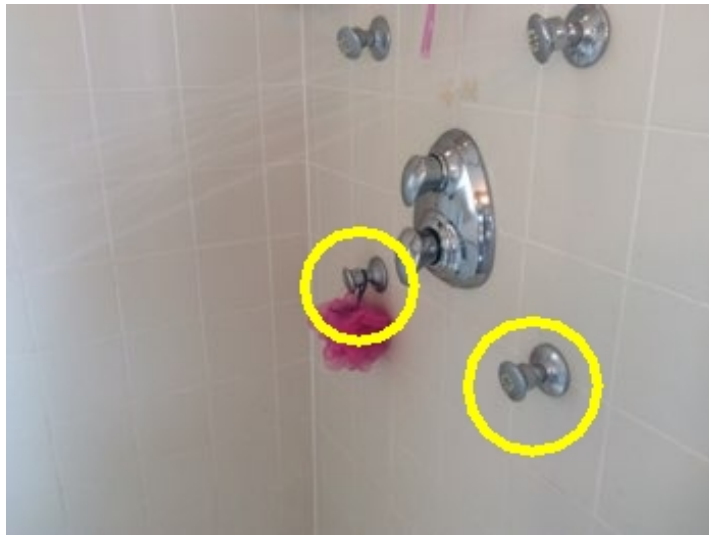
Wall mounted shower sprayer components are not working properly.

- Wall mounted shower sprayer components are not working properly.
- Recommend evaluation for repair or replacement as necessary.

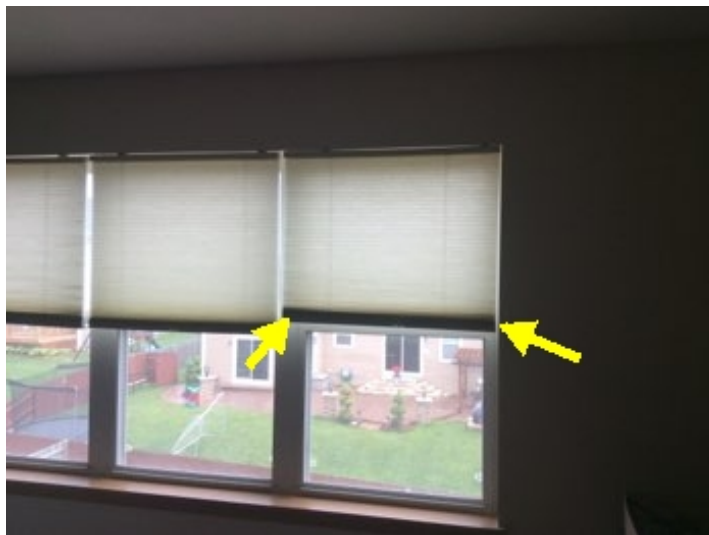
Window blind needs repair.

- Window frames appear to be in good condition for age and type.
- Window blind needs repair.
- Recommend repair or replacement as necessary.
- Window treatments are not inspected.

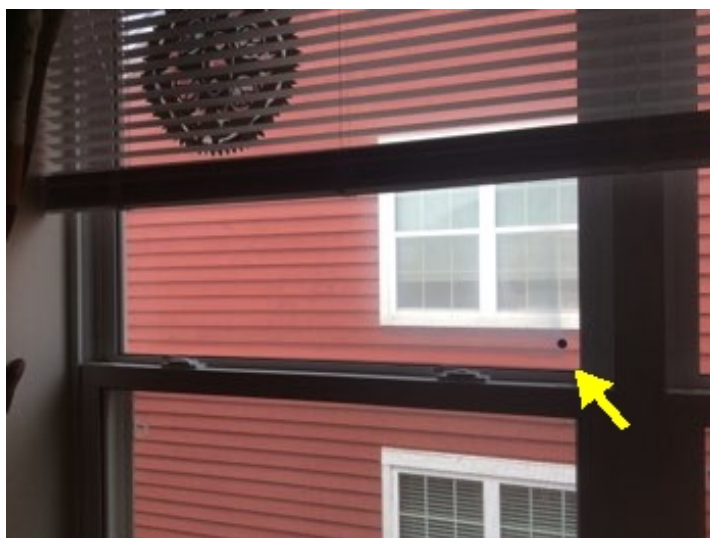
Evidence of lost seals marked with sticker.

- Evidence of lost seals marked with stickers. 1Total
- Recommend review by a qualified professional for repair or replacement as necessary.

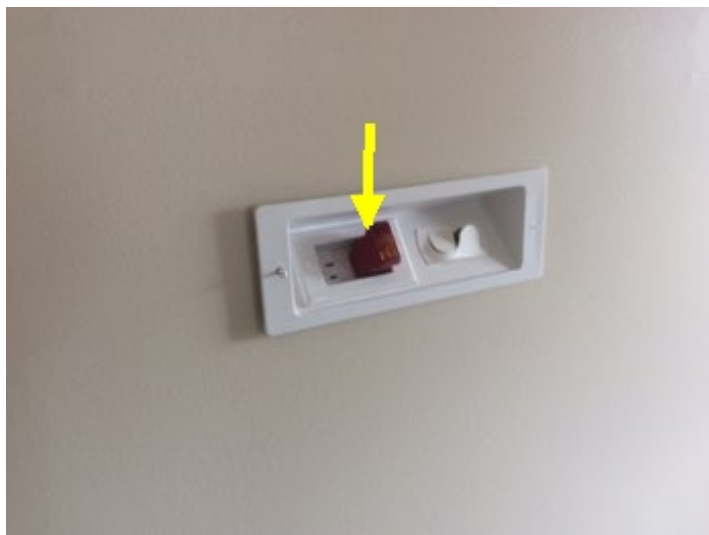
Wall outlet is not working and may not be up to current standards.

- Wall outlet is not working and may not be up to current standards.
- Recommend repair or replacement as necessary.
