## INSPECTION REPORT

N/A, IL  
Inspection prepared for: John Smith  
Date of Inspection: 6/18/2015  
Age of Home: 1966  
Sample report

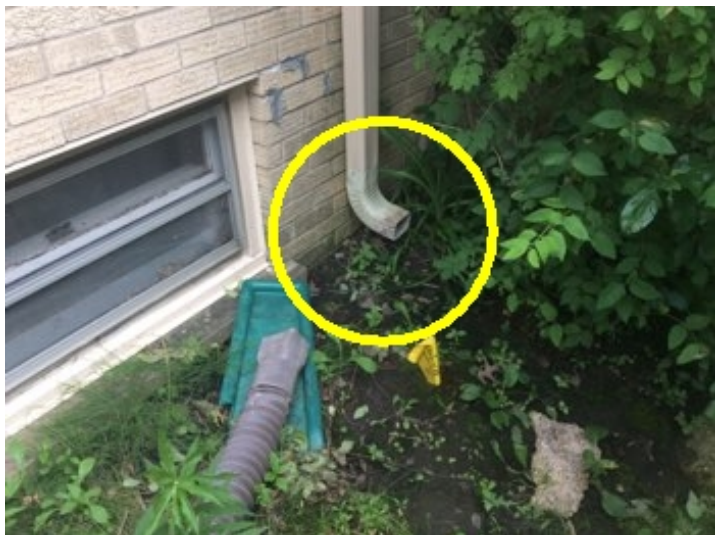
Downspout discharges water at foundation.

- Downspout discharges water at foundation.
- Recommend installation of gutter extensions to ensure proper drainage away from foundation.
- Gutter nails pulled away from facia or house framing. Possibly from ice build up, leaking gutters and/or rotted wood. Recommend to repair and secure gutters to structure.
- Dents visible in gutters.
- Recommend repair by as necessary.

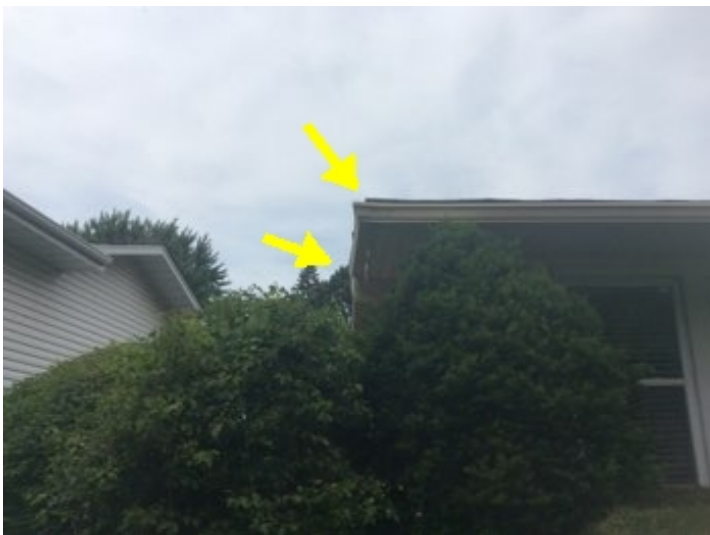
Recommend to repair and secure gutters to structure.

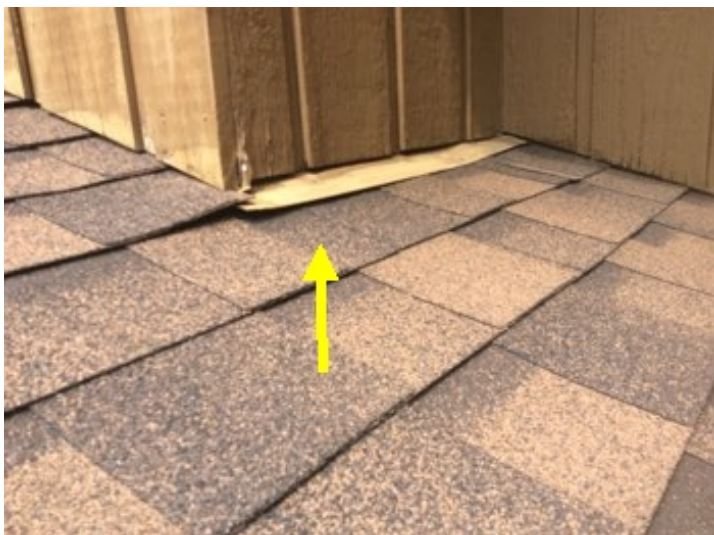
Flashings have lifted and need repair.

- Flashings have lifted and need repair.
- Recommend repair or replacement as necessary.

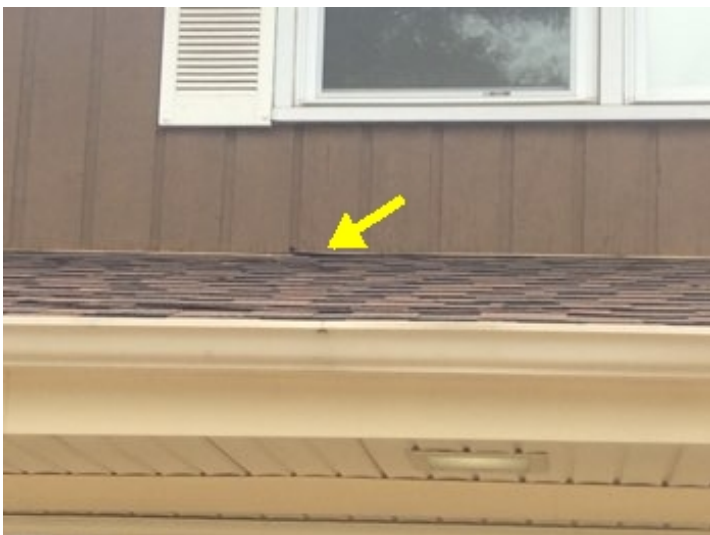
Flashings have lifted and need repair.

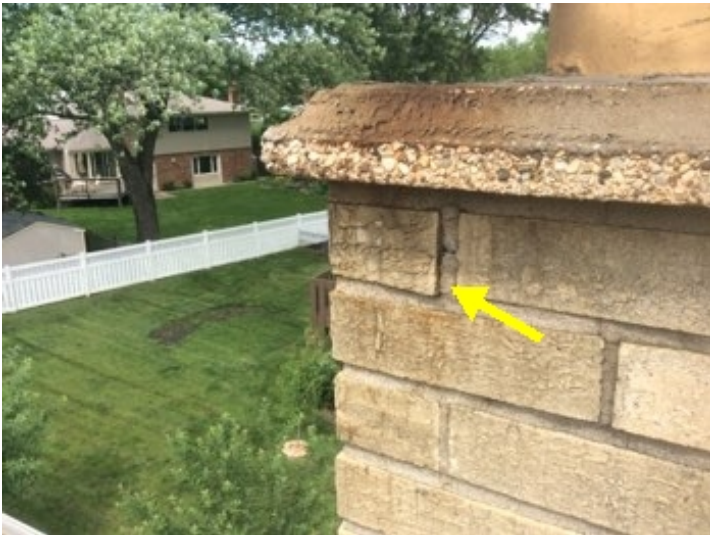
Evidence of cracks in bricks at chimney chase.

- Evidence of cracks in bricks at chimney chase.
- Evidence of moss buildup on chimney chase.
- Recommend repair as necessary.

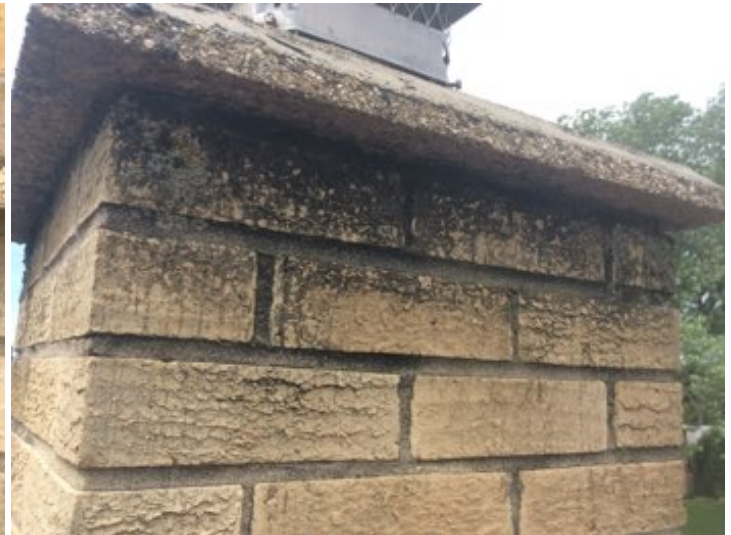
Evidence of moss buildup on chimney chase.

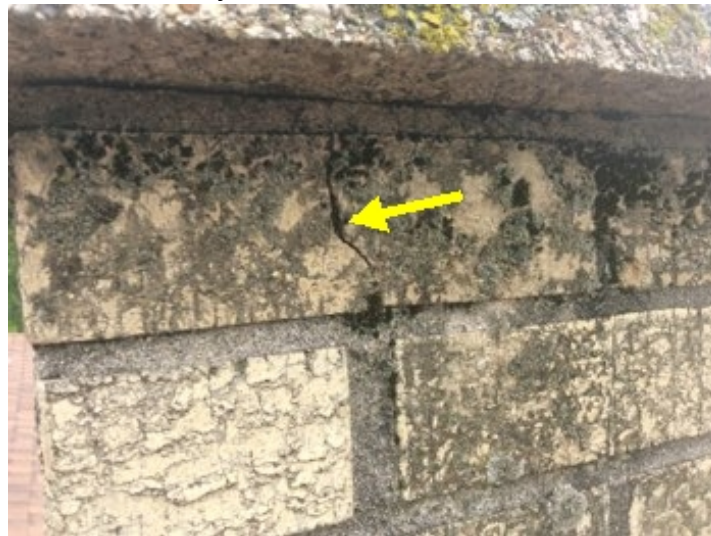
Evidence of cracks in bricks at chimney chase.

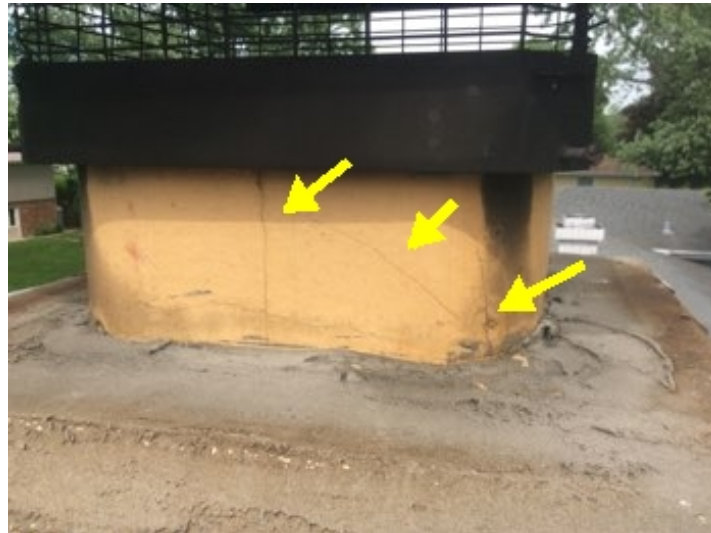
Cracked flue liner observed.

- Interior of chimney flue is not visible due to rain cap(s).
- Cracked flue liner observed.
- Recommend to have the chimney flue evaluated by a professional chimney contractor.

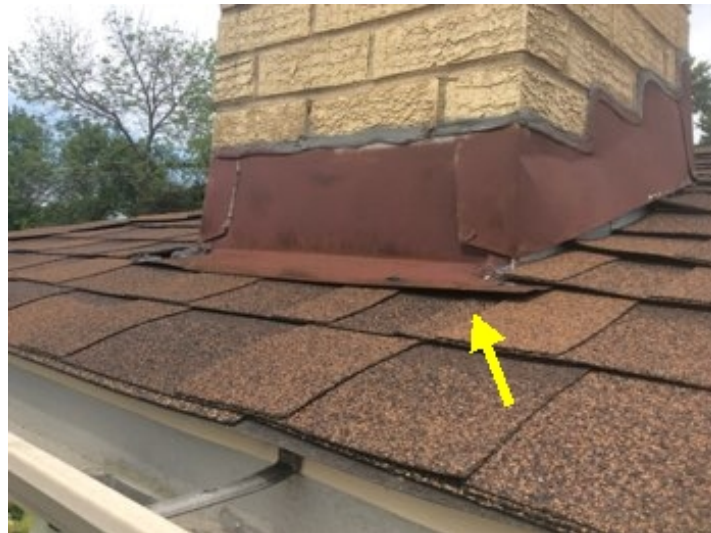
Flashing at chimney has lifted and needs repair.

- Flashings at chimney shows evidence of rust and should be addressed to prevent deterioration.
- Flashing at chimney has lifted and needs repair.
- Recommend repair or replacement as necessary.

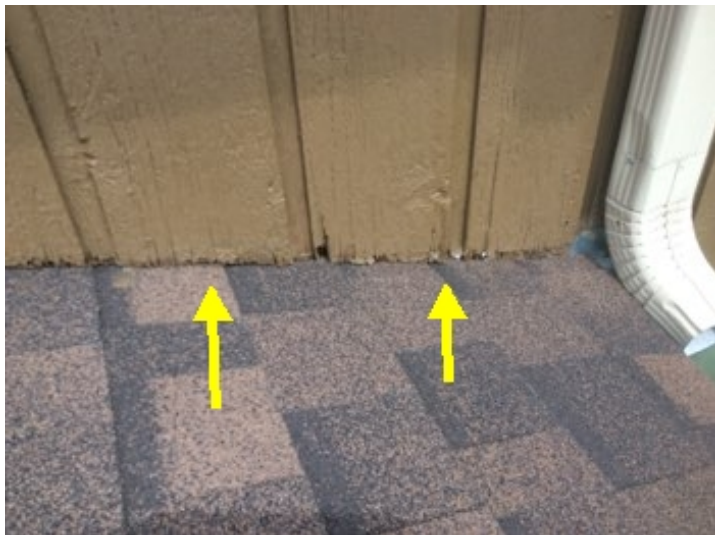
Damage to siding visible.

- Condition of the structure behind siding cannot be determined without removal of existing coverings and is outside the scope of this inspection.
- Damage to siding visible.
- Peeling paint observed, suggest scraping and painting as necessary.
- Recommend caulking at open seams.
- Evidence of curling and cupping of wood siding.
- Evidence of cracks in siding present.
- Recommend to replace damaged siding.
- Evidence of repairs observed.
- Possible woodpecker holes with damage visible.
- Recommend repair or replacement as necessary.

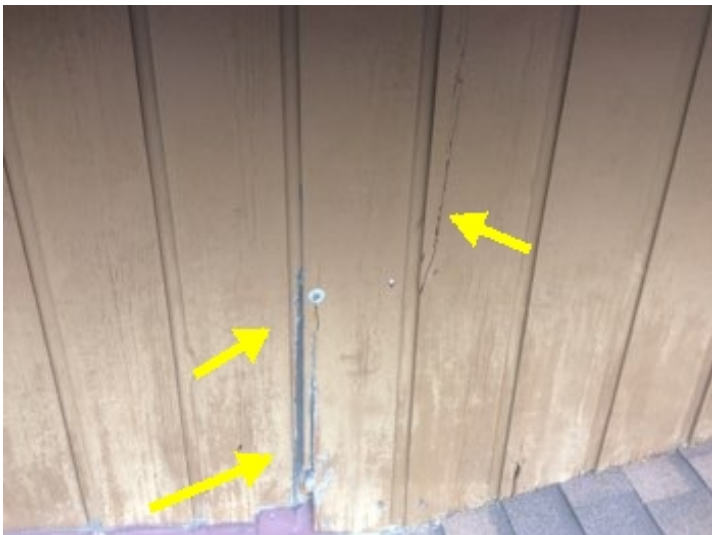
Evidence of repairs observed.

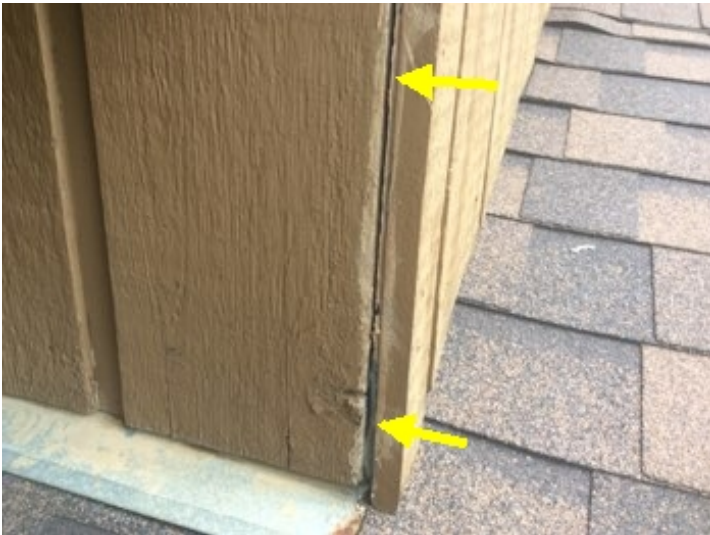
Recommend caulking at open seams.

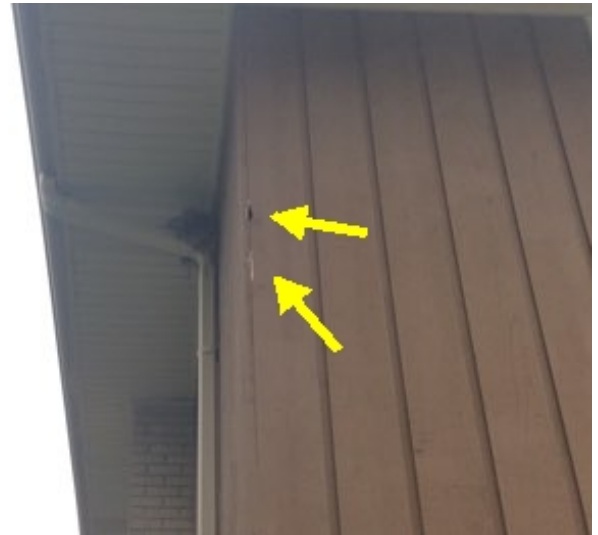
Possible woodpecker holes with damage visible.

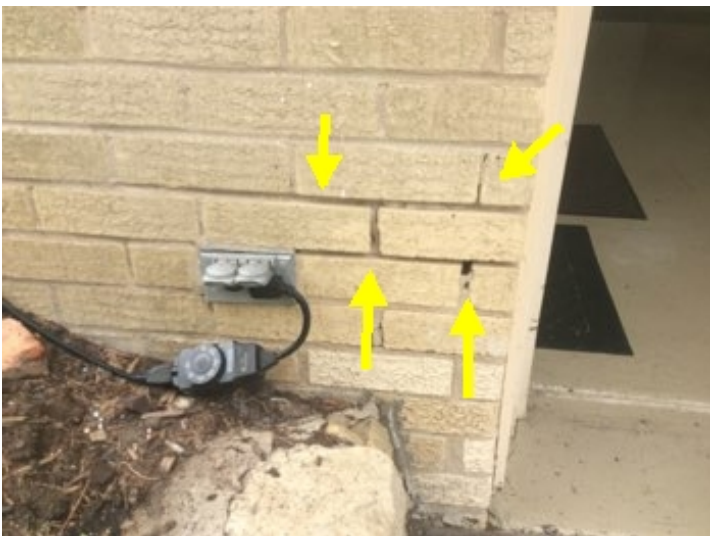
Evidence of missing mortar needs repair.

- Condition of the structure behind masonry cannot be determined without removal of existing coverings and is outside the scope of this inspection.
- Masonry extends to grade at much of the house. This condition can allow moisture to enter and cause deterioration and damage to framework and interior components. Conditions behind masonry are not visible and cannot be inspected. Masonry should be begin 6-8" above final grade.
- Evidence of missing mortar needs repair.
- Evidence of step cracks visible between bricks.
- Evidence of spalling and cracks in bricks.
- Recommend evaluation by a professional mason contractor for repair or replacement as necessary.

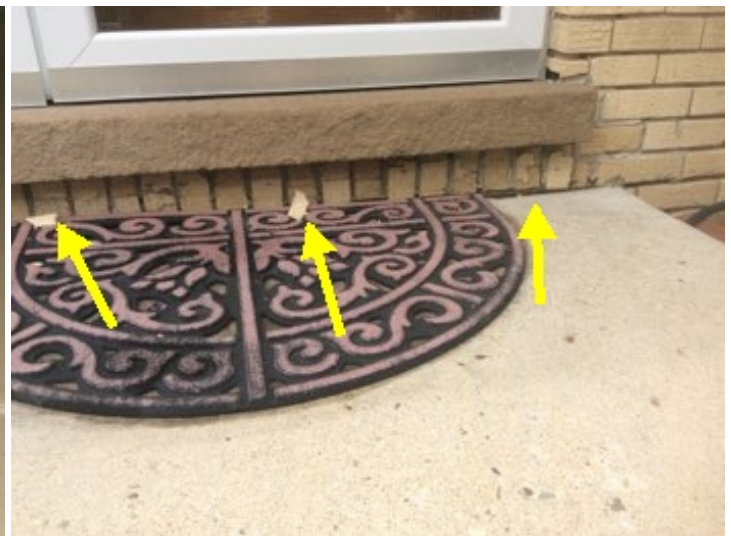
Evidence of spalling and cracks in bricks.

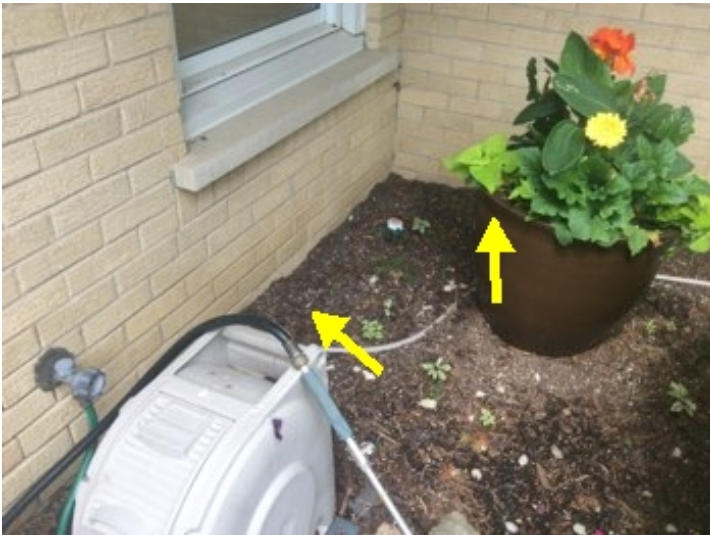
Masonry extends to grade at much of the house.

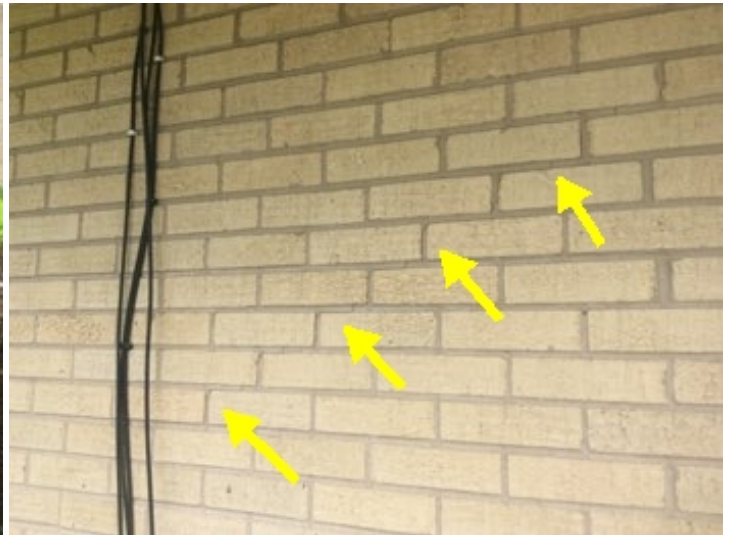
Evidence of step cracks visible between bricks.

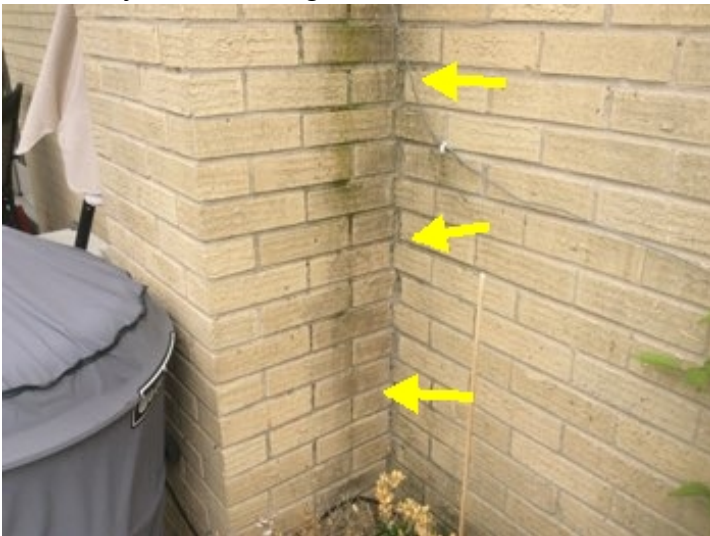
Evidence of missing mortar needs repair.

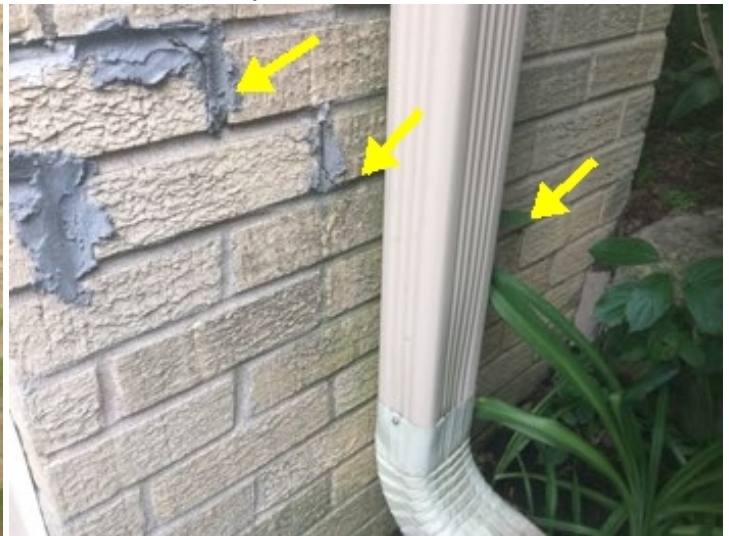
Evidence of step cracks visible between bricks.

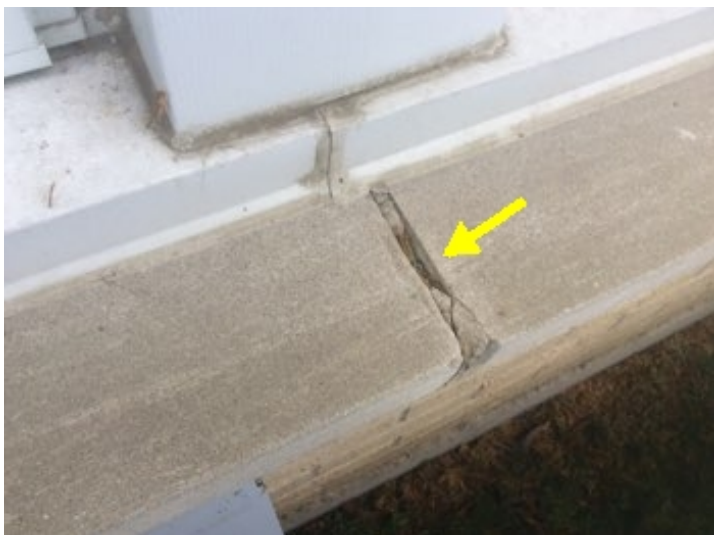
Recommend to repair mortar joints between limestone sills.

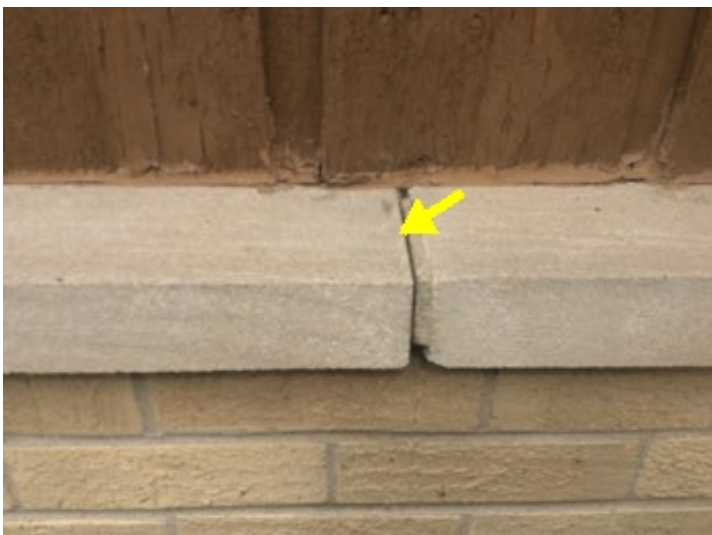
Recommend to repair mortar joints between limestone sills.

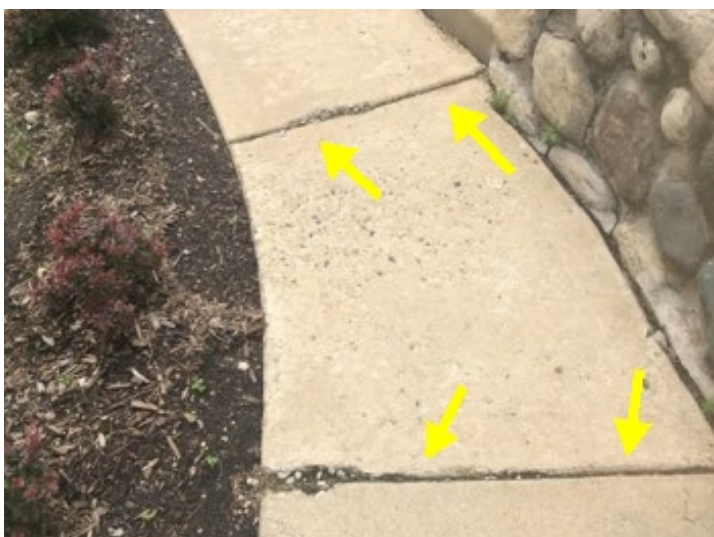
Possible trip hazards present.

- Evidence of settlement and cracks in walkways.
- Evidence of settlement in walkways with possible trip hazards present.
- Recommend evaluation by a qualified contractor for repair or replacement as necessary.

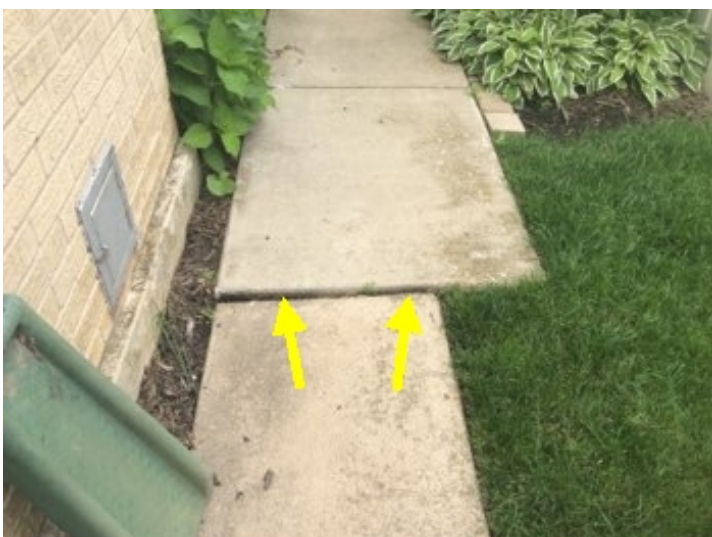
Possible trip hazards present.

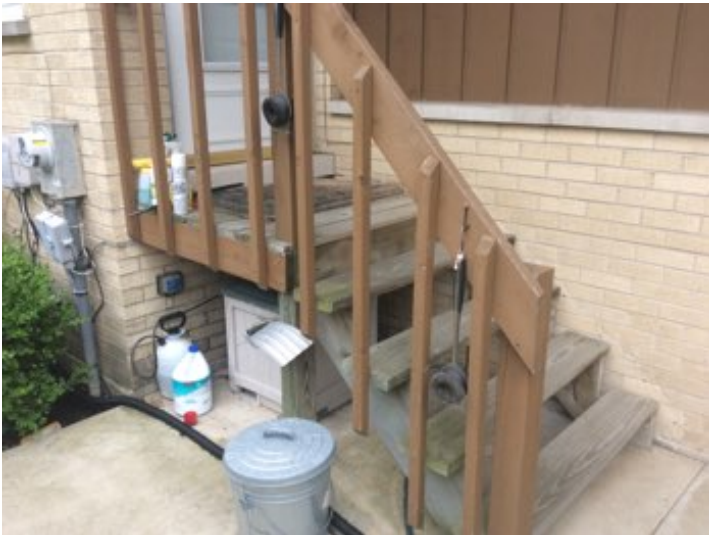
Steps are not properly supported or attached to landing.

- Recommend to paint rusted railings.
- **Recommend installing handrails at exterior basement stairway.**
- **Recommend to bolt header into wall.**
- **Deck balusters are spaced too far apart according to current standards. Recommend replacement of balusters with spacing not exceeding 4" apart.**
- **Steps are not properly supported or attached to landing.**
- **Recommend evaluation and repair by a qualified contractor, as necessary.**

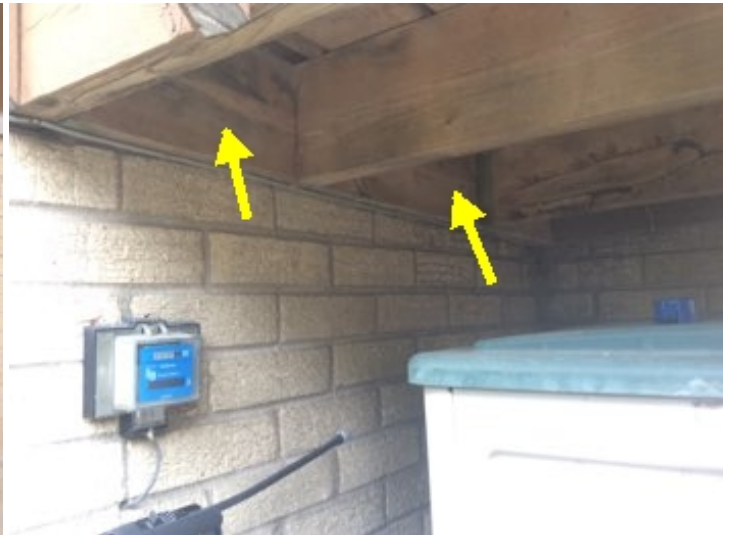
Recommend to bolt header into wall.

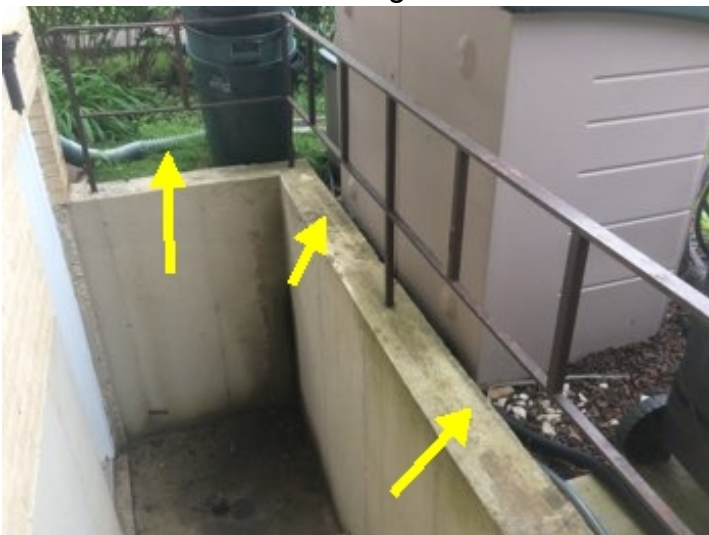
Balusters are spaced too far apart according to current standards. Recommend replacement of railings with spacing not exceeding 4" apart.

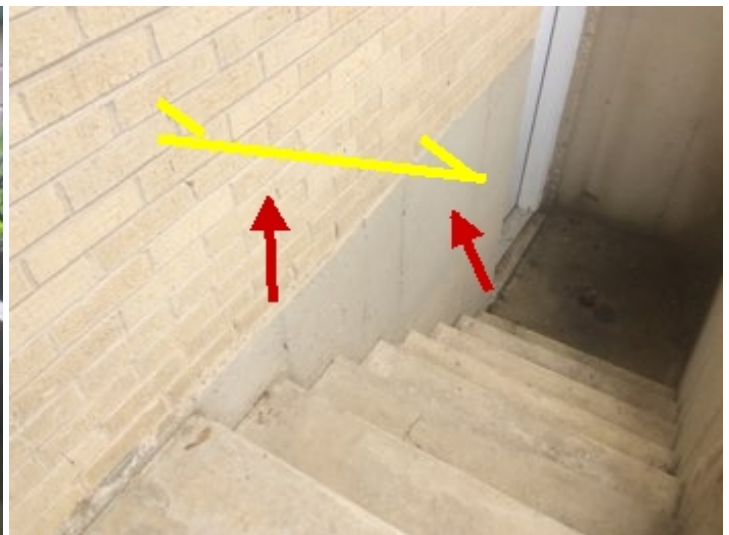
Recommend installing handrail at exterior basement stairway.

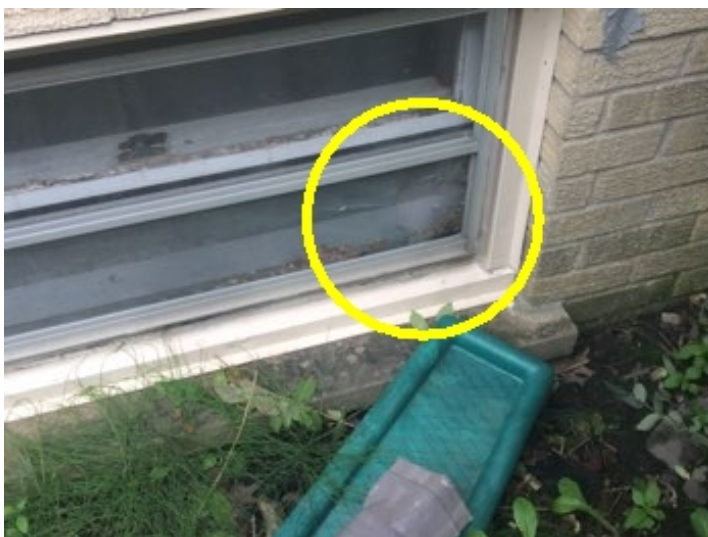
Broken storm window needs repair.

- Damaged screens are considered an item subject to wear and tear and will not be included in this report.
- **Broken storm window needs repair.**
- **Recommend repair or replacement as necessary.**

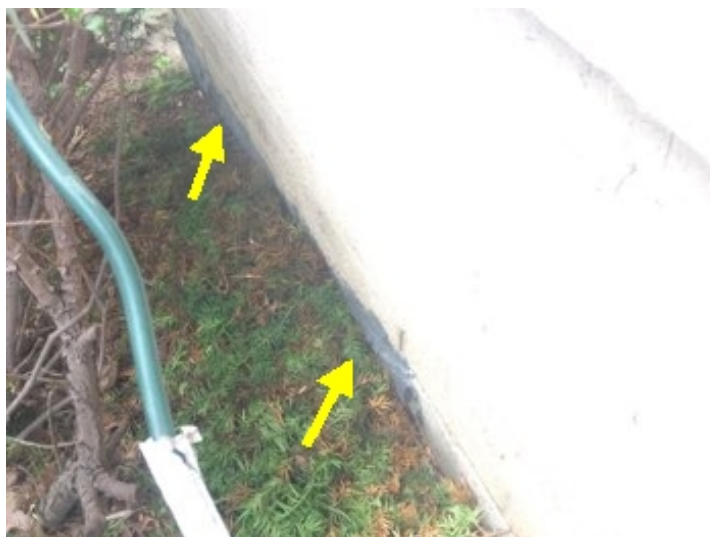
Evidence of possible foundation crack repairs.

- Evidence of settlement cracks visible in foundation.
- Settlement and shrinkage cracks are very common and appear in almost all foundations. While these may not be structural in nature they can allow moisture infiltration. Recommend to monitor foundation cracks for seepage and repair if necessary. Foundation cracks can be professionally repaired by a qualified waterproofing contractor so that moisture will not enter the structure.
- Evidence of possible foundation crack repairs.
- Repairs done from the exterior are commonly only above grade and subsoil repairs are usually not performed. Most repair work is performed from inside the house.

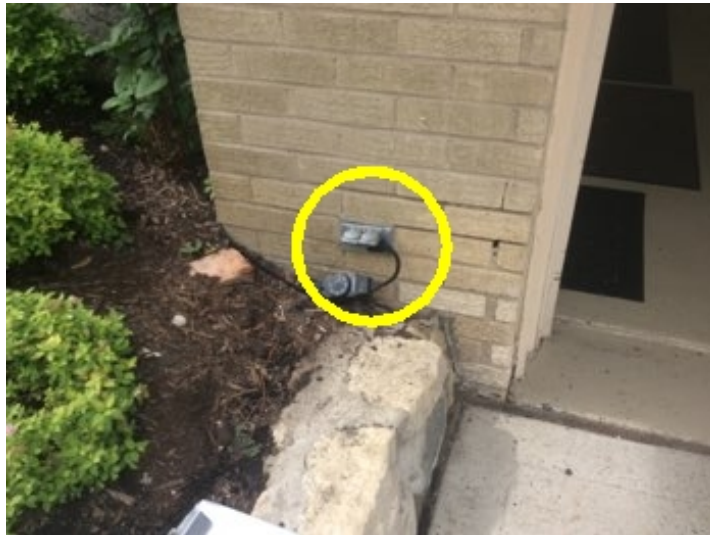
Recommend to add GFCI's at all exterior outlets.

- Electrical outlets may be present in yard and may not have been tested. Surveying the yard for electrical system components is technically exhaustive and not part of this report.
- Buried electrical system components are not visible and are not part of this report.
- Low voltage lighting components are not inspected.
- Recommend to add GFCI's at all exterior outlets.
- **GFCI protected receptacles may not have been required when the house was built. We suggest buyer consider upgrading with GFCIs at all exterior receptacles where missing.**

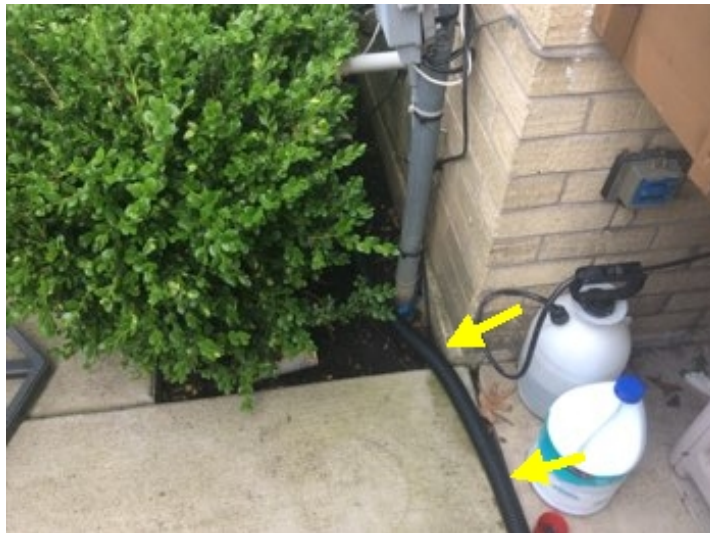
Sump pump discharge line should be removed in winter.

- Sump pump discharge line should be removed in winter as it may back up into house if becomes frozen.

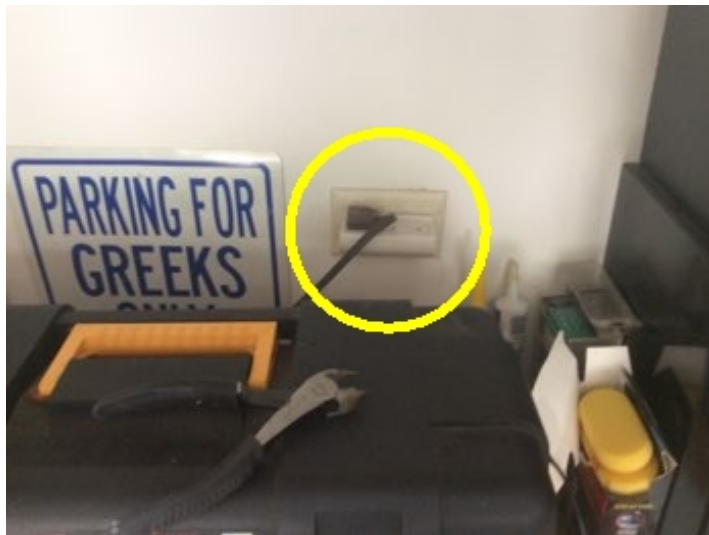
Recommend installing GFCI protected receptacles for safety.

- Ground Fault Circuit Interrupters (GFCI) may not have been required when the home was built. Recommend upgrading with GFCI's at all receptacles in garage.

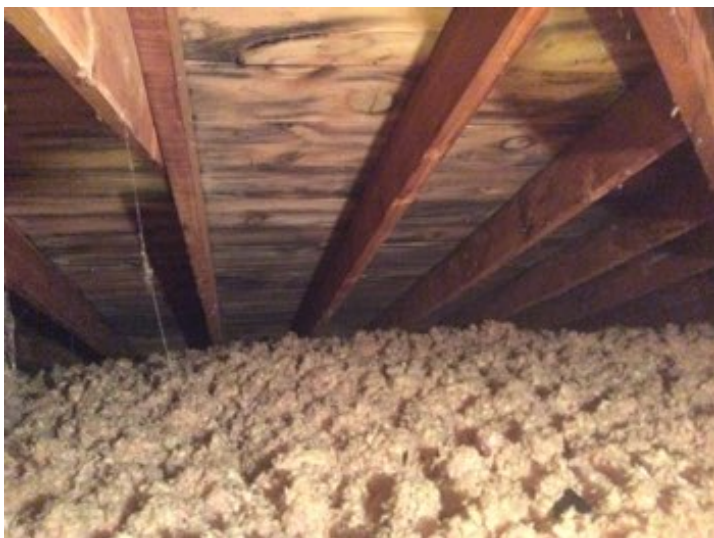
Evidence of a possible moldy substance found on components.

- Evidence of a possible moldy substance found on components in attic. Recommend further evaluation by a licensed environmental inspector.

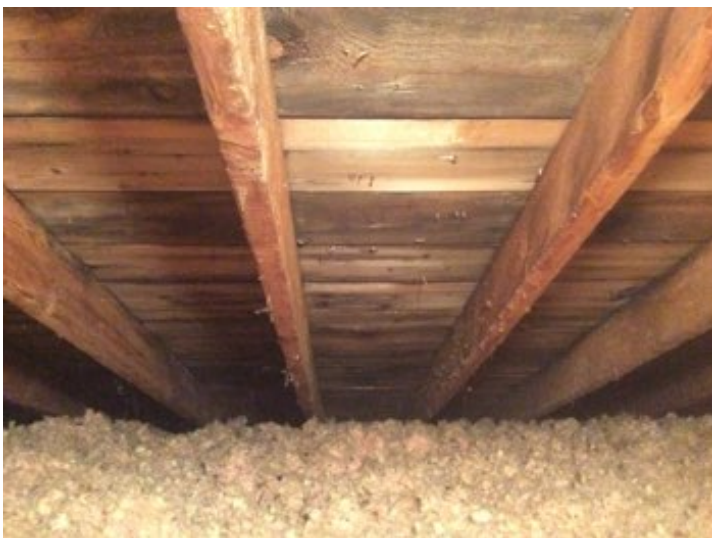
Evidence of a possible moldy substance found on components.

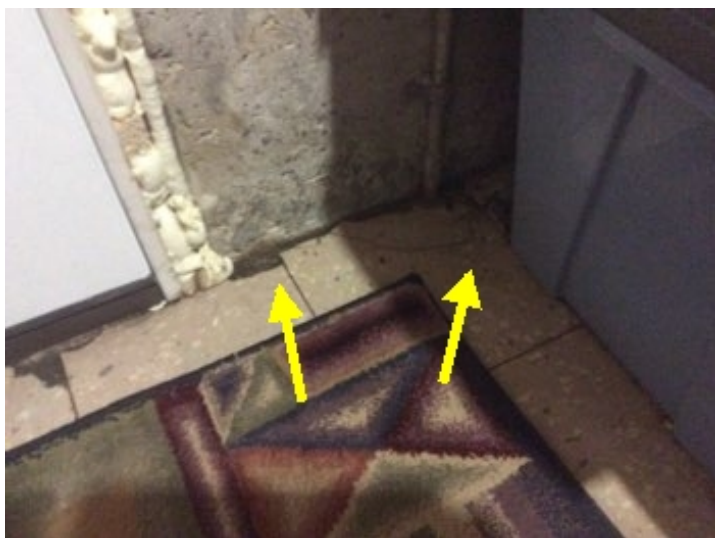
Evidence of seepage stains around door.

- The drain in exterior stairway must be kept clear to prevent flooding into the basement.
- Operation of exterior drain at basement door could not be confirmed at time of inspection.
- Evidence of seepage stains around door.
- Recommend review for repair or replacement as necessary.

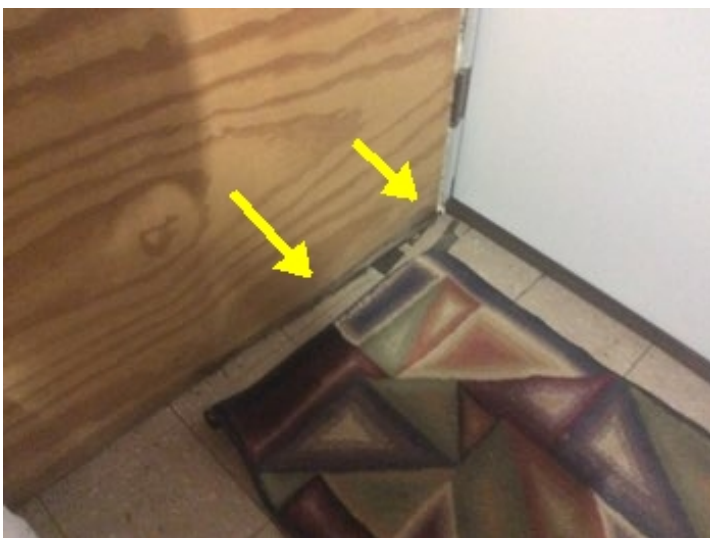
Evidence of seepage stains around door.

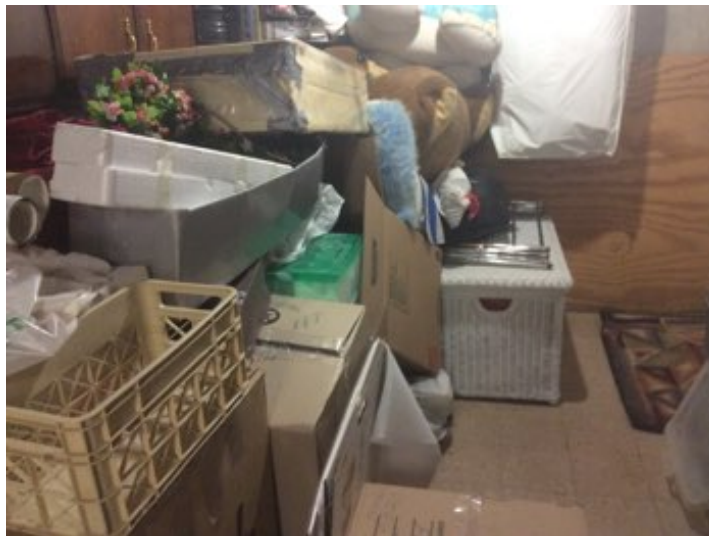
Limited visibility of foundation walls due to personal storage.

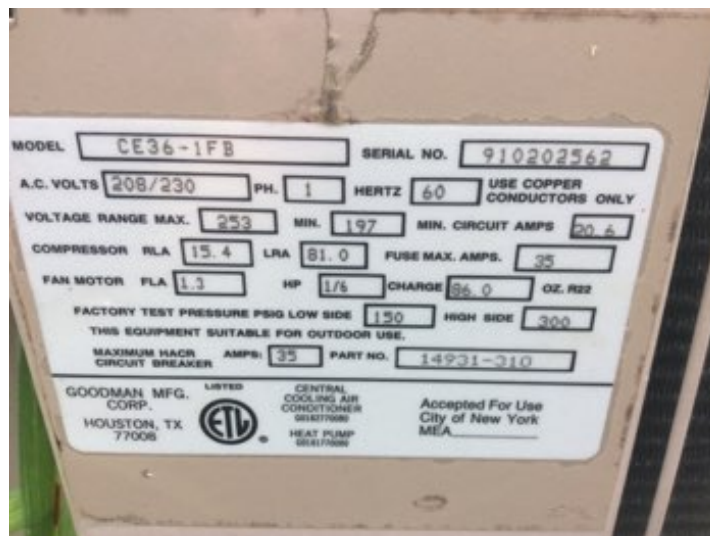
Service tag.

- Air conditioning was in serviceable condition at time of inspection.
- Temperature differential for A/C is about 18 at time of inspection.
- The air conditioner is near the end of its useful life due to age. Older air conditioning systems become less energy efficient, tend to break down more and need repairs more often.

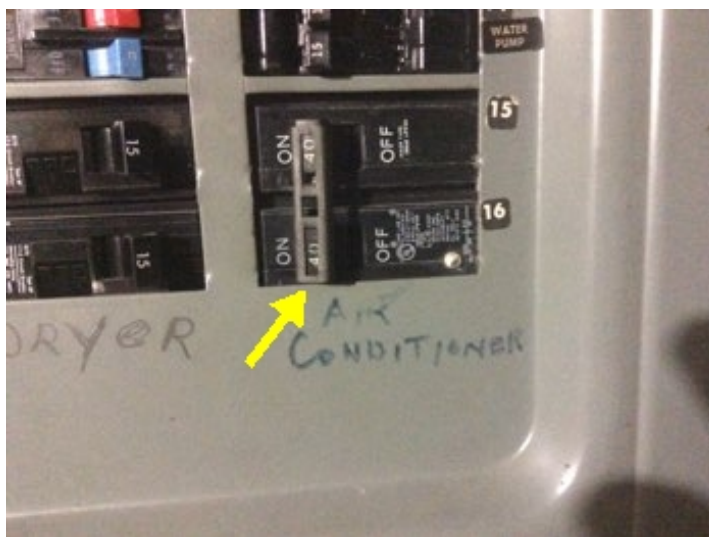
A/C manufacturer states max breaker is 35A.

- Service panel appears to be good condition at time of inspection.
- Tandem breakers may not be allowed by local municipalities or panelboard manufacturer.
- A/C manufacturer states max breaker is 35A. Recommend to change 40A breaker to 35A.
- Recommend evaluation and repair by a licensed electrician for repair or replacement as necessary.

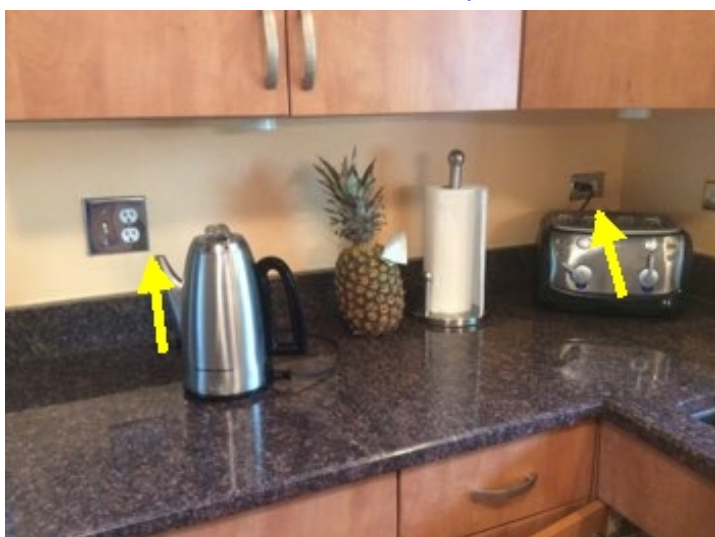
Recommend installing GFCI's on kitchen countertops where missing.

- Under cabinet lighting commonly are installed by home owners and are not fully visible during inspection. Recommend to evaluate wiring when cabinets are empty and wiring is visible.
- Limited outlets on kitchen countertops.
- **GFCI protected receptacles may not have been required when the house was built. Recommend upgrading to GFCIs at all receptacles on kitchen countertop outlets where not installed or missing.**

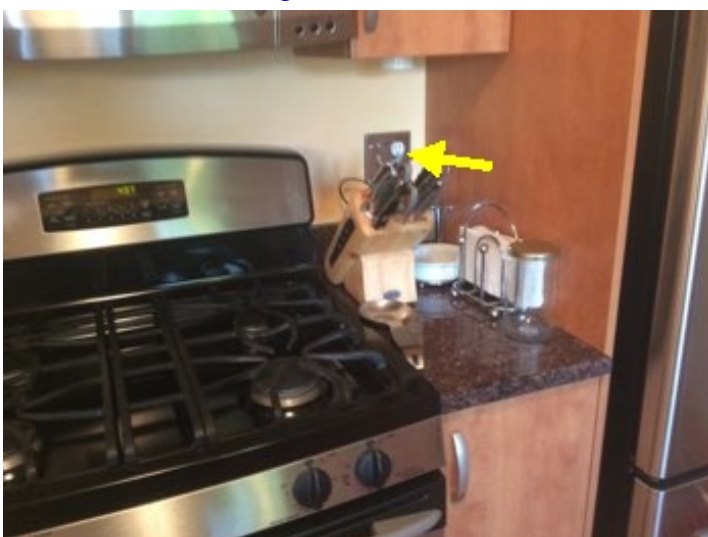
Recommend installing GFCI's on kitchen countertops.

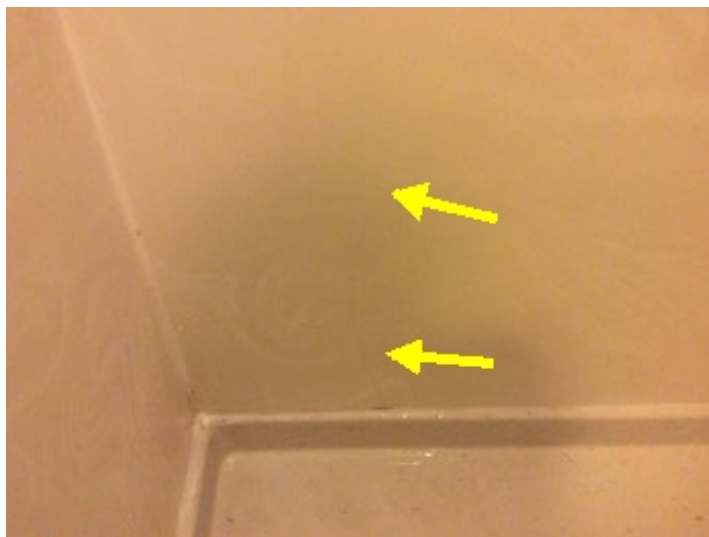
Cracked shower surround needs repair.

- Damaged shower surround needs repair.
- Recommend evaluation by a qualified contractor for repair or replacement as necessary.

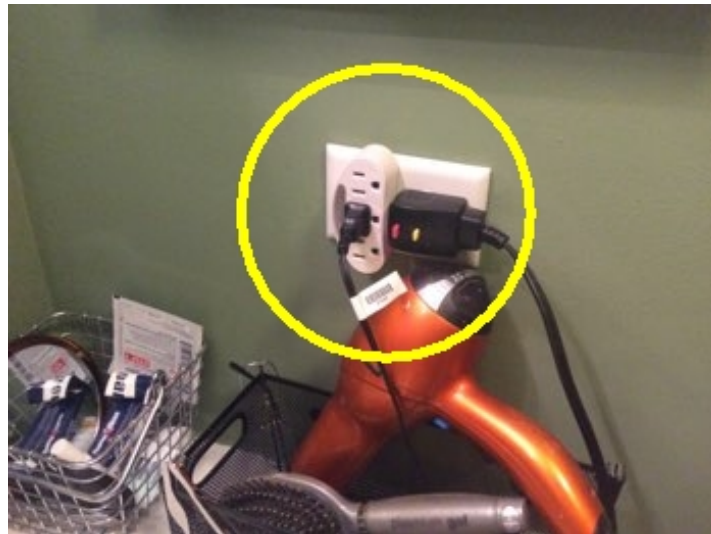
Recommend to install GFCI outlets at bathroom outlet.

- Recommend to install GFCI outlets at bathroom outlets where missing.
- GFCI protected receptacles may not have been required when the house was built. Recommend upgrading with GFCIs at all receptacles near water sources.
