# TOTAL PICTURE HOME INSPECTIONS

## CONFIDENTIAL HOME INSPECTION REPORT

**1111 Any Street  
Hometown, VA 22124**

# 6-Point Inspection

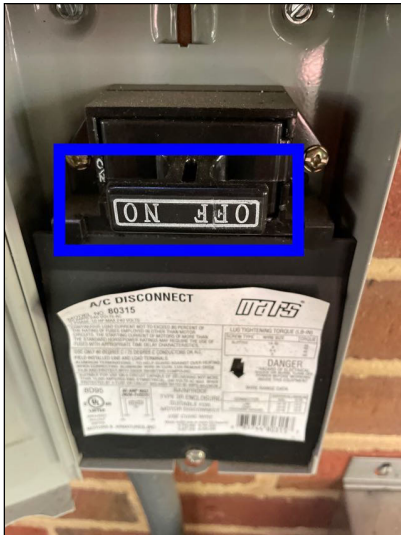
Compressor/Air Conditioning Service Disconnects are located near and within direct eyesight of each exterior Air Conditioning unit. Disconnects are a fuse which is pulled directly out of the housing unit.

Air Conditioner Electrical Disconnect — Primary Unit

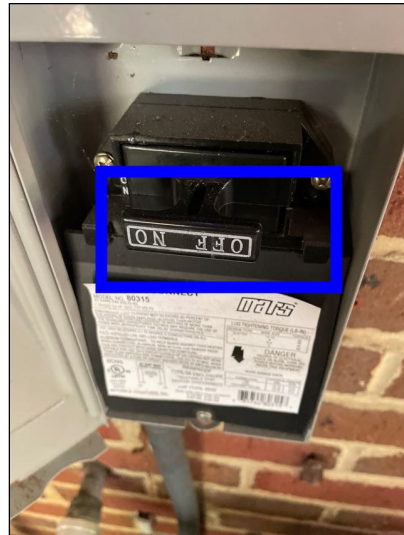
Air Conditioner Electrical Disconnect — Unit No 2

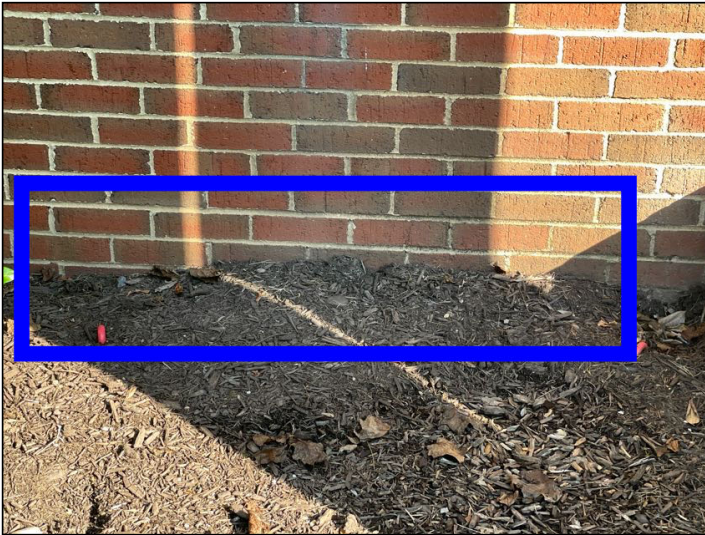
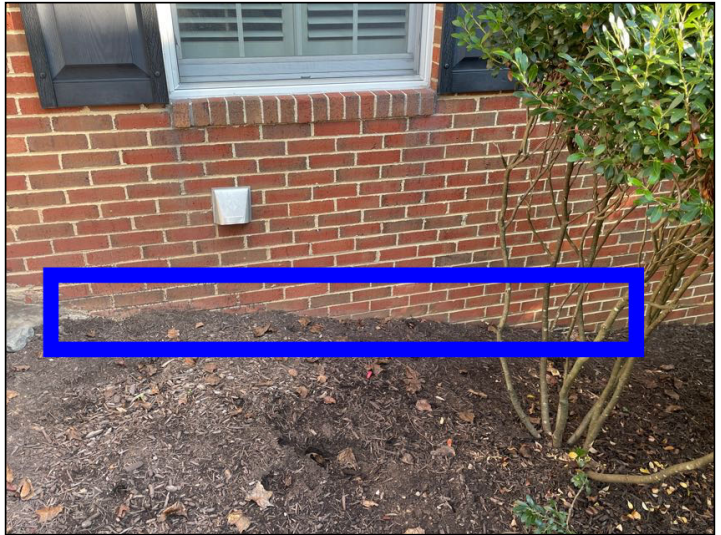
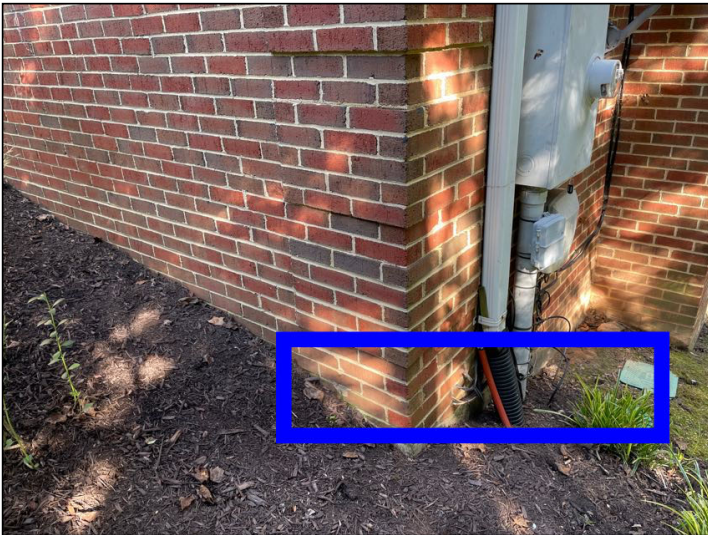
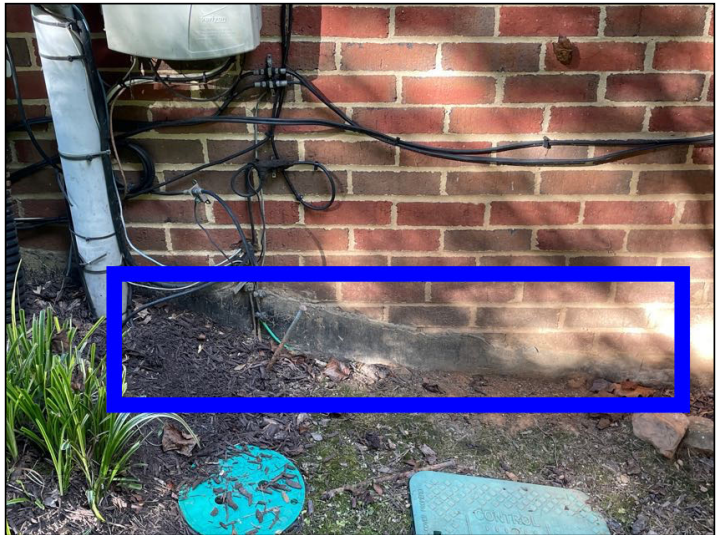
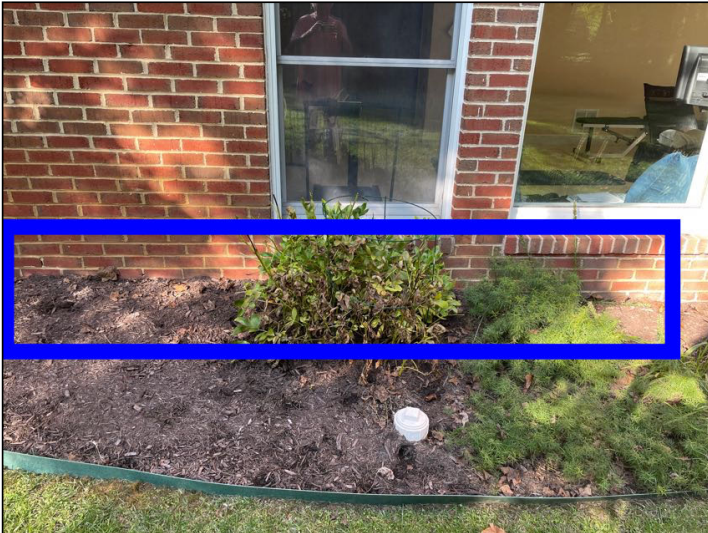
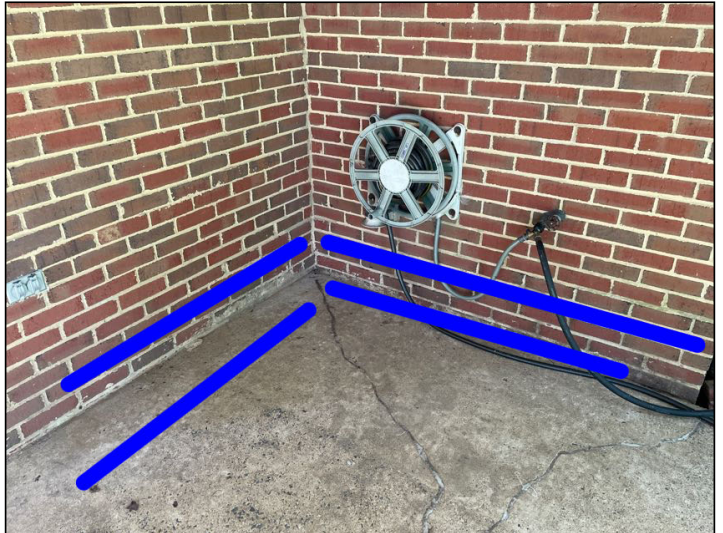
- An additional inspection of the structural soundness of the foundation was performed to examine the fit and snugness of doors to evaluate if there has been a material shift in the foundation. Based on a sampling of these elements, the additive inspection confirms a sound foundation.

Observed Outdoor Foundation Hidden By Brick

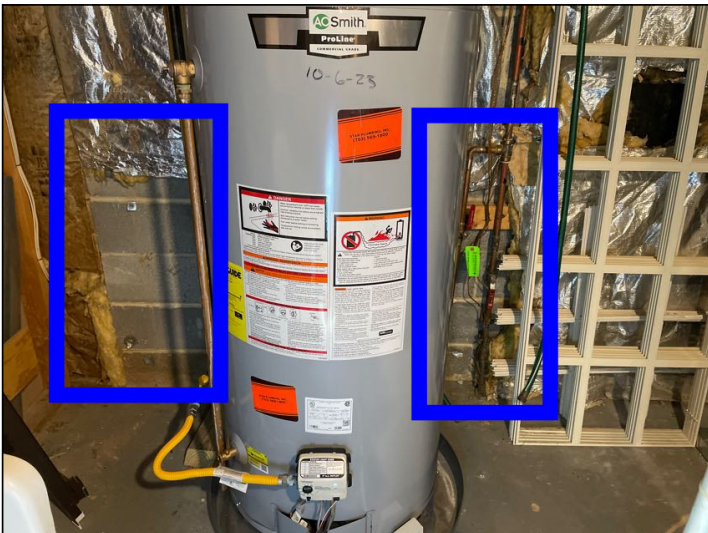
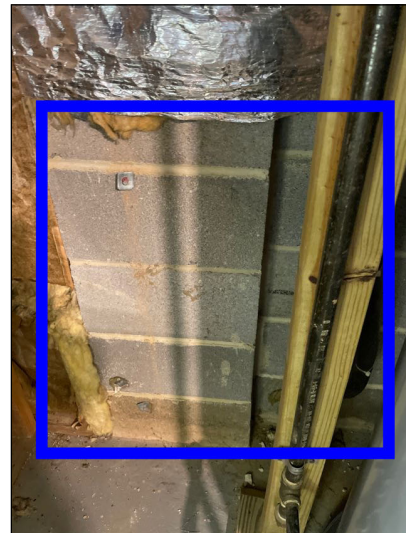
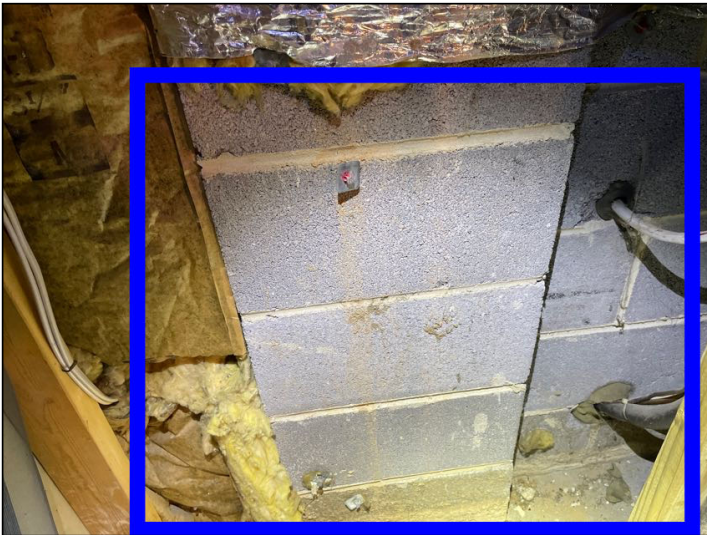
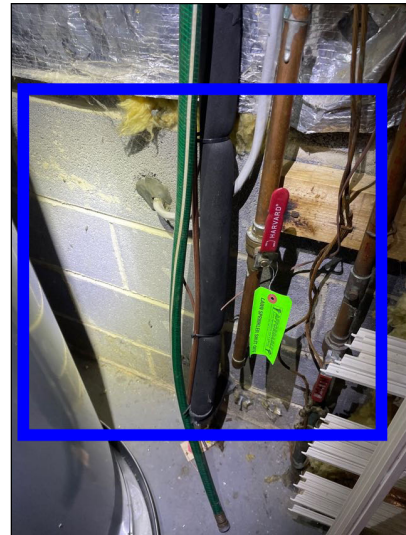
Observed Interior Foundation Area; Appears Solid

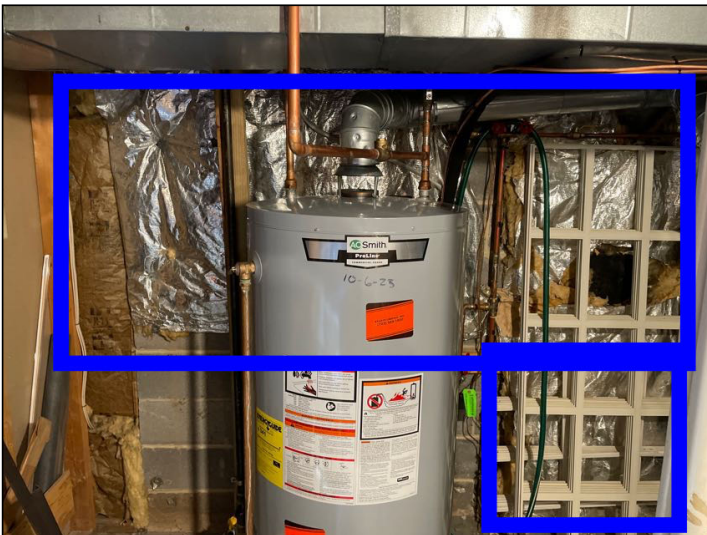
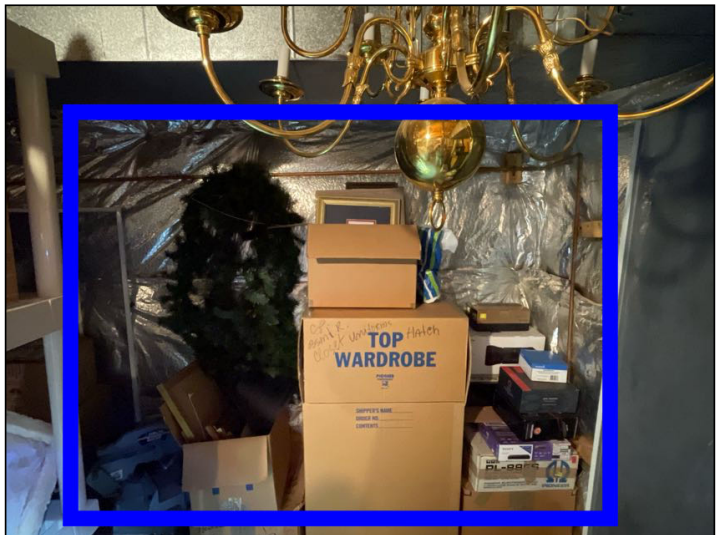
Observed Internal Foundation Area Hidden By Blanket Insulation

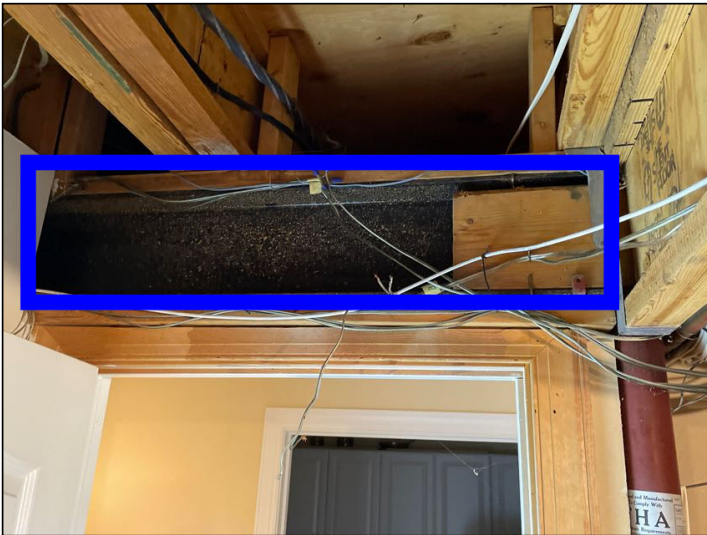
- The beams (also called girders) observed appeared functional with no observable deficiencies. The beams appear level with no "sagging."
- The entirety of the beam(s) as well as other beams were not observed as they were hidden or covered with (finished) material.

Observable Beam(s)

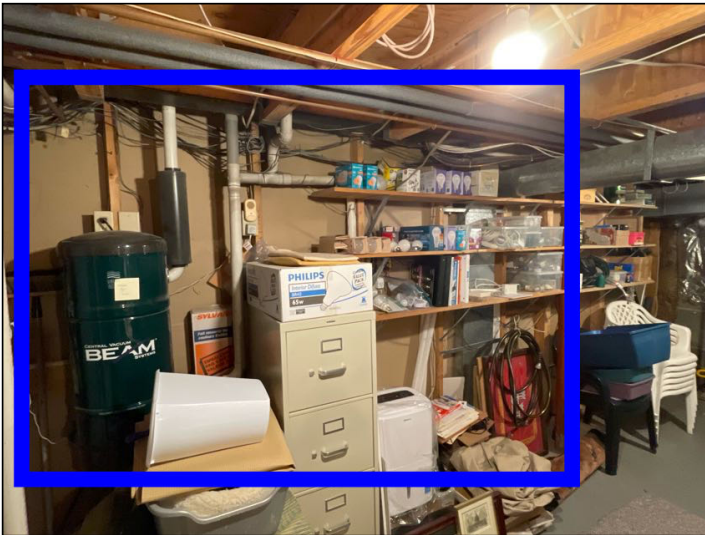
- The components of the bearing walls observed appeared functional with no observable deficiencies. Bearing walls are noted as flush and level.

Observable Bearing Wall

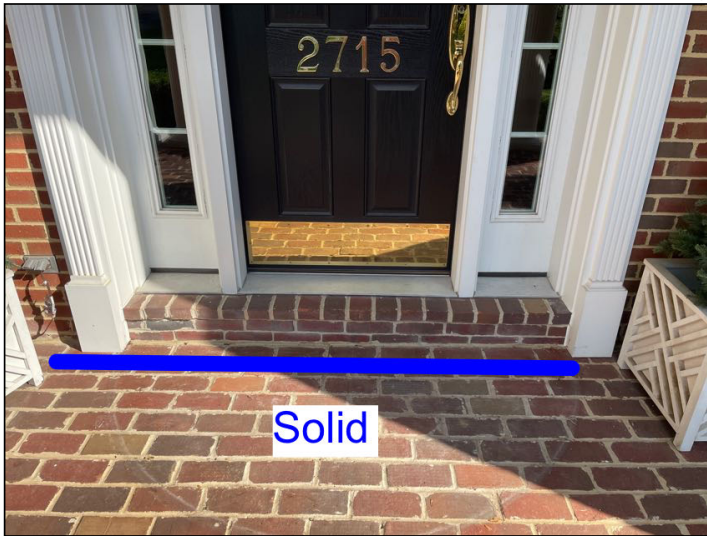
- Steps and Stoop are found to be in an acceptable condition with no noticeable deficiencies. While not part of the foundation/structure, the stoop and adjoining steps are evaluated to assess any settlement and safety issues.
- Settlement crack noted on right rear stoop. The crack is not structural and not active. Settlement cracks are common as the foundation soil under the stoop is often not as “packed” as that under the residence. Minor shifts can cause the crack; perhaps even the 5.8 earthquake that hit the Virginia Piedmont region August 23, 2011.

Front Step & Stoop

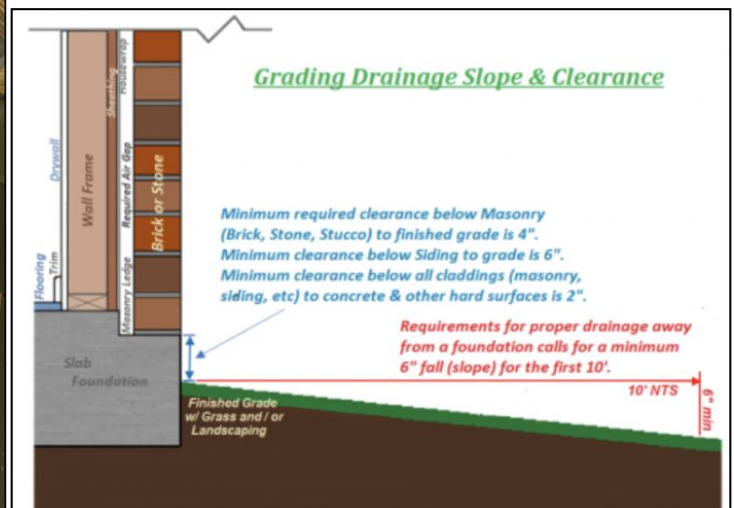
Proper Drainage Slope From Foundation

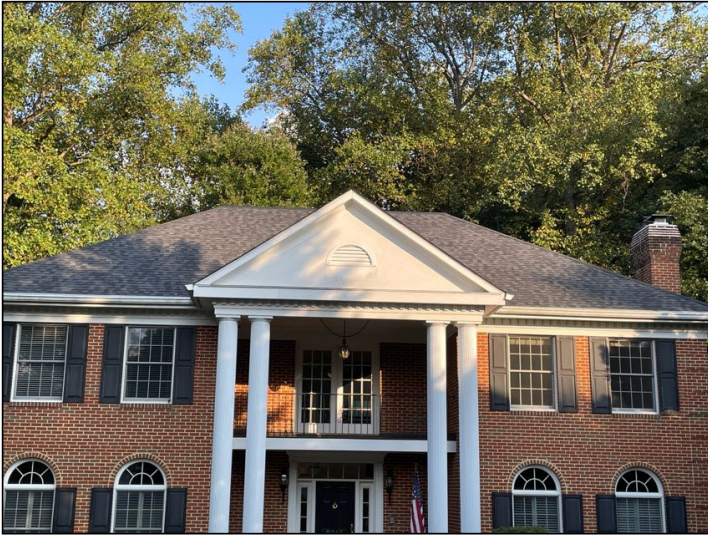
- A**
- Roof structure (independent of shingles/roofing material), as viewed externally from multiple vantage points, is noted as functional with no observable deficiencies. Roof plane is even across all observed elements with no signs of waviness, sagging, humps, buckling or curling. Ridge lines are shown as even with no breaks or cracks noted.

Front Residence Roof

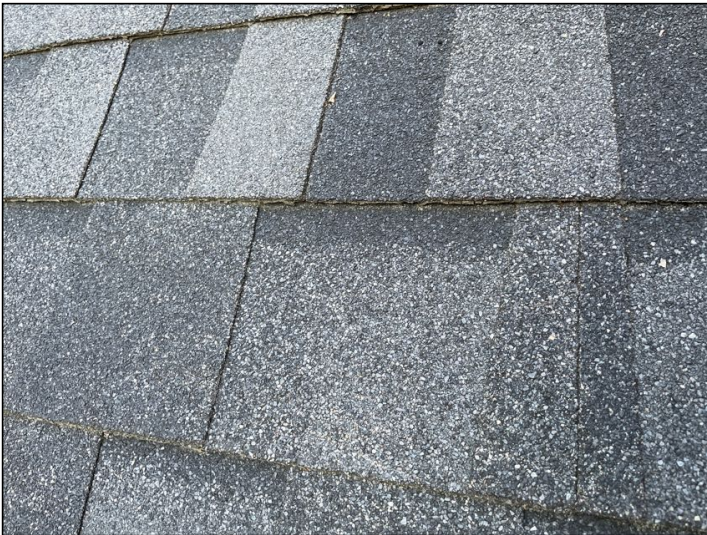
- Shingles/Roofing Material appears to be functional with no observed deficiencies. No shingle damage or missing shingles were observed. No missing, loose, damaged or poorly nailed shingles were noted. Shingles are NOT noted as curling or cupping, a sign of deterioration.

Snapshot of Shingles/Roofing Material (Closeup)

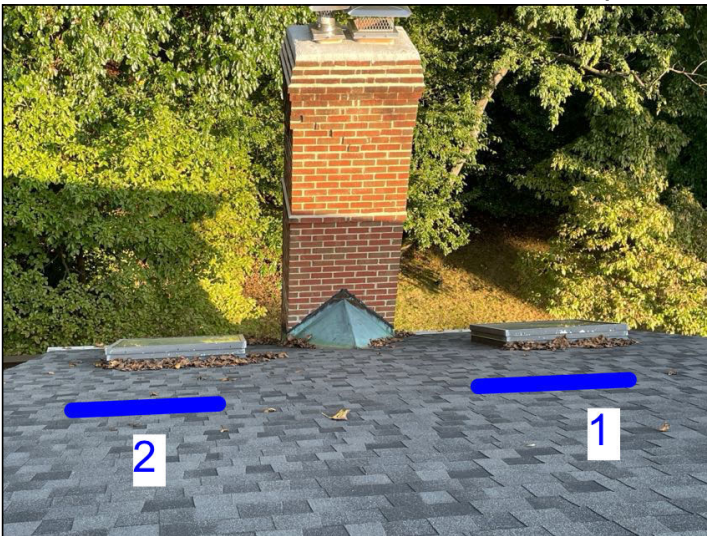
- A**
- 6 Skylights noted.
  - Skylight(s) appear to be functional with no observed deficiencies -- no signs of active or prior leaking around/within the skylight were observed.
  - MESSAGE: Typically a skylight will last between 8 - 15 years, depending on how well it was installed and the quality of the skylight's manufacturing. The majority of problems with skylights falls within the area of water leaks. Traditional sealants, namely mastic and similar sealants, may fail with time, causing water leaks. Glazing can crack or even break with increased exposure to the sun. Seals may break causing condensation and fogging. Recommend annual maintenance inspection of skylights.

Exterior View of Skylights — Center Rear

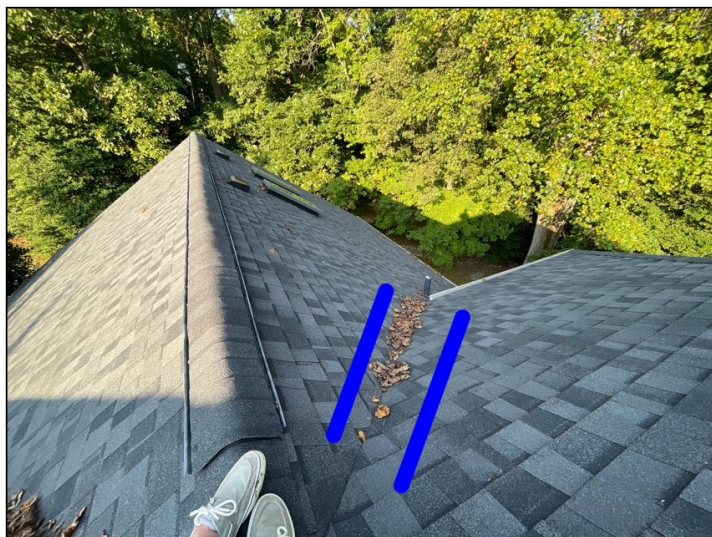
- Plumbing and heating/exhaust vents and caps appear to be functional with no observed deficiencies. Component flashing appears functional and secured appropriately to the roof structure.

Roof Valley Flashing

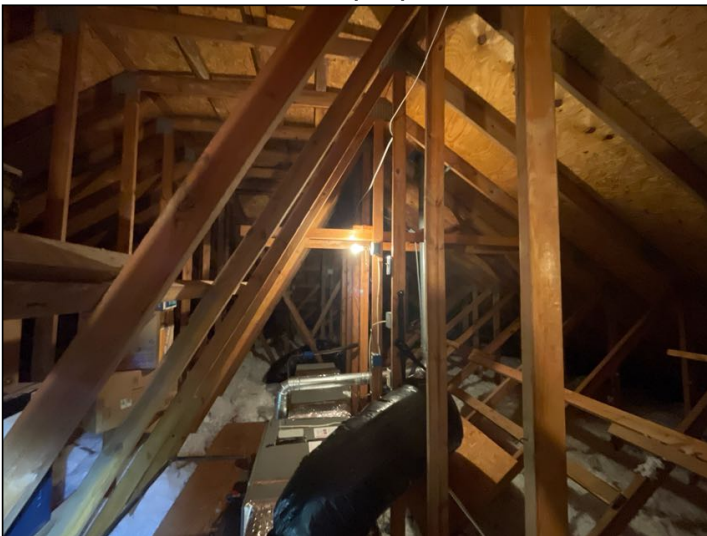
- Rafters as observed within the attic were found to be functional with no observed deficiencies. No improper cuts, notches or bores of framing members were observed.

Roof Framing

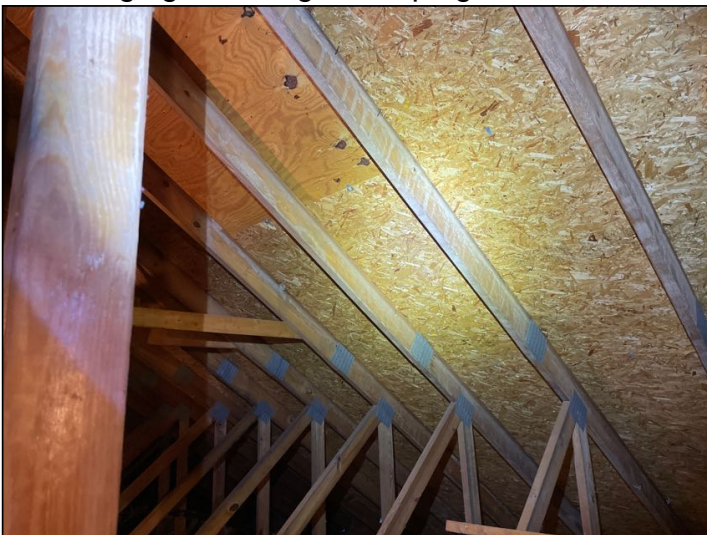
- A representative area of the roof sheathing was observed from the attic. The noted sheathing appeared functional with no noticeable deficiencies. There were no indications of bulging, buckling or warping.

Attic/Roof Sheathing

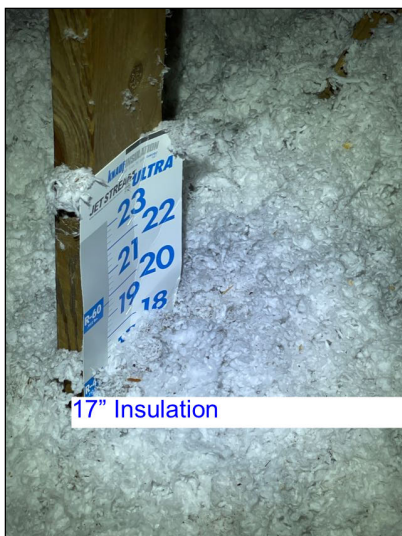
- A**
- Insulation observed given access viewed as satisfactory.
  - Insulation noted as having 17 inches of depth/covering
  - Insulation is a variety of products that help reduce the loss of winter heat and summer cooling through the roof, helping to save on electricity and gas use. The two basic types of attic insulation are rolled insulation and blown-in insulation.

Attic Insulation

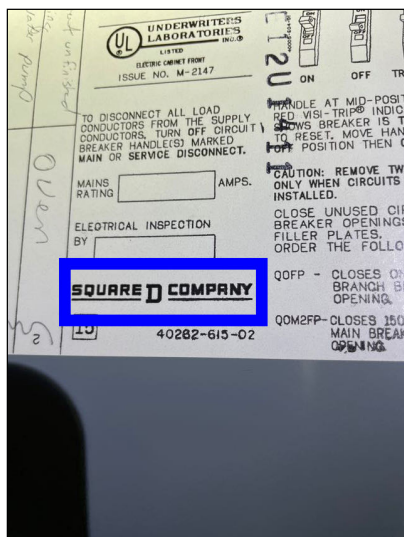
- Two main service panels are present.
- Panel(s) appears functional and in satisfactory condition. Panel cover was removed yielding detailed inspection of main service wiring, branch service wiring, breakers, and bonding.
- Panel Age: Original
- MESSAGE: The breaker panel is essentially a big switch filled with other smaller switches. The smaller switchers — breakers — control the power in all aspects of the building. They're similar to the switches inside a living room. Flip with the switch on the wall, and you've got power and vice versa. As an added feature, these breakers perform a variety of safety services. They protect the wiring from overload, your home, and its occupants from fire and electrical shock.

Main Service Panel Manufacturer

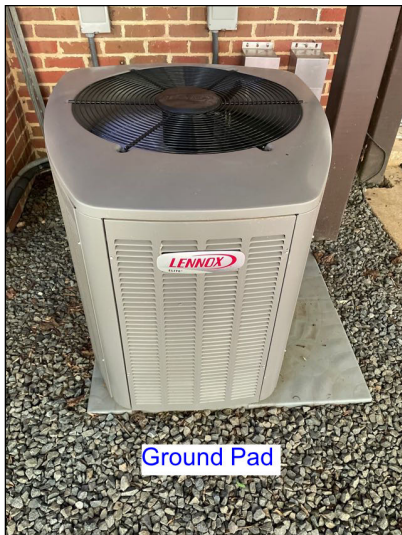
- Unit is located at the right side of residence
- Unit serves the 1st floor and basement
- The unit is supported by a ground pad which appears to be in good condition
- This Air Conditioning unit is paired to the heating unit located in the basement identified as Heating -- Primary Unit. Various system components are shared: Air Distribution/Handler, Duct Work, Return Air Supply, Filter, HVAC Sources, Thermostat. Please see the noted heating unit for this information.

Ground Pad

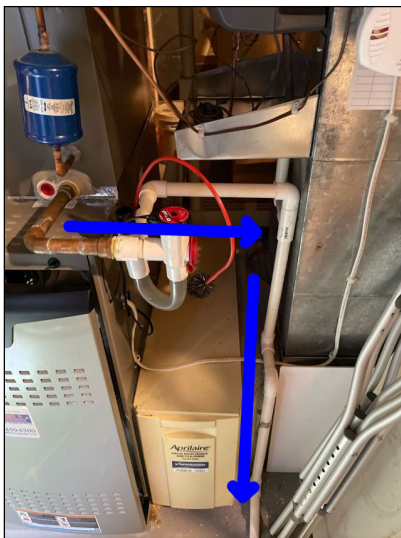
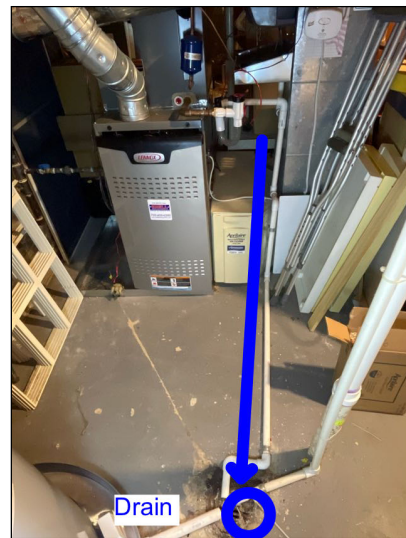
Air Conditioning Condensation Line

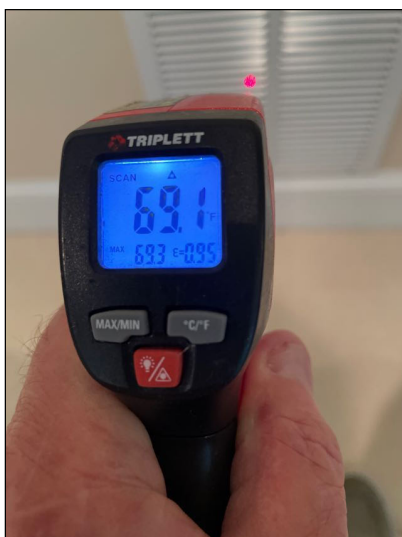
**MESSAGE:** The typical temperature differential between the air flow and the return register is 16 - 22 degrees although newer homes tend to have a lower differential, perhaps 12 - 15 degrees. If the differential is outside this range, it is advised to engage an HVAC specialist to evaluate the unit and make necessary adjustments/repairs.

Air Conditioner Return Air Temperature

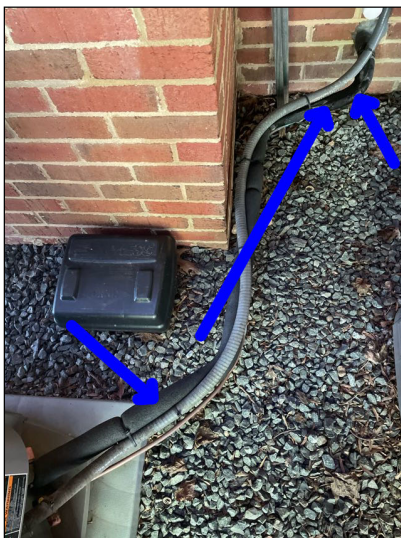
- A** • External refrigerant line, key to the operation of an air conditioning unit, appears functional and in satisfactory condition. The full line of external facing insulation on the larger "suction" or return line is intact.

Compressor Refrigerant Line (External)

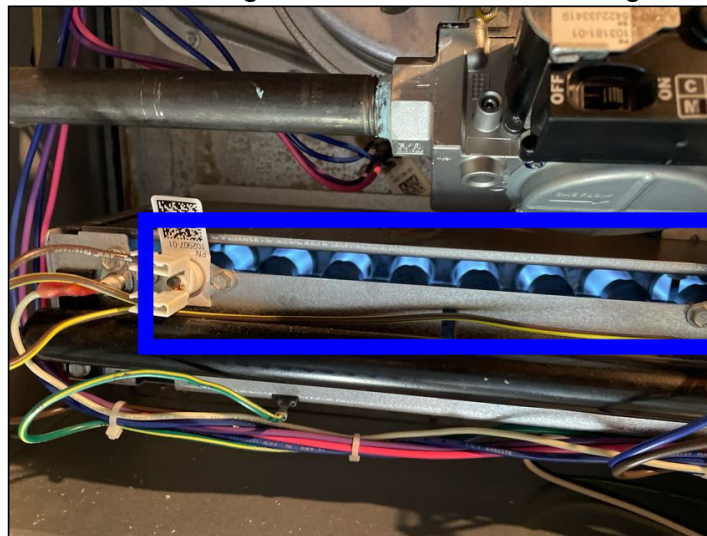
- A** • Heating system was inspected using normal operating controls and found to be functional and in acceptable condition.
- The gas burners of the heating system are functional.
- Blue burner flame is noted indicating that furnace is combusting fuel efficiently.

All Furnace Burners Operational

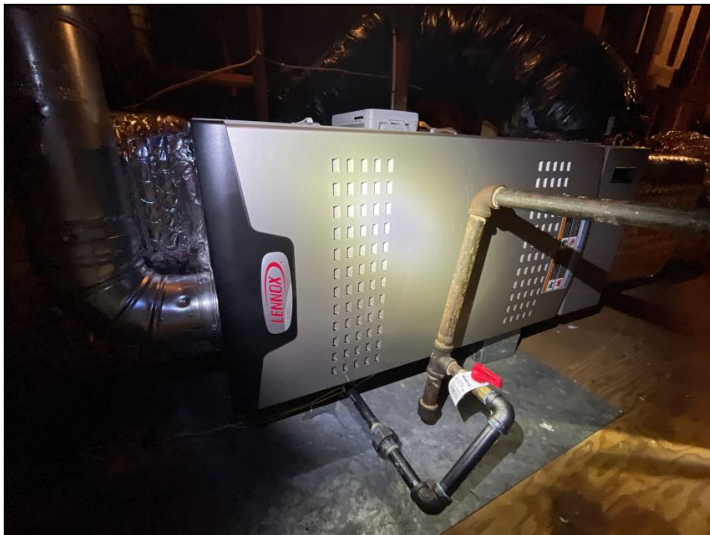
- Heating system is a gas furnace, forced hot air.
- A** • The heating unit is a mid-efficiency furnace with a 80% Annual Fuel Utilization Efficiency (AFUE) rating. In this type of furnace, 20% of the energy produced is expelled as exhaust.
- MESSAGE: An annual HVAC service contract is recommended.

Furnace

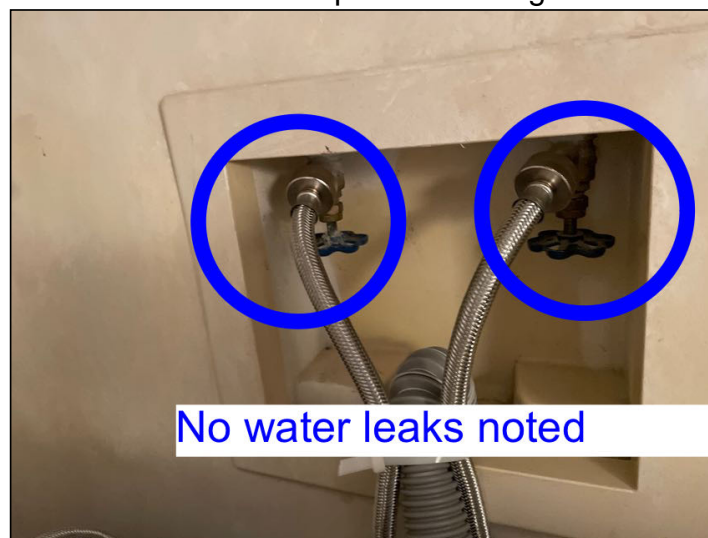
- A**
- The examination of washer hookups looks for water leaks in/around the the connection nodes/hoses and on the floor area at the base of the washer immediately below the hookups, likely caused by a faulty or broken plumbing connection.
  - A visual examination of the washer hookups show no signs of water leaks.

Washer Hookups

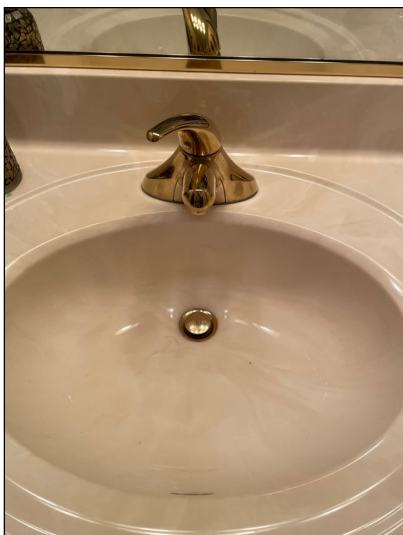
- A**
- The examination of sinks, basins and faucets looks for water leaks in/around the sink/basin and faucet(s) and on the floor area at the base of the sink/basin, likely caused by a faulty or broken plumbing connection.
  - A visual examination of the Sinks, Basins & Faucets show no signs of water leaks.

Bathroom Sink

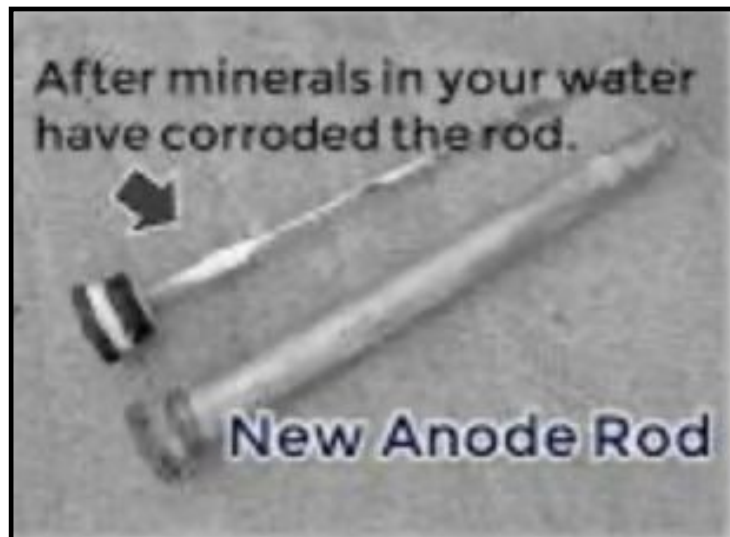
- Want To Extend The Life Of Your Water Heater? Most tank hot water tanks have one or two magnesium or aluminum anode rods inside to protect exposed steel by giving up ions. In general, a tank with a 6-year guarantee has one rod; a tank with a 10- 12-year guarantee has two rods. Replacing the rods every two to four years will greatly extend the life of the tank. Refer to YouTube for instructions.

Magnesium or Aluminum Anode Rods.

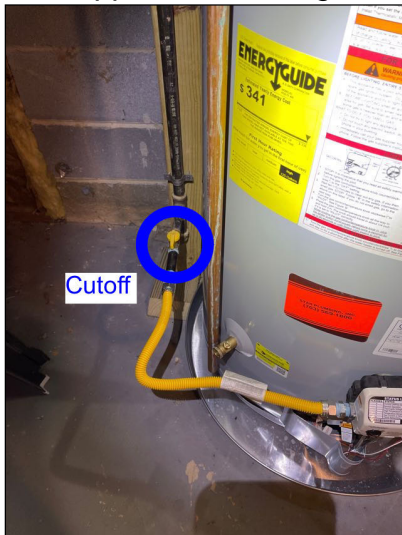
- Fuel source line originates with the Utility Company via the gas meter located at the exterior of the residence. Reference Heating -- Primary Unit/Fuel.
- Fuel delivery line is noted as functional and in satisfactory condition. Shutoff located on fuel delivery line near the water heater.
- Fuel line:
  - Black Iron; threaded, black in color; similar to galvanized steel but without zinc corrosion protection. Black iron pipe is the most preferred pipe for natural gas. The pipe is less expensive, already in use in most homes, and is seamless, making it less prone to gas leaks.
  - 1/2 " Copper Gas Tubing Coated With Yellow Polyethylene

Gas Water Heater Delivery Line; Gas Cutoff Noted

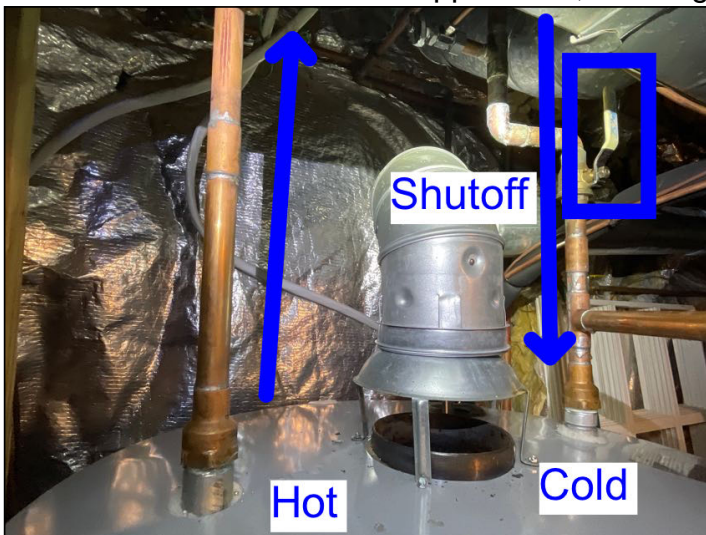
- Observable distribution lines appear functional and in sustainable condition.
- Type of water distribution lines:
  - Copper -- one of the most commonly used materials for service pipes; relatively resistant to corrosion. Scratch for copper color; not magnetic.

Water Distribution Lines &amp; Shutoff Valve

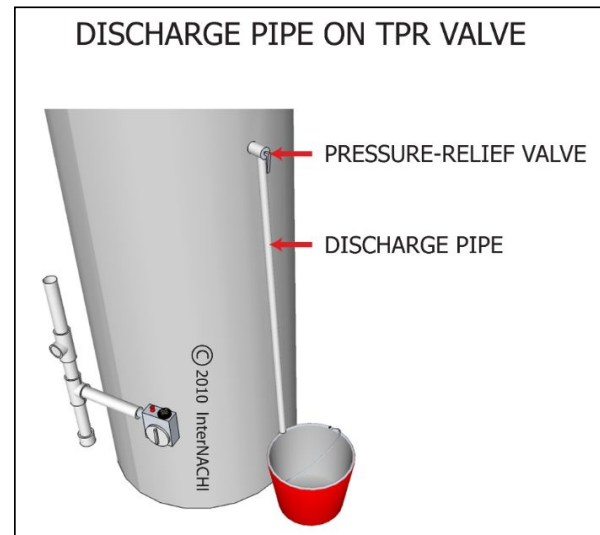
We recommend testing your **TPR valve** every 6 months to make sure it is working properly. To test the TPR valve, simply lift it up and down several times and hot water should briefly flow out of the drainpipe.

Temperature Pressure Relief Valve

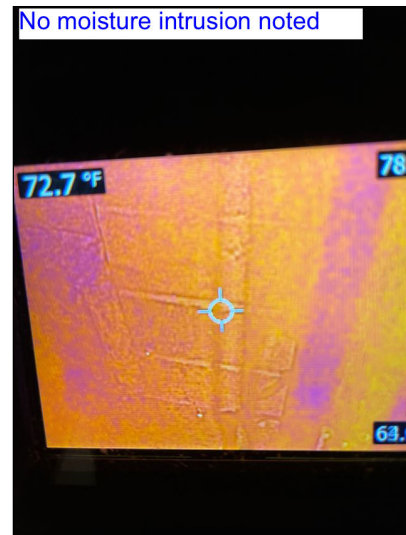
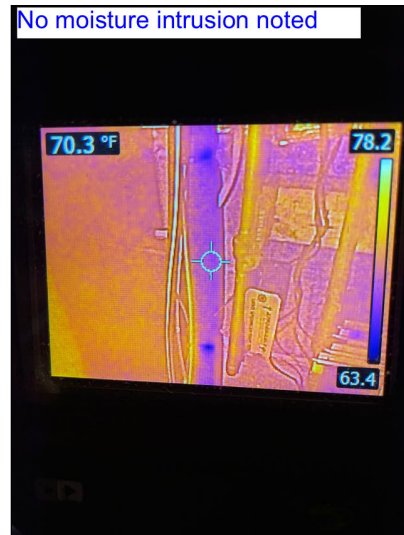
Infrared Meter Scan of Representative Area of Internal Foundation Walls

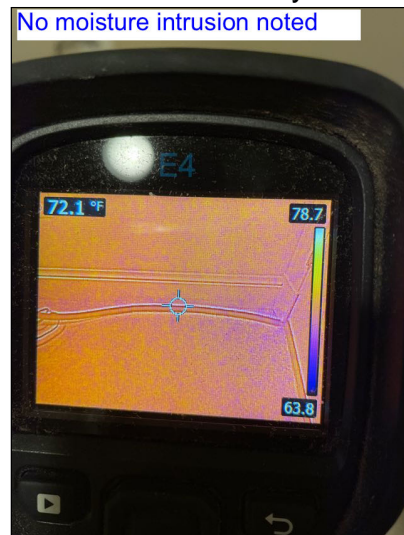
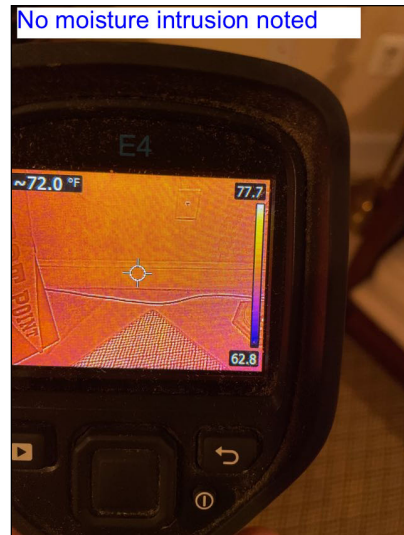
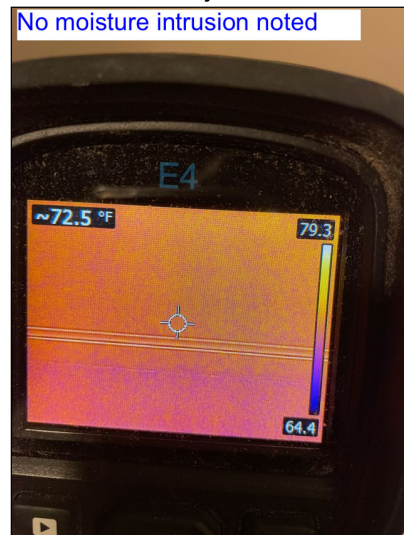
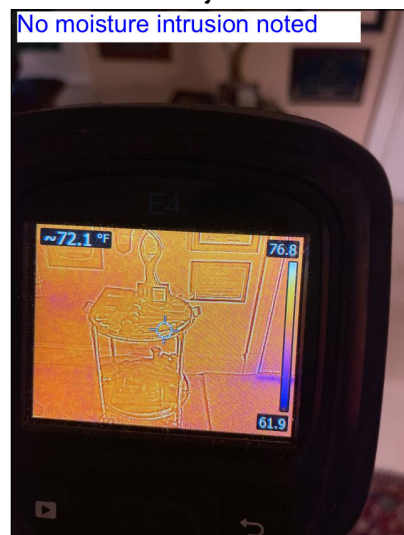
Infrared Meter Scan of Representative Area of Basement Walls Adjacent to Foundation
