Keystone Home Inspections

Property Inspection Report

123 Main Street, Kokomo, IN 46901
Inspection prepared for: Sam Samples
Date of Inspection: 6/13/2014 Time: 9:00a
Age of Home: 44 Size: 5070
Weather: Sunny, 75

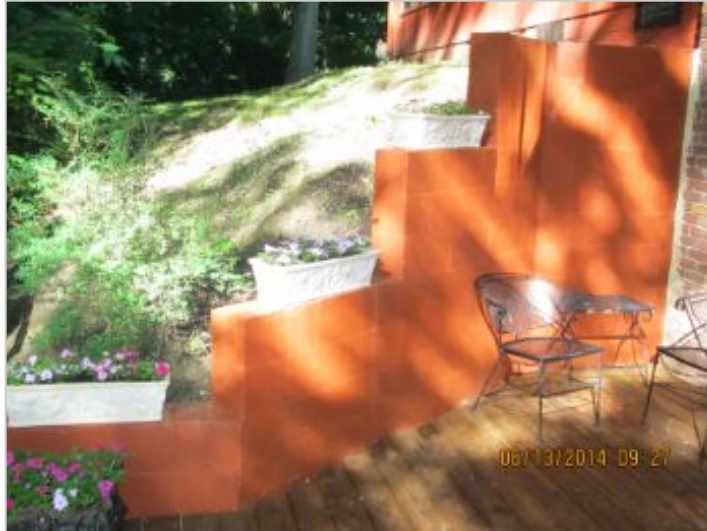
- The inspector observed no deficiencies in the retaining walls at the time of the inspection.

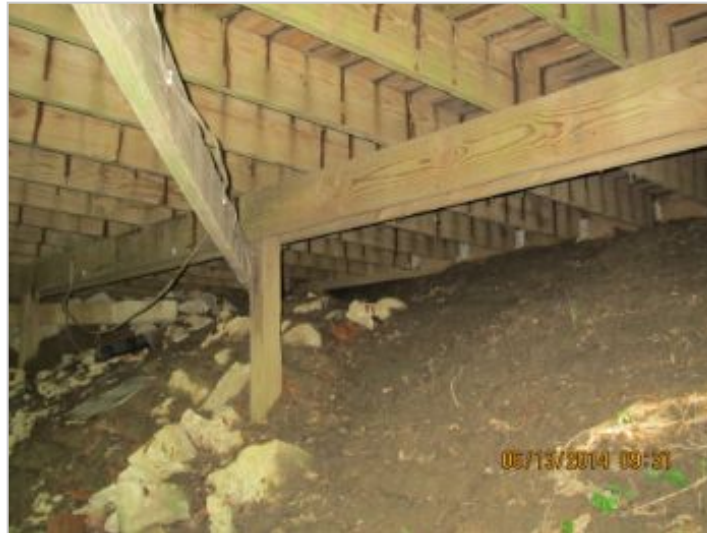
- The basic deck structure was built of wood.
- The structure of this deck appeared to be in serviceable condition at the time of the inspection. Inspection of deck framing typically includes examination of the following:
 - Visible foundation
 - Posts (main support and handrail)
 - Diagonal bracing (permanently-installed only)
 - Adequately-sized fasteners
 - Adequate fastener schedule (spacing between fasteners)
 - Adequate connections between framing members.

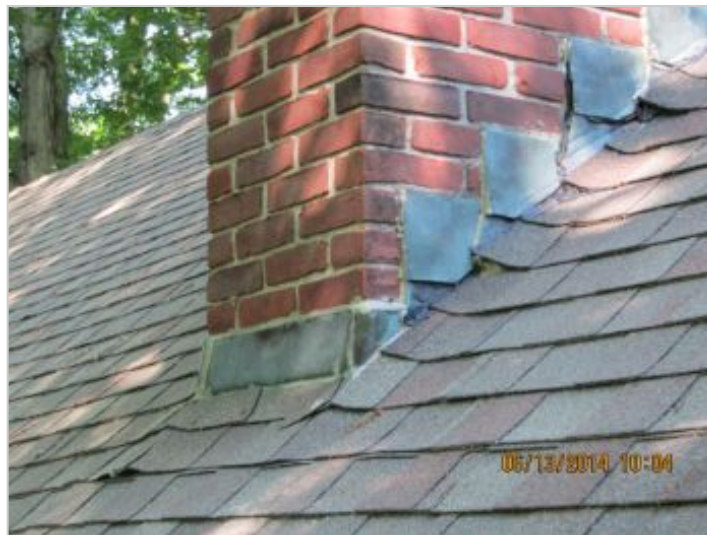
- Chimney flashing appeared to be in serviceable condition at the time of the inspection.

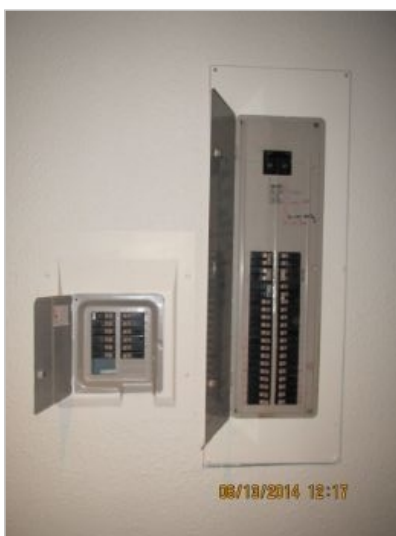
- Panel interior and exterior condition
- Panel amperage rating
- Main disconnect amperage rating and condition
- Service entrance conductor amperage ratings
- Branch conductor types, amperage rating and condition
- Wiring visible materials, types, condition and connections
- Circuit breaker types, amperage ratings and condition
- Label information present
- Service and equipment grounding
- Bonding of service equipment

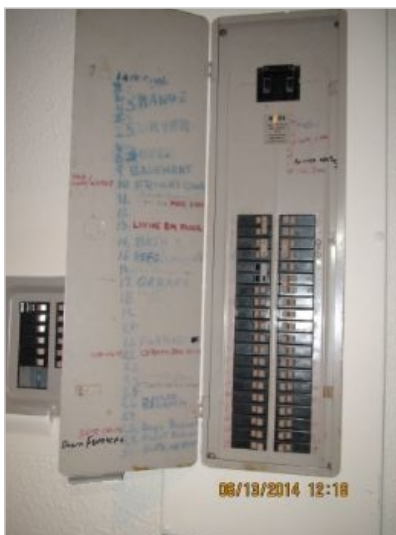
- The Circuit Directory label for the service panel is shown in the photo.

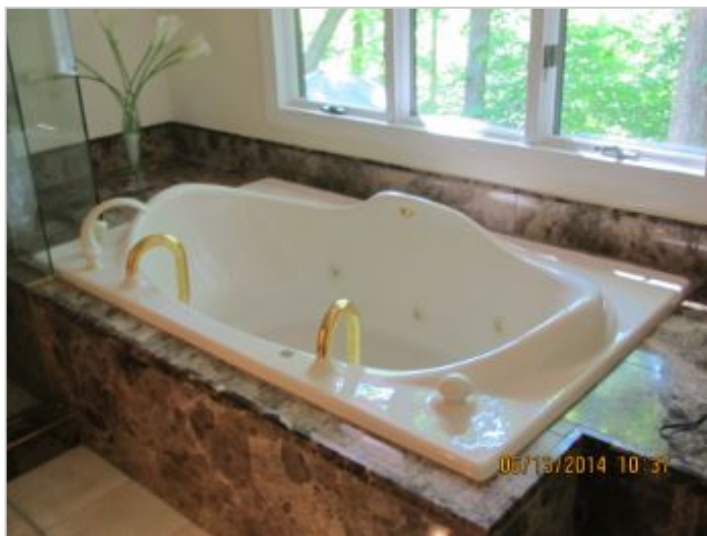
- This bathroom contained a sink in a cabinet, a toilet, a jetted tub with a double shower.

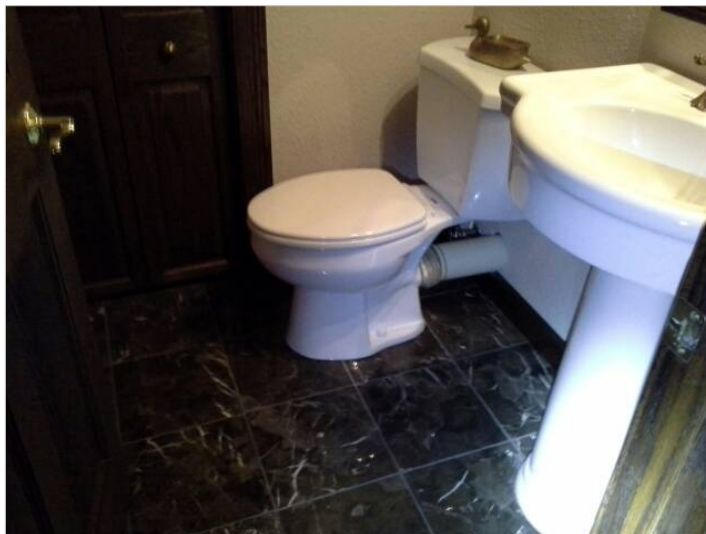
- This bathroom contained a pedestal sink and a toilet.

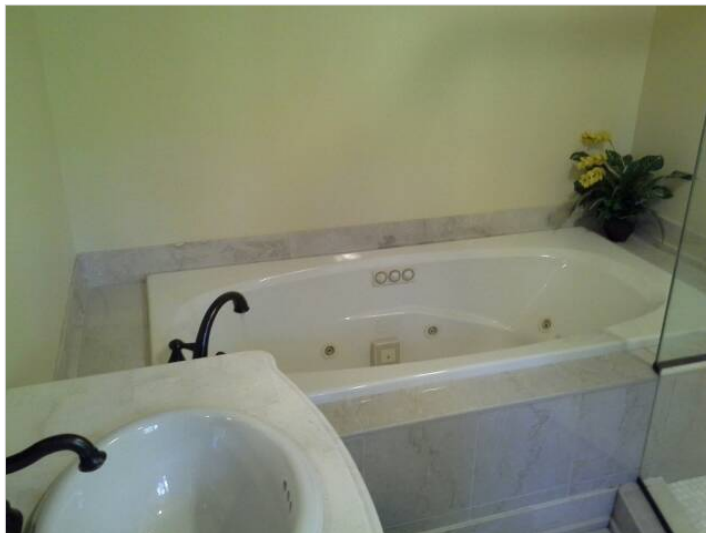
- This bathroom contained a sink in a cabinet, a toilet, a jetted tub with a shower.

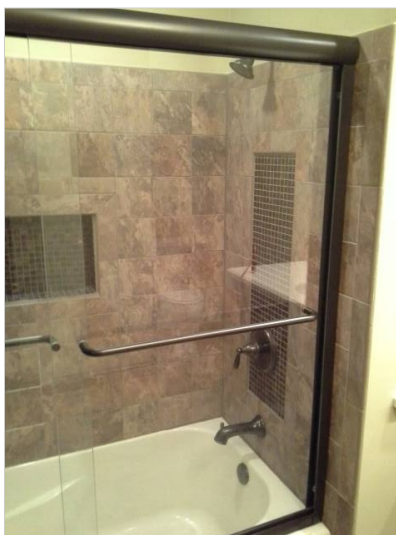
- This bathroom contained a sink in a cabinet, a toilet, and a tub with a shower.

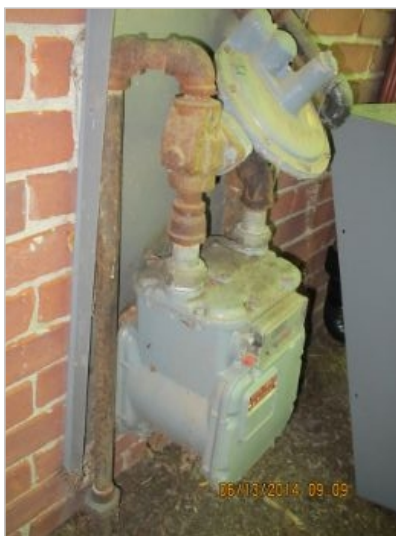
- The home had no single gas shut-off at the structure which would allow gas to be shut off from the outside. This is a defective condition and the Inspector recommends that a main shut-off valve be installed in compliance with local jurisdiction.

At the time of the inspection, individual in-line shut-off valves were installed where gas piping branched off to various gas appliances.

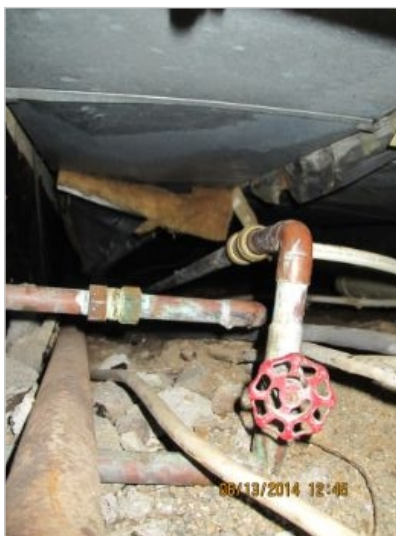
- The main water supply pipe was 3/4-inch copperpipe.
- The main water supply shut-off was located in the basement.
- Although the main water supply shut-off valve was not operated at the time of the inspection it was visually inspected and appeared to be in serviceable condition.

Main water shutoff located in crawl space access door off of mechanical room in basement

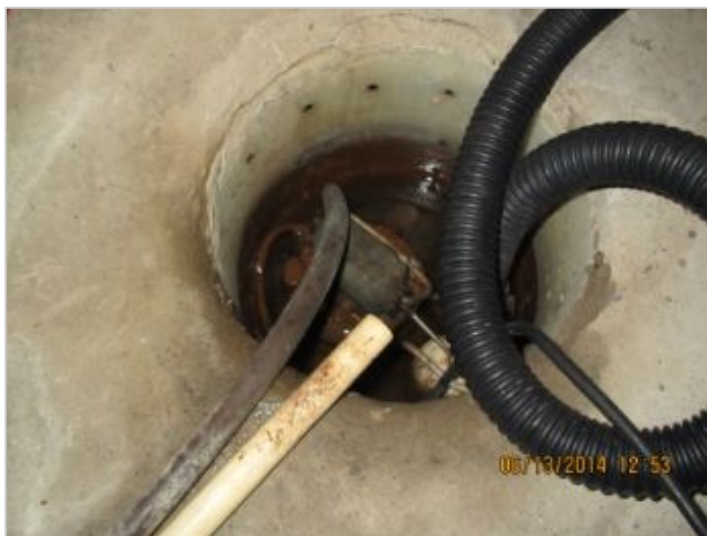
- The home had a sump pump installed in a pit in the basement floor. Sump pumps are installed to prevent rising groundwater from entering the home. Sump pumps should be tested on an annual basis to ensure that they are in working order. The pumps can be tested by lifting the float, but to avoid potential shock/electrocution hazard testing should be performed using a tool which will not conduct electricity. Pumps have a filter that should be cleaned during routine maintenance.
- The sump pump responded to the controls at the time of the inspection.

This system protects the home from water intrusion by discharging rising groundwater or seepage from surface runoff to the exterior of the home or to a waste pipe or storm drain. Sump pumps require periodic maintenance to ensure that they work when they're needed. The Inspector recommends having it serviced immediately and asking the service provider for advice on the best maintenance schedule.

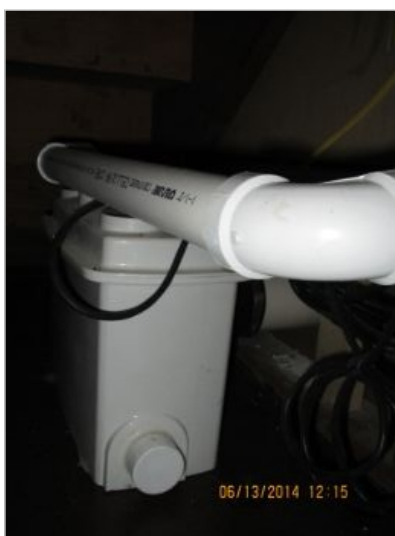
- The home had a sewage ejector pump installed. Sewage ejector pumps are designed to pump waste from lower-level drain/waste pipes up to the main sewer pipe, which is drained by gravity. Typical examples of situations requiring a sewage ejector pump are homes with finished basements and hillside homes.

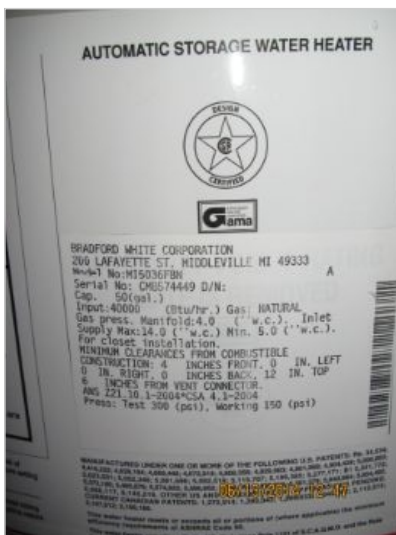
- The water heater was manufactured by Bradford White
- Water heater capacity was 50 gallons.
- The date of manufacture for this water heater appeared to be 2006.

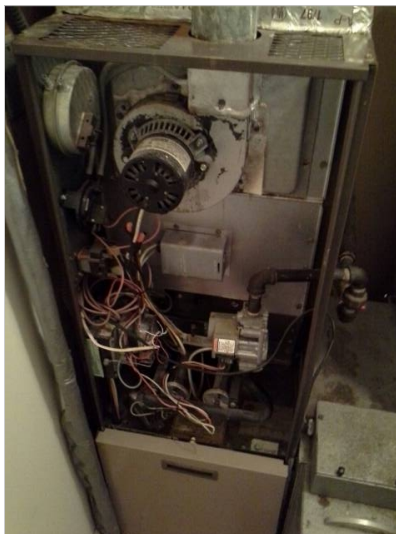
- This furnace was gas-fired, mid-efficiency, forced-air.

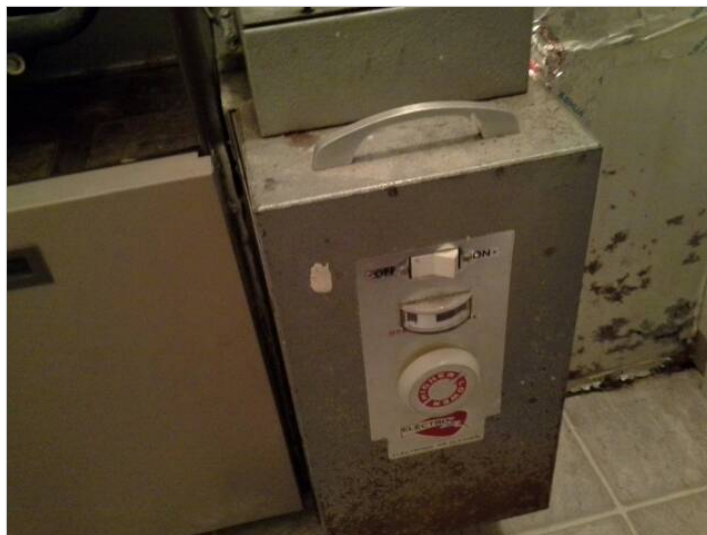
- The inspector was unable to find a manufacturer's label or data plate.

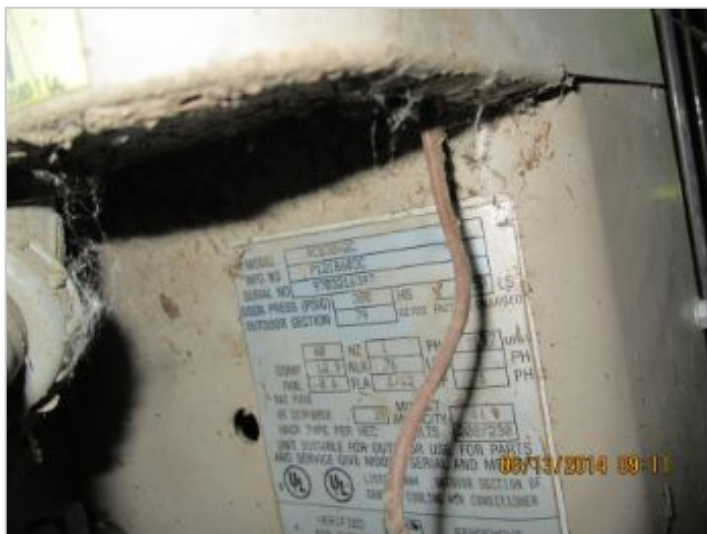
- Information from the air-conditioner label/data plate is shown in the photo.
- The air-conditioner date of manufacture appeared to be 1997.

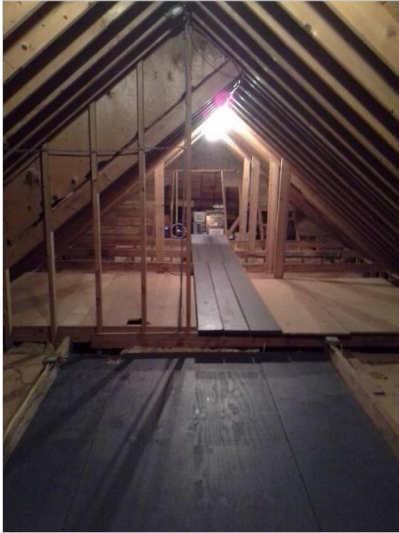
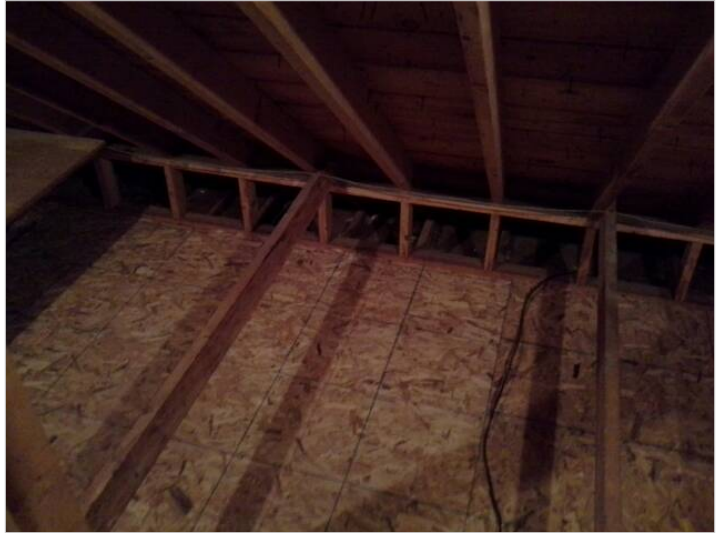
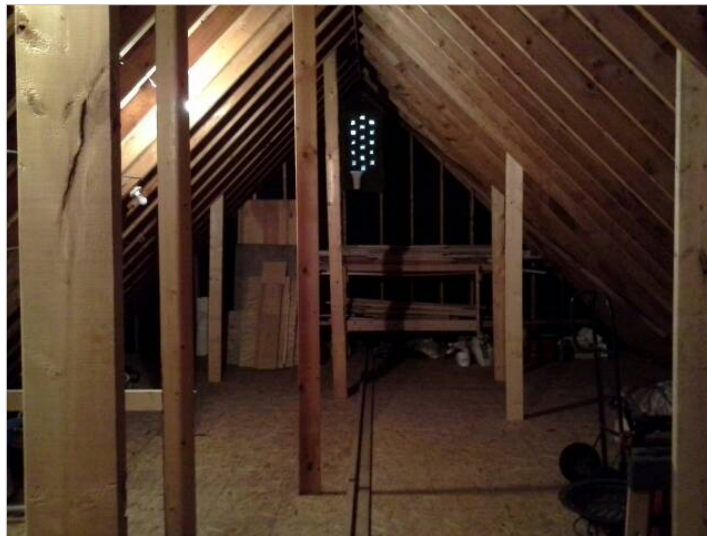
- The roof structure was built using conventional framing methods (rafters and ridge).
- The conventionally-framed roof appeared to be properly-constructed. No deficiencies of roof framing were observed at the time of the inspection.

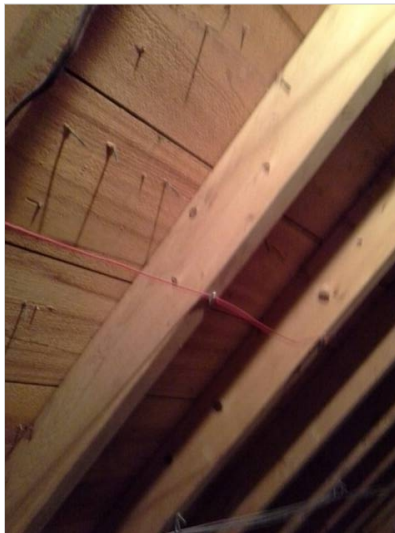
- The Inspector observed no deficiencies when inspecting the roof sheathing.
- The roof was sheathed with wood boards approximately 3/4 inch thick..

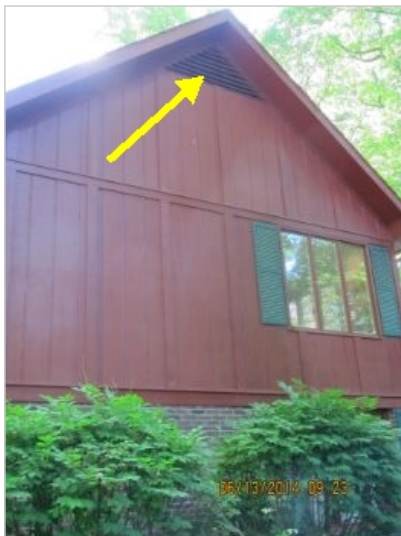
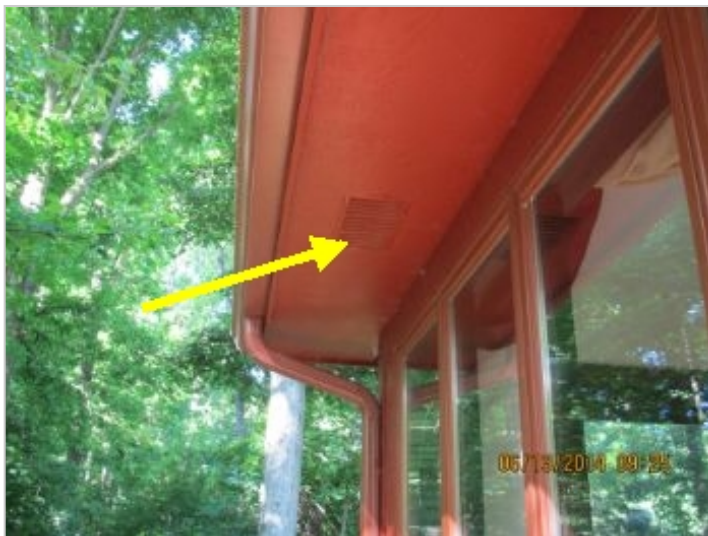
Soffit vent

- Soffit vents were installed as part of the attic ventilation system.
- Gable vents were installed to ventilate the attic space.
