302 Ave B, Cloquet, MN 55720  
Inspection prepared for: Leigh Deppa  
Date of Inspection: 8/5/2014

## Coleman Home Inspections

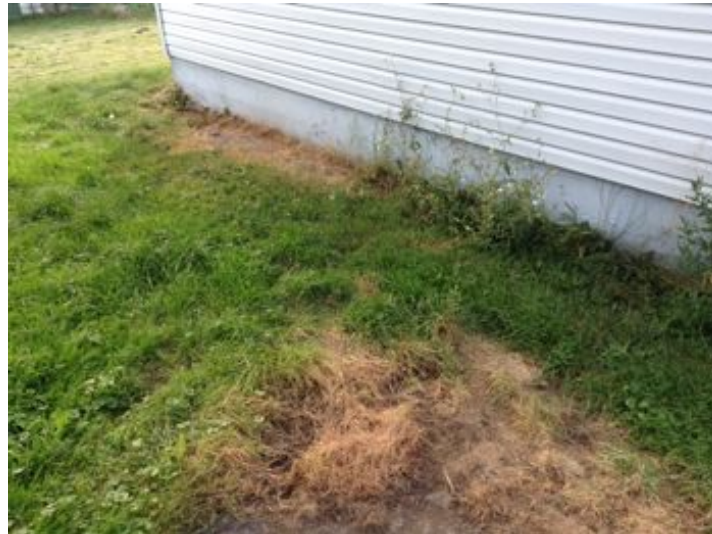
Views of the exterior of the house. , Appeared to be in serviceable condition, at time of inspection.

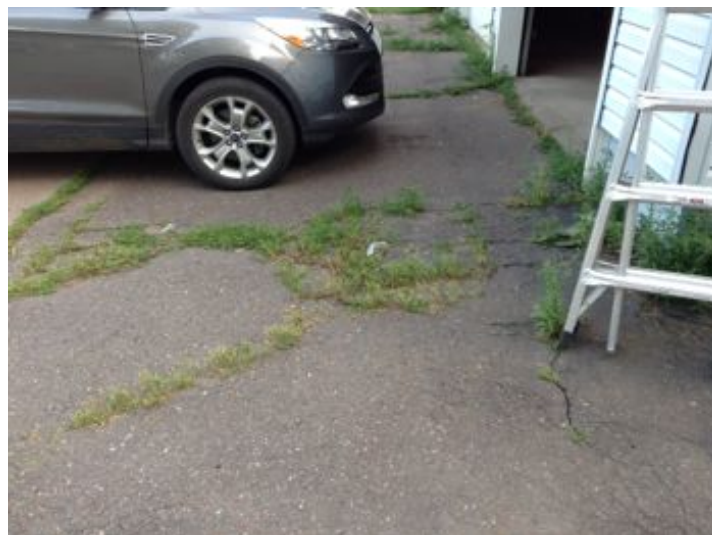
Observations: Appeared to be in serviceable condition, at time of inspection.

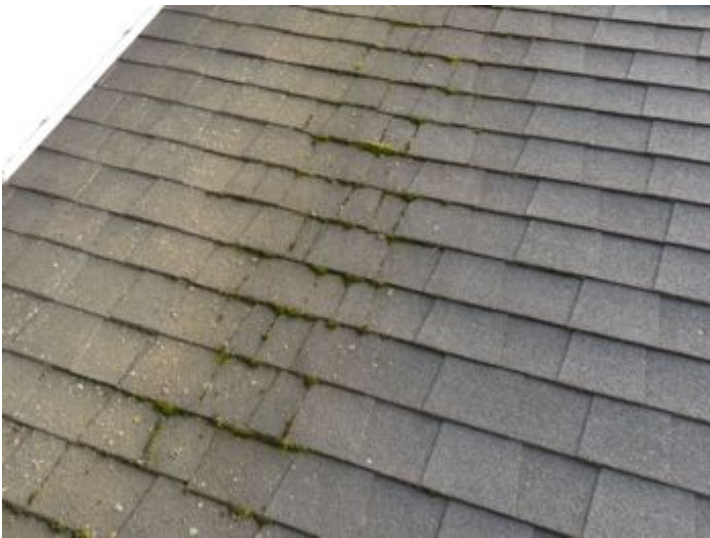
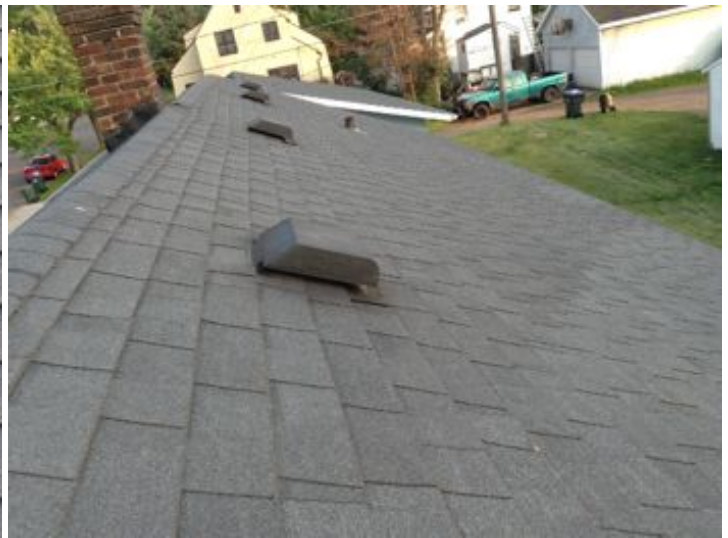
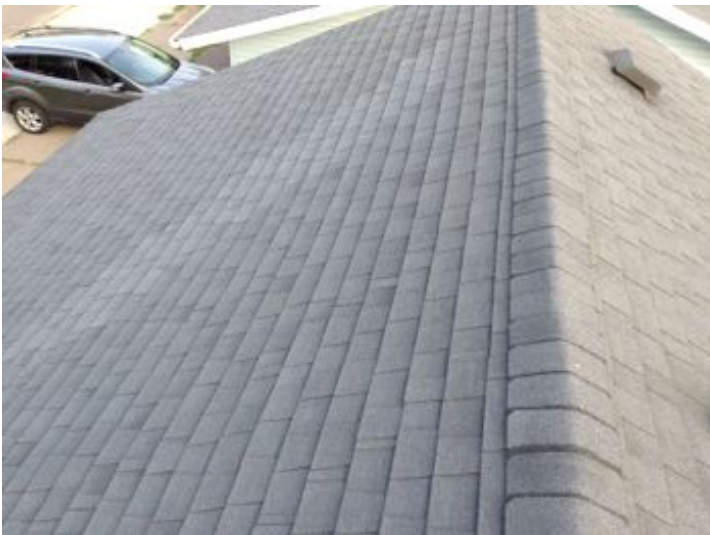
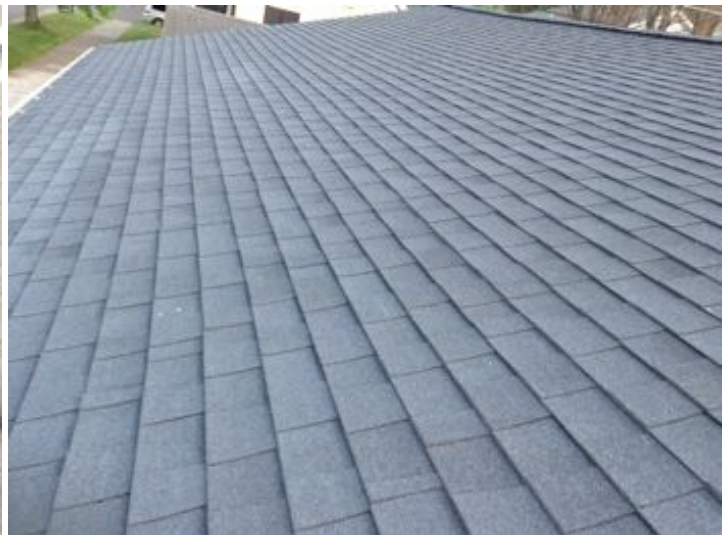
Observations: **Roof appeared serviceable. No prediction of future performance or warranties can be offered.**

**1 visible layer observed**

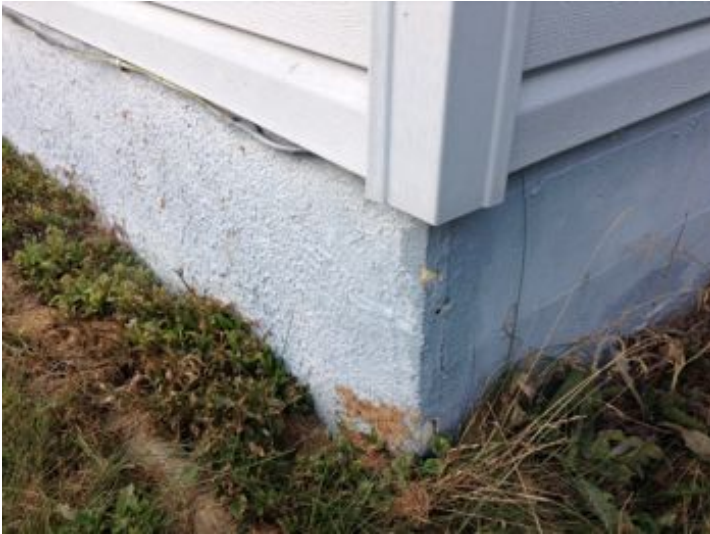
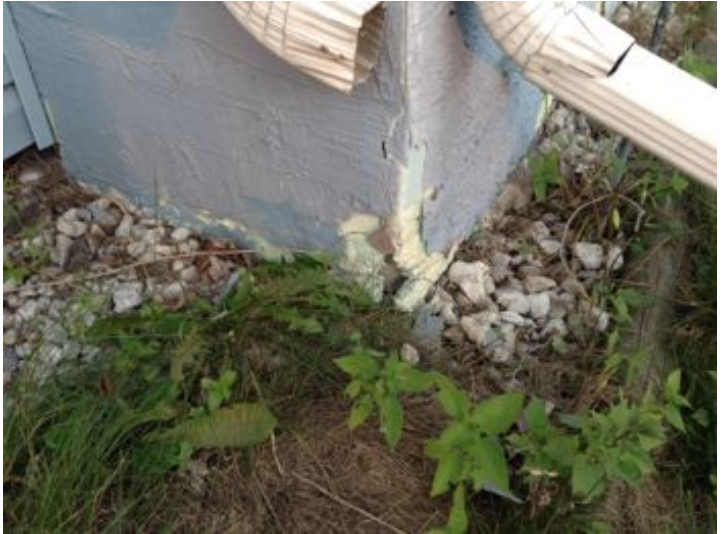
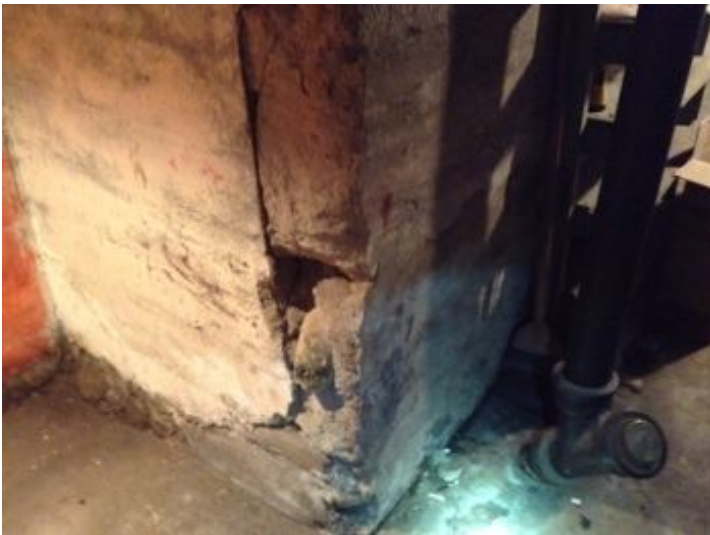
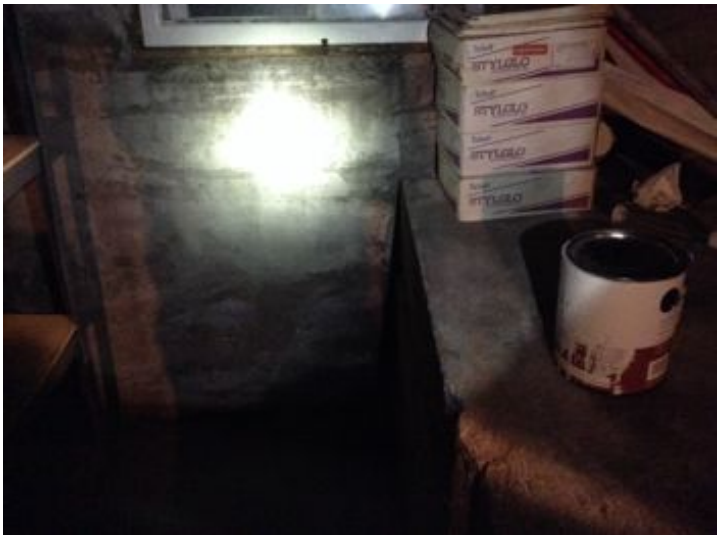
Description: **Poured concrete partial basement.**

Observations: **Appeared to be in serviceable condition, at time of inspection.**

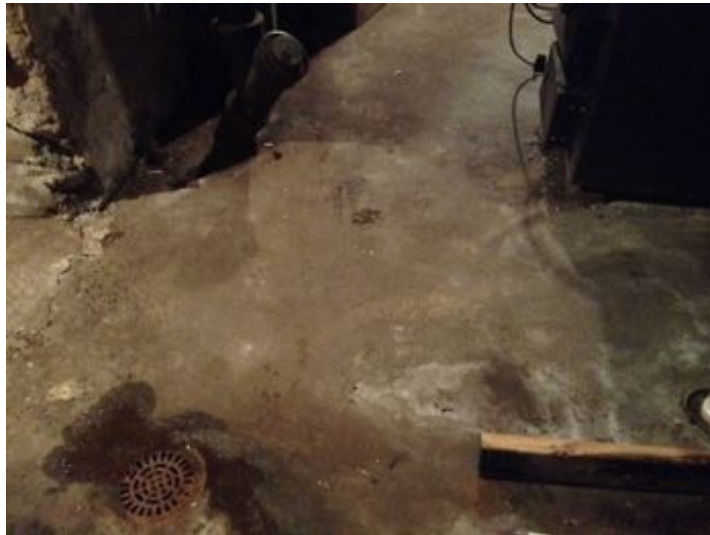
Crawl Space: **gravel floor**

Observations: **Appeared to be in serviceable condition, at time of inspection.**

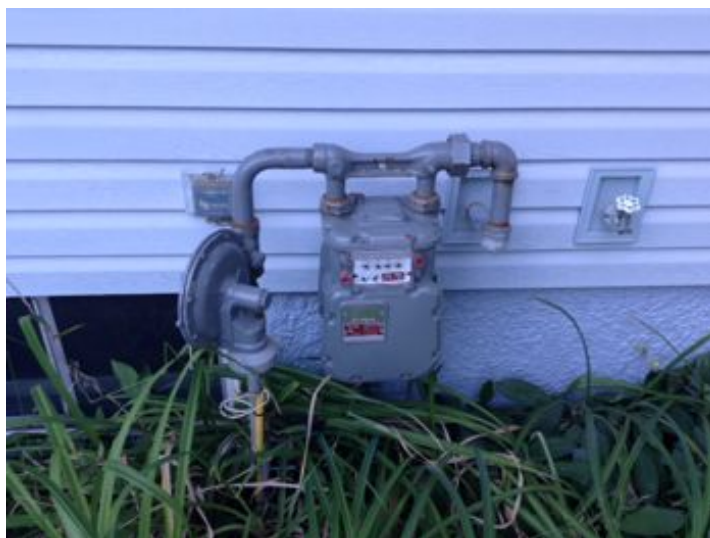
Observations: Meter located at exterior. Main shutoff is at the meter. All gas appliances have shut off valves in line at each unit. No gas odors detected.

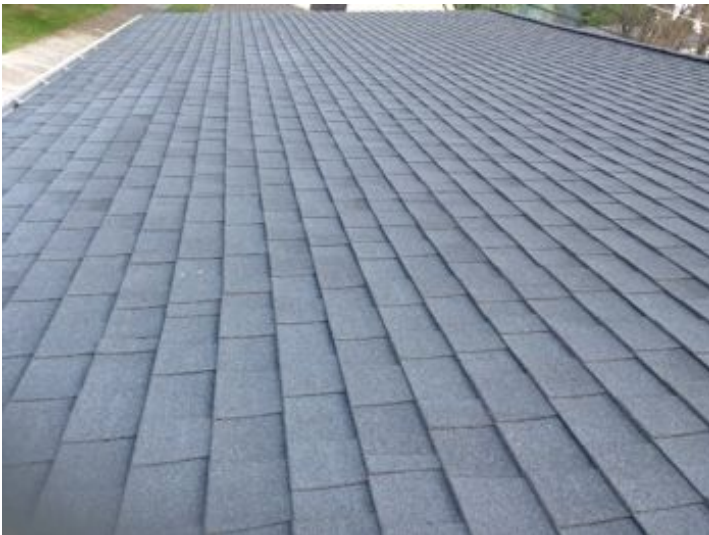
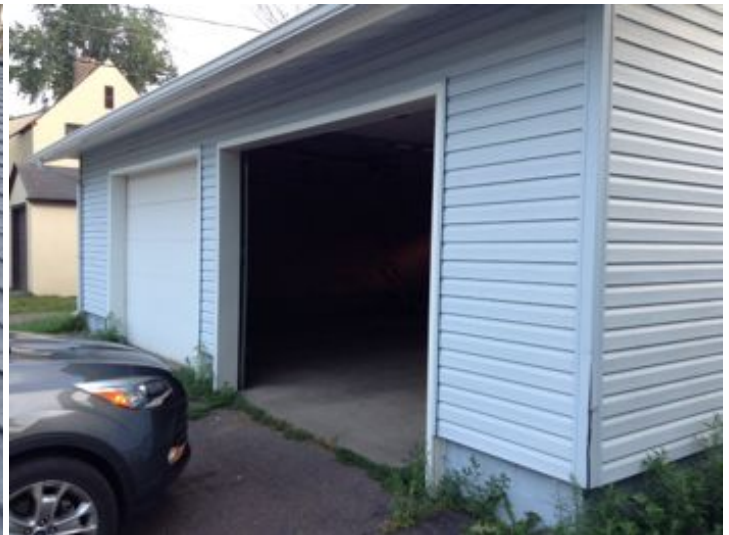
Observations: Roof appeared to be in good condition at the time of the inspection. No future warranty of roof performance is given by this statement. These shingles appear to be in the first third of their life cycle.
