1st Inspection Svcs

Home Inspection Report

1234 Sample Road, Sample City, FL 12345

Date of Inspection: 10/1/2024 Time: 9:00 a.m.

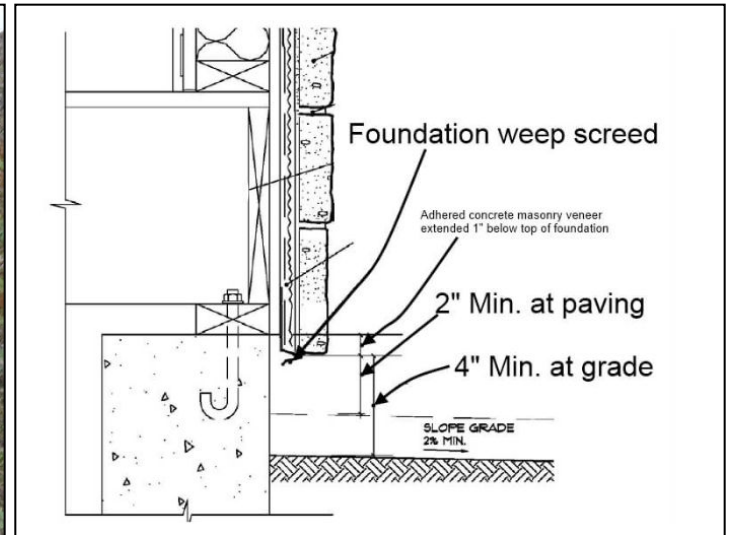
4.1. Siding to Soil contact or proximity. This may provide entrance of moisture or insects to siding. Recommend grading soil so there is at least 4" of space (where practical) between the siding and the soil below and checking for any damaged trim and siding materials.

Siding soil contact example

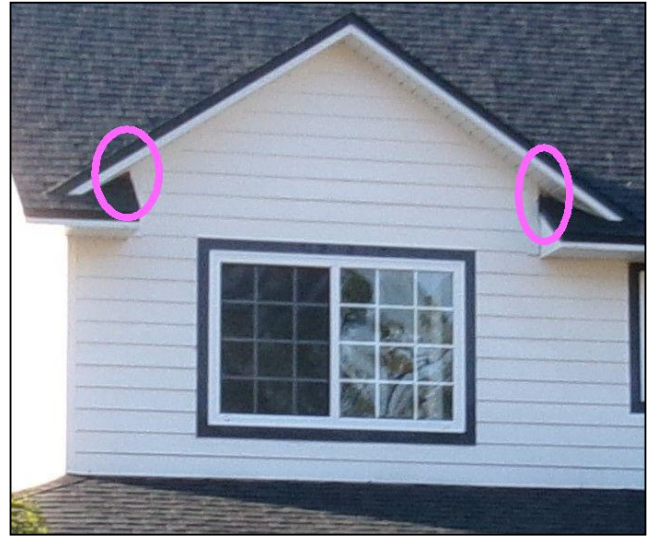
2.4. There are a few openings on the exterior walls. We recommend these be sealed as to prevent pest and moisture intrusion.

All exterior openings need sealing

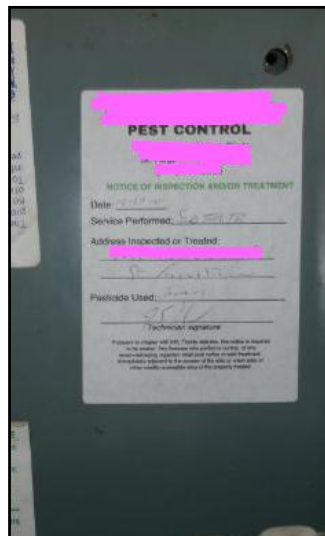
- At the time of the inspection the interior was found to be in satisfactory overall condition.
- The interior of the structure appeared to have been cared for throughout.
- We noted a pest treatment sticker from 12-17-2018 We recommend inquiring about a termite bond.

Termite treatment sticker

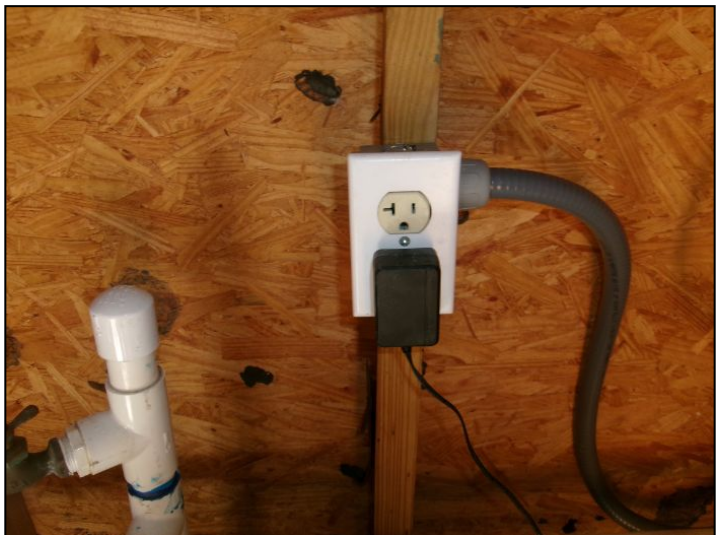
Exterior outlets not GFCI protected

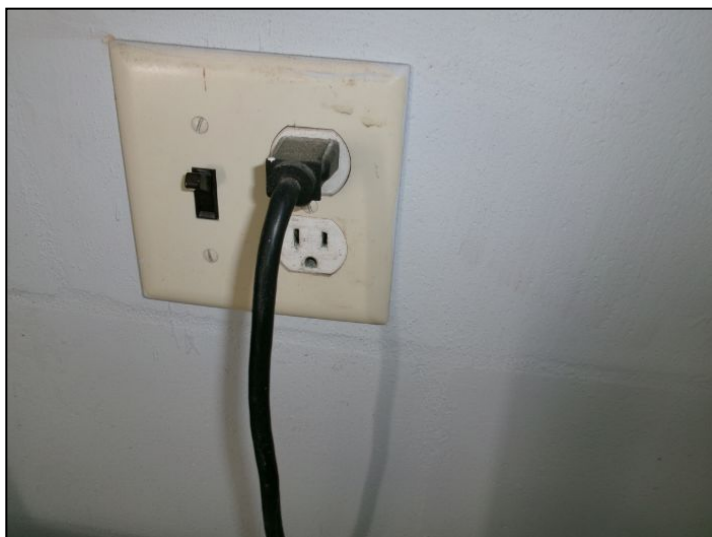
Garage outlets not GFCI protected

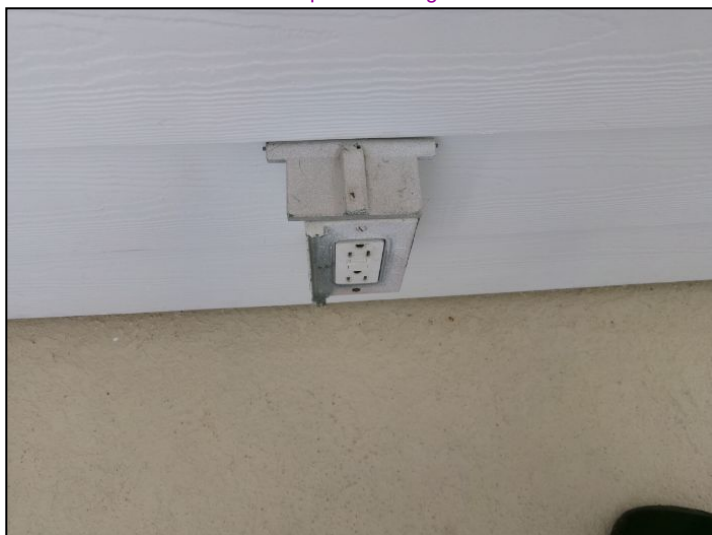
9.5. Outlet(s) on the exterior need a flat type weatherproof cover installed, when under a four foot overhang.

Outlets need weatherproof covers installed

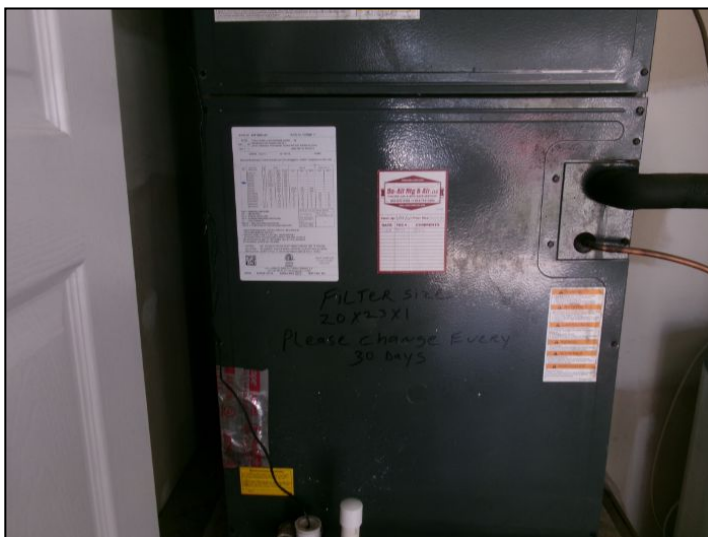
Air handler

- 1.7. The air handler was located in the garage and was in satisfactory condition and was equipped with a condensate drain overflow warning or shutoff device, the device if installed was not tested.

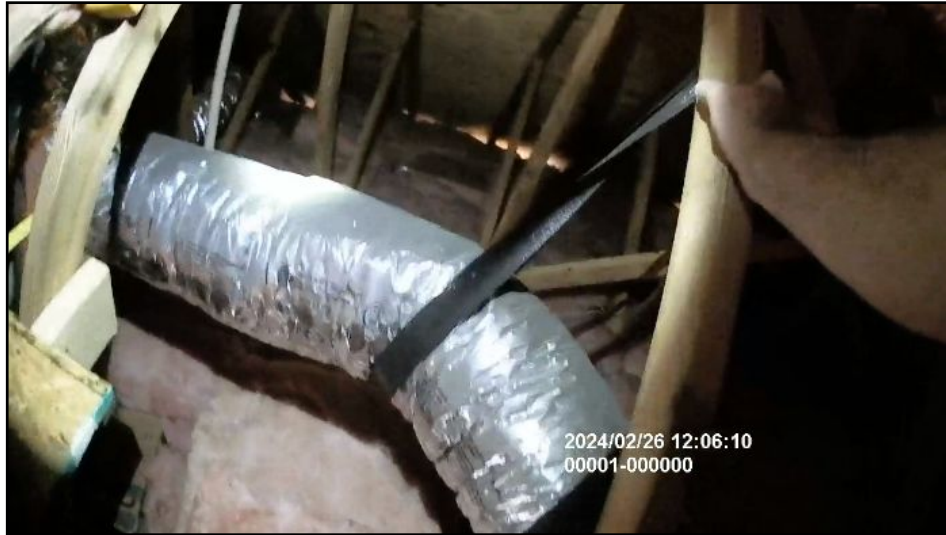
Ductwork

- The exposed and accessible **ductwork** was visually inspected only and found to be in satisfactory condition with exceptions noted.
- We recommend periodically inspecting the ductwork to check the **vapor barrier** and prevent leakage of warm or cool air from the system.
- For fire prevention reasons, it is always recommended for new homeowners to clean out the dryer ducts to ensure no lint build up or blockage exists. [Click here for more information.](#)

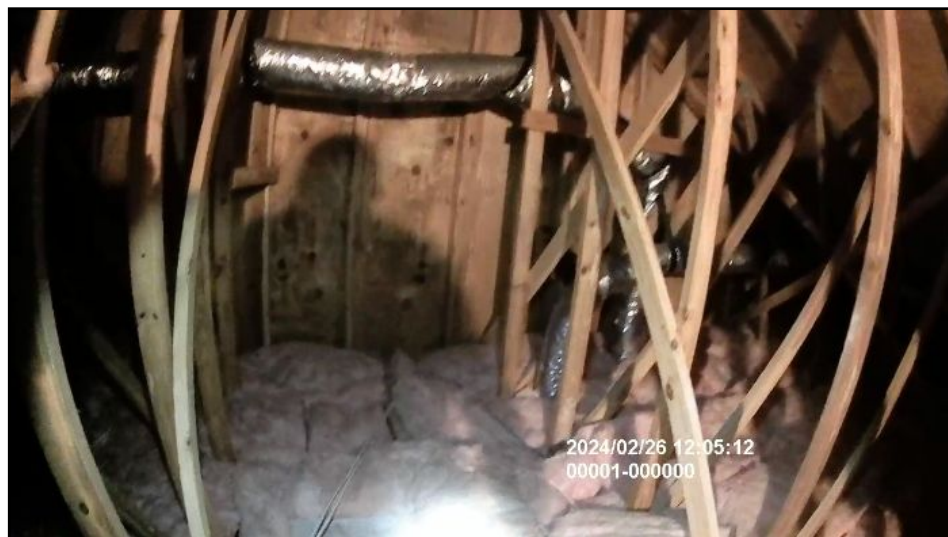
Insulation average depth

- At the time of this inspection we found the insulation to be in satisfactory condition with any exceptions noted.
- The attic area over the main structure was insulated to an average depth of 10-14 inches and less in some areas. [Click here for energy saving tips.](#)

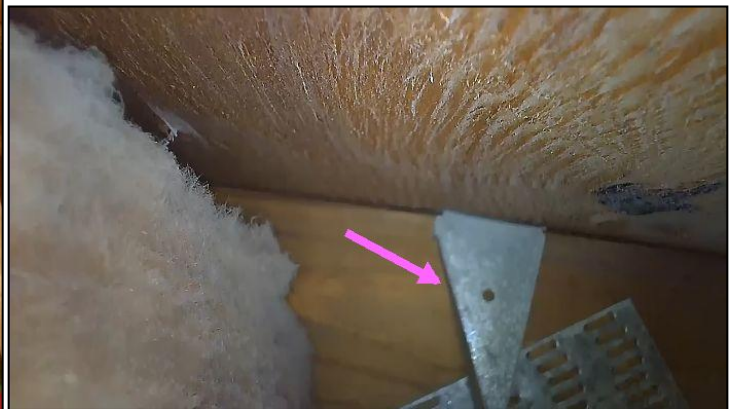
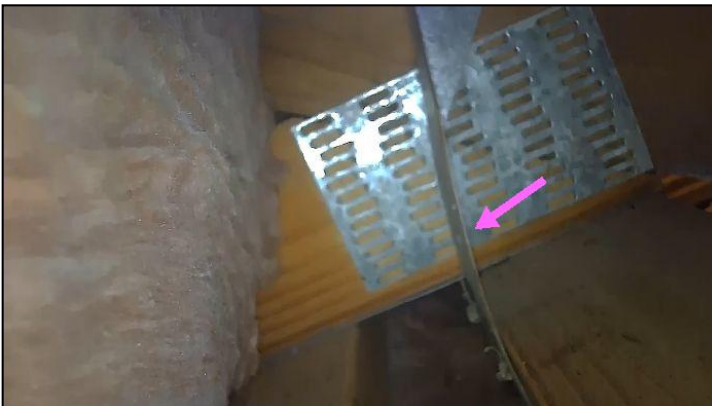
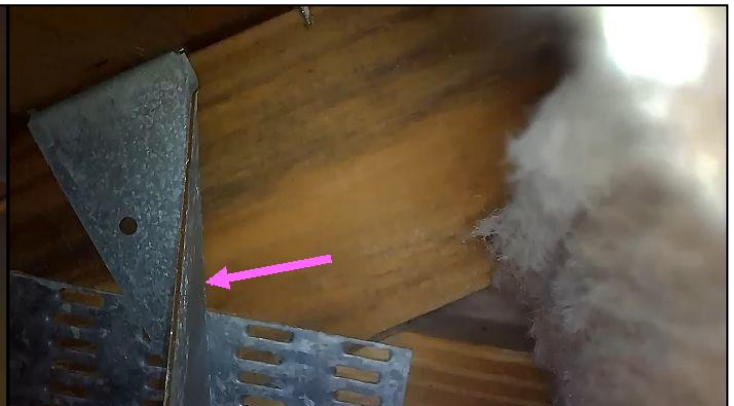
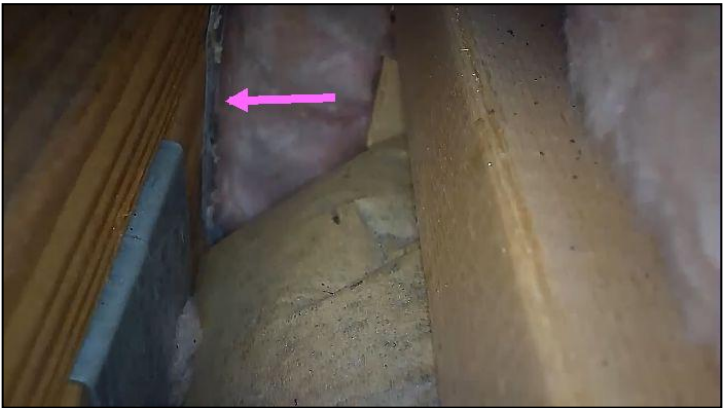
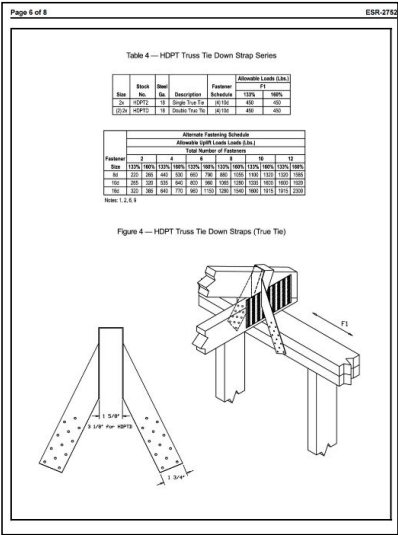
- Hurricane straps and/or clip fasteners were noted on a sampling of trusses where visually accessible.

Hurricane straps and/or clip

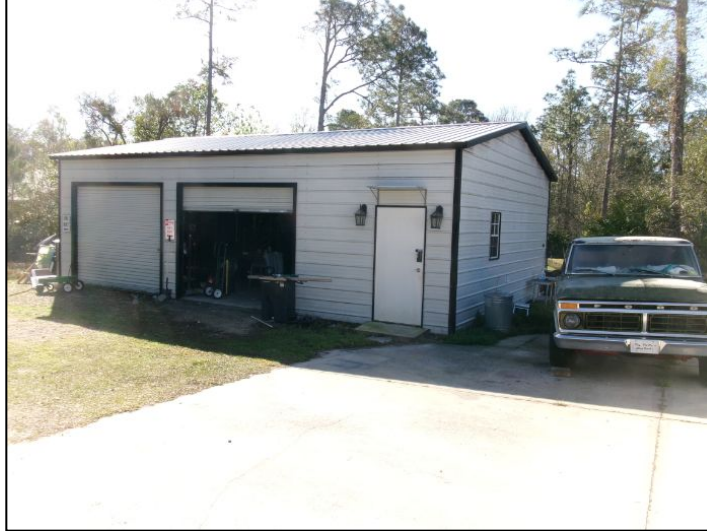
Outbuilding

- At the time of the inspection, we found the structure to be in satisfactory overall condition in relation to other buildings of a similar age and style of construction.
- The building is a single story metal frame structure on concrete slab with a gable type roof design.
- We did not find any visual evidence of major structural deficiencies or defects.

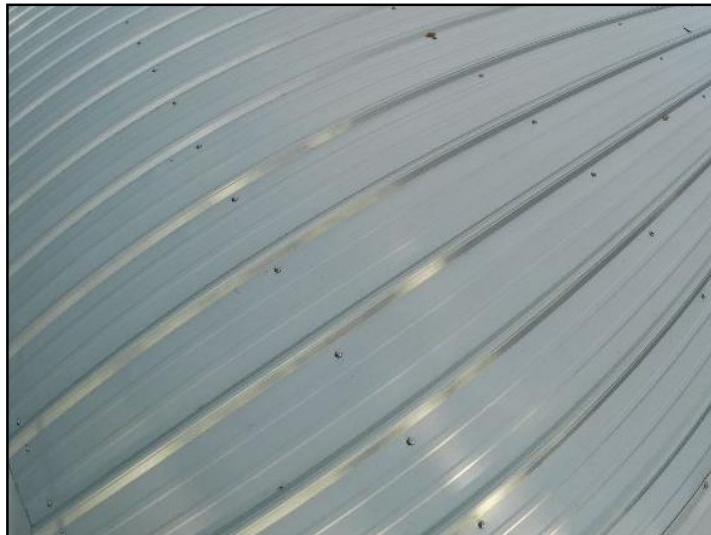
Metal roof

- The roof was inspected from a ladder around the perimeter of the dwelling. Walking on the surface could cause damage.
- The roof surfaces were inspected visually. Accessible attic areas, eaves, and interior ceilings were checked for signs of leakage.

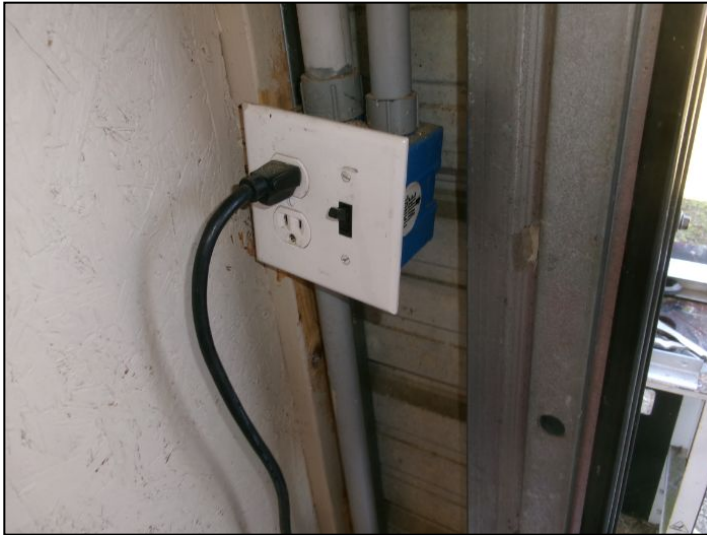
- 5.1. Panel was a hand made panel and not UL rated, recommend evaluation by a licensed electrical contractor.
- 5.2. Outlets in the building were not GFCI protected. We recommend these be replaced with GFCI outlets as to avoid a shock/short hazard.
- 5.3. Wiring entering the panel did not have proper protection. We recommend a grommet/bushing be installed as to prevent a shock/fire hazard.
- 5.4. Multi lugged neutrals inside panel box (more than one electrical conductor attached). This is not standard practice, and may cause overheating or even an electrical fire. Recommend evaluation by a licensed electrical contractor.

Outlets not GFCI protected

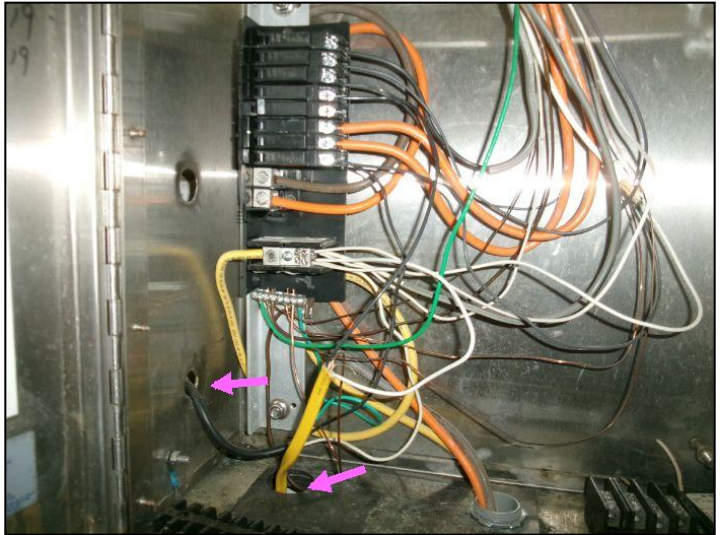
Wires not protected by grommet

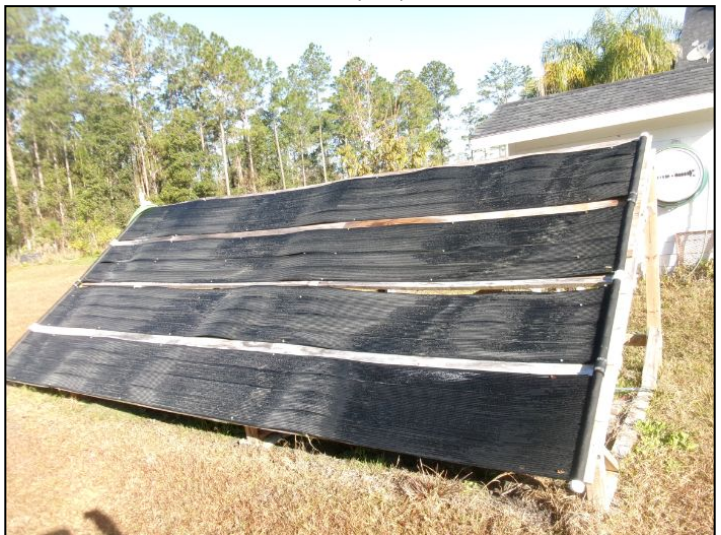
- A visual inspection was performed on the pool, deck and equipment. At the time of the inspection, the variable speed pool pump, cartridge filter, timers, and pool lights were operational.
- We did not find evidence of major displacement or shifting to the deck based on our visual inspection. We did not note any cracking to the interior of the pool surface.
- Typical concrete/marcite style pools are constructed using concrete (usually approximately 6" shotcrete) over a reinforced steel "cage", then installing approximately 1/2" of a trinity white cement/marble dust finish for cosmetic appearance.
- We recommend contacting a licensed pool contractor to repair as necessary and/or for general servicing, water quality testing, maintenance, etc.
- The solar pool heater was not operational at the time of the inspection.

Solar panel not tested
