# PROPERTY INSPECTION REPORT

**1234 Beach Blvd**  
**Inspection Prepared For: John Doe**  
**Agent: Janette Ledea - Remax Tri-City**

**Date of Inspection: 3/12/2026**  
**Age of House: 1924 102 yrs old Size: 1362 SqFt**  
**Weather: Sunny & Hot**

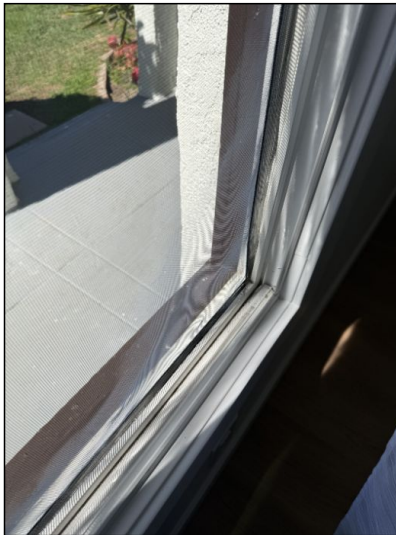
| Interior Areas | | | |
|---|---|---|---|
| | Page 9 Item: 8 | Window Condition | • loose screen bed 3 |

- The windows were tested and are functional.
- loose screen bed 3

Screen loose

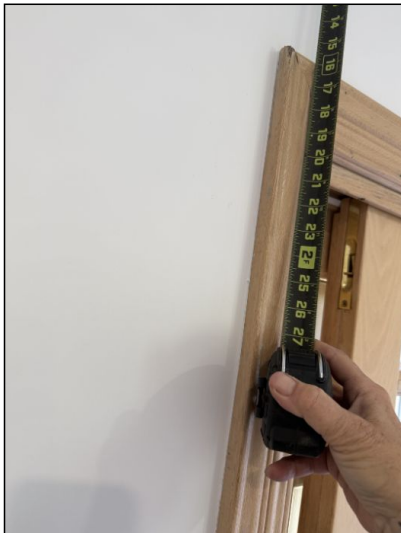
- The door frame is 16" L/S and 17" R/S. The door functions properly.

L/S 16"

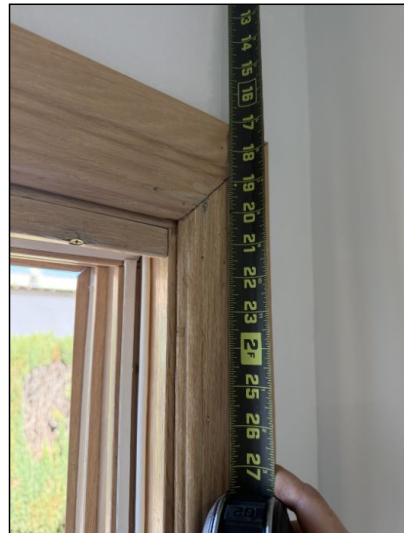
R/S 17"

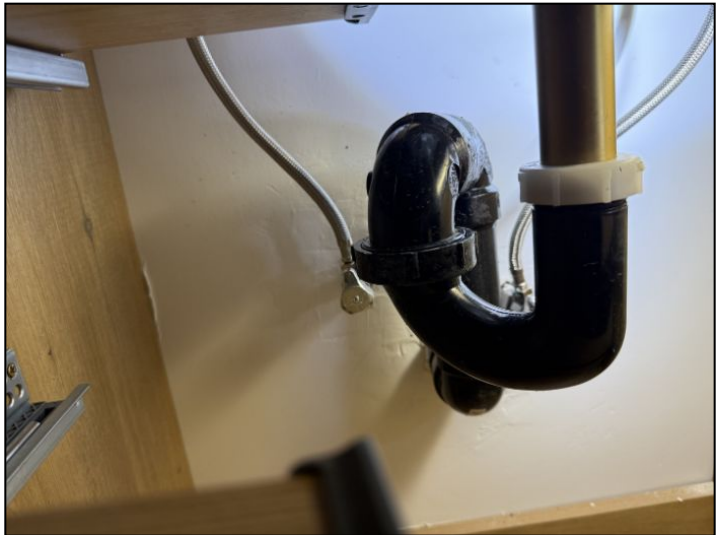
| Interior Areas | | | |
|---|---|---|---|
| | Page 12 Item: 9 | Plumbing | • Improper "S" trap noted. This trap configuration may cause the trap to siphon dry, allowing sewer gas and odour to enter the dwelling. This situation may be rectified by the installation of an anti siphon device (cheater vent). Suggest repair by a qualified professional. In the alternative, run a little bit of water into the sink to reseal the trap if odour is detected. |

S-Trap primary

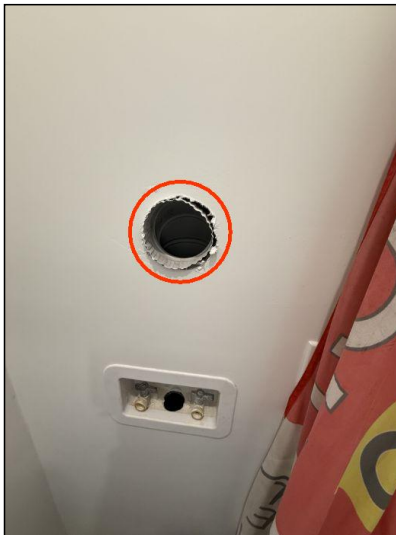
| Interior Areas | | | |
|---|---|---|---|
| | Page 17 Item: 4 | Dryer Vent | • Dryer vent wall plate missing. Recommend installing. |

- Dryer vent wall plate missing. Recommend installing.

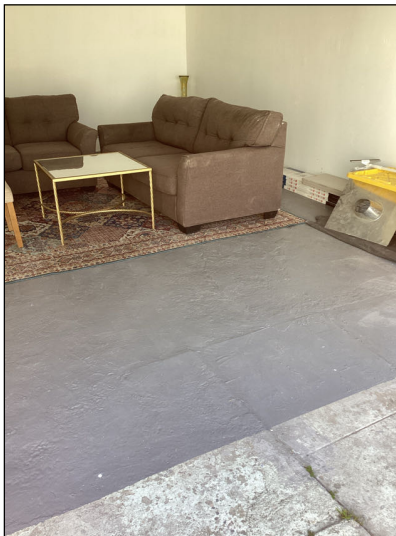
- Evidence of repairs observed, unable to determine the effectiveness of these repairs.
- Could not fully inspect garage floor due personal belongings covering.

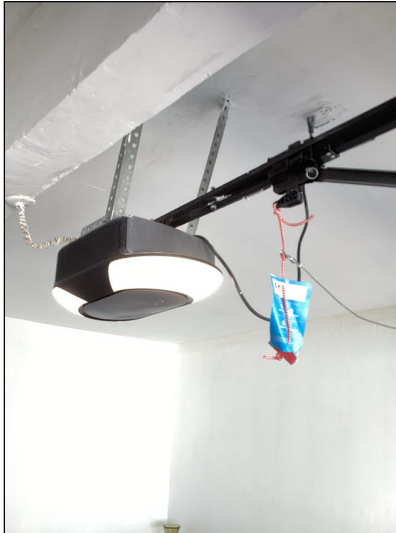
- Belt drive opener noted.

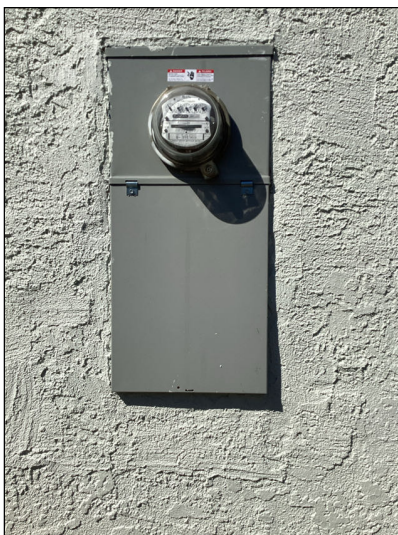
- Panel cover screw(s) missing.
- Dead front cover very difficult to remove and install.

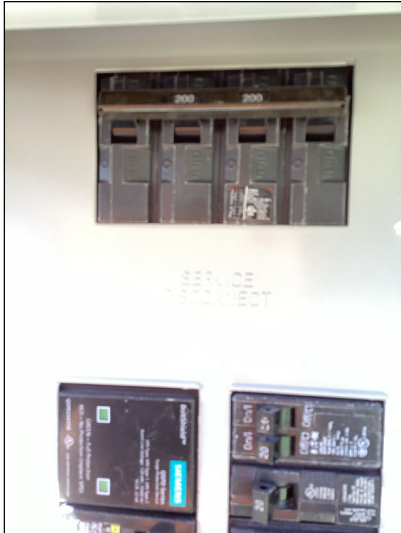
## 2. Main Amp Breaker

- 200 amp main breaker.

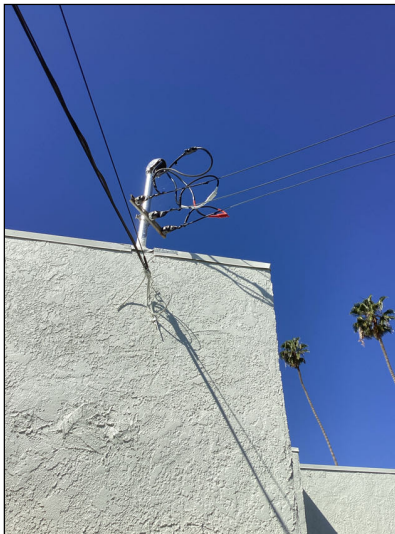
- There is an overhead service drop noted.

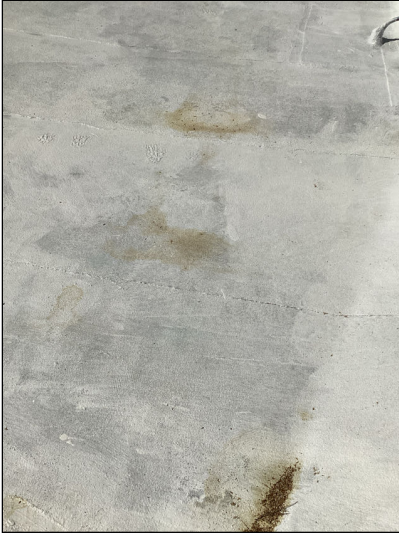
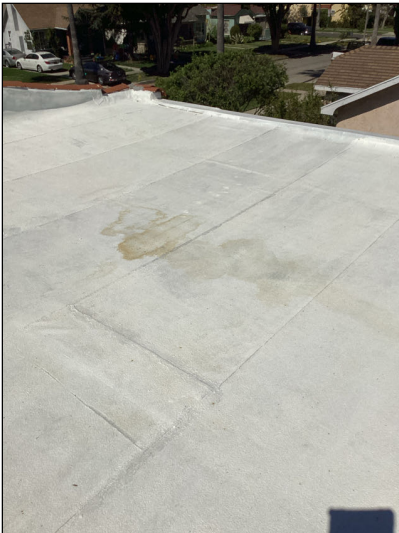
## 1. Roof Condition

- No major system safety or function concerns at time of inspection.
- Condensation noted near package unit.

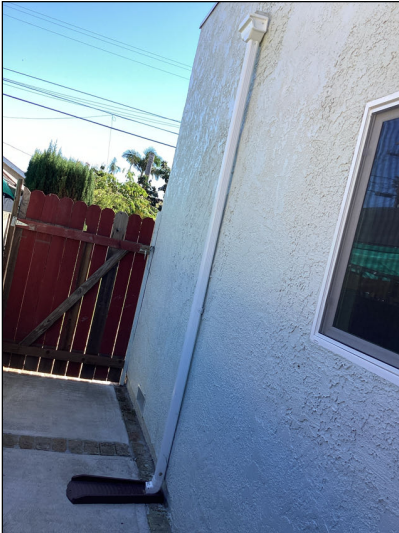
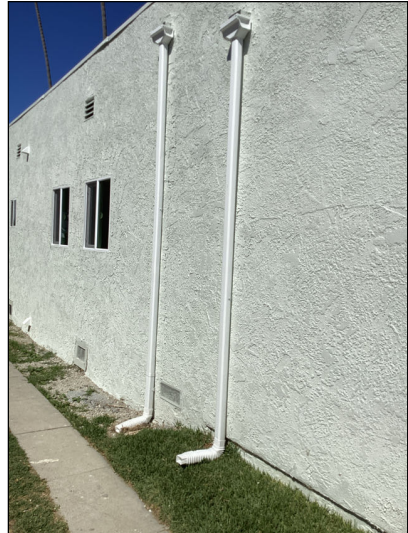
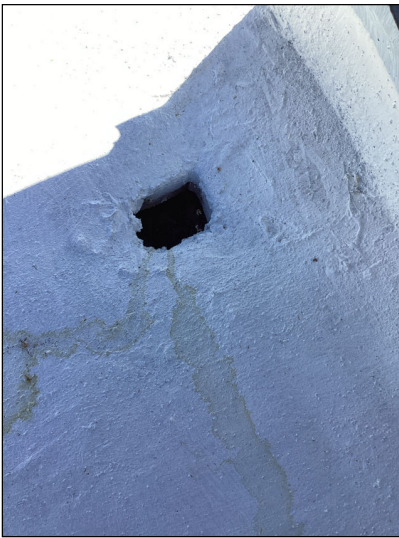
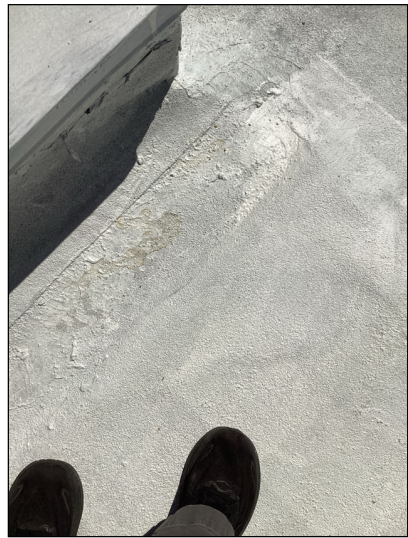
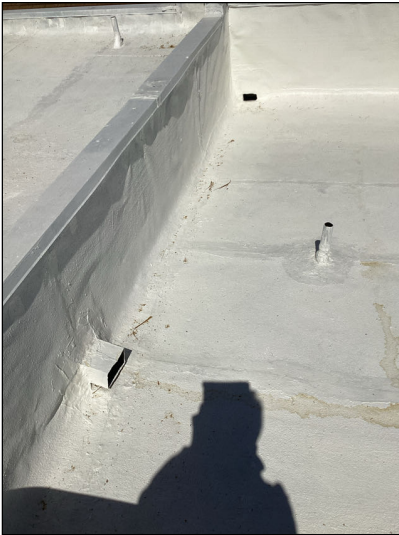
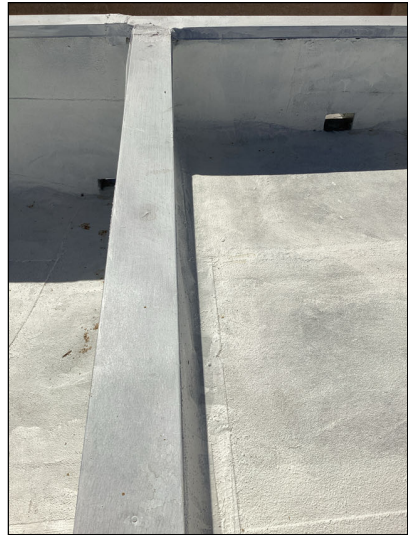
## 3. Gutter

- No major system safety or function concerns noted at time of inspection.

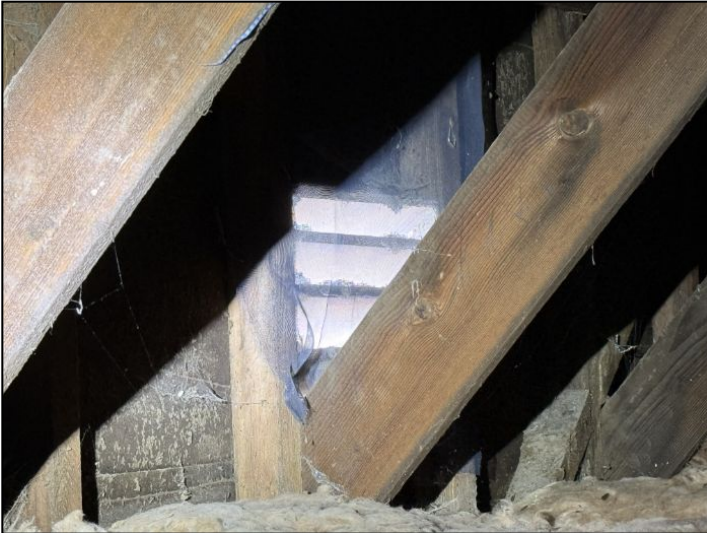
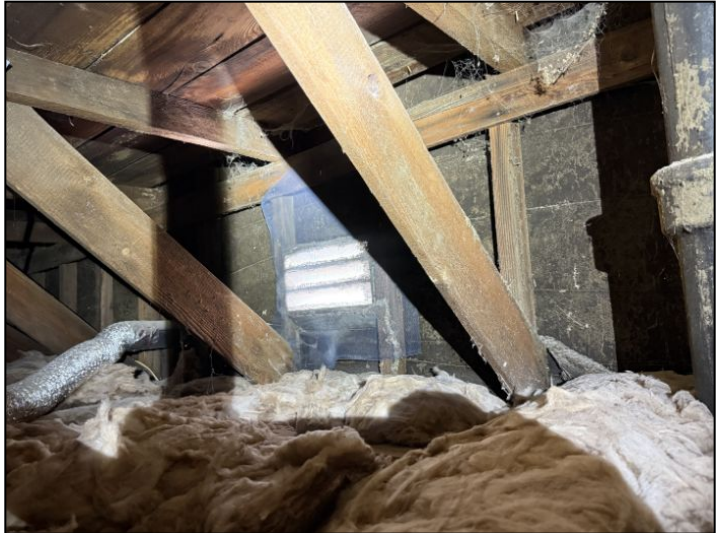
### 3. Ventilation

- Gable louver vents noted.

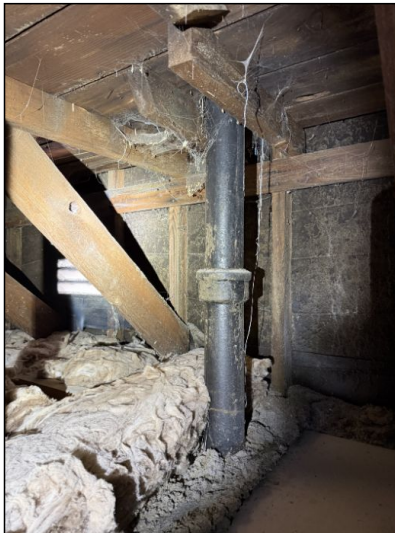
- No deficiencies noted in plumbing vent piping.

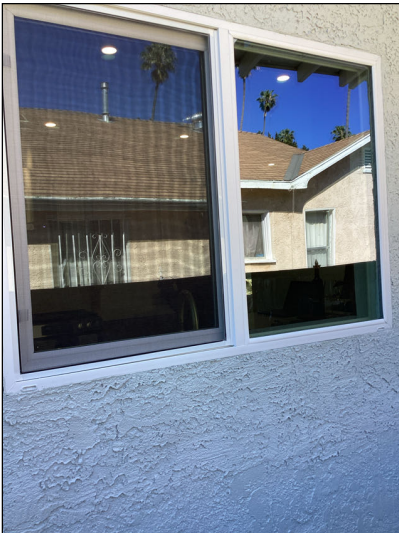
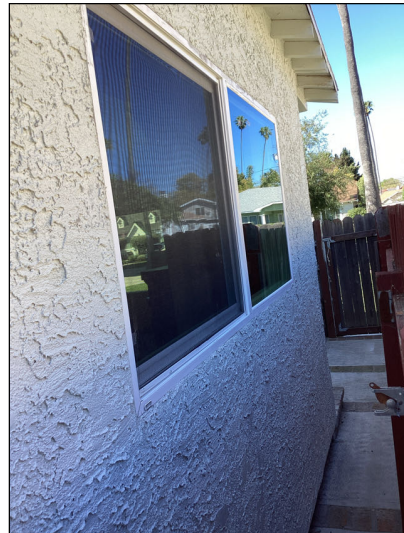
## 2. Window Condition

- Components appeared in satisfactory condition at time of inspection.

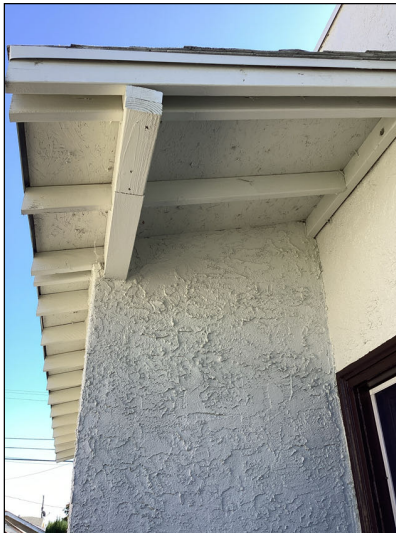
### 3. Eaves & Facia

- No discrepancies noted at time of inspection.

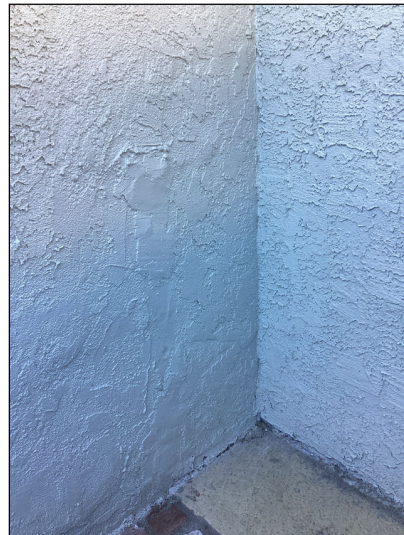
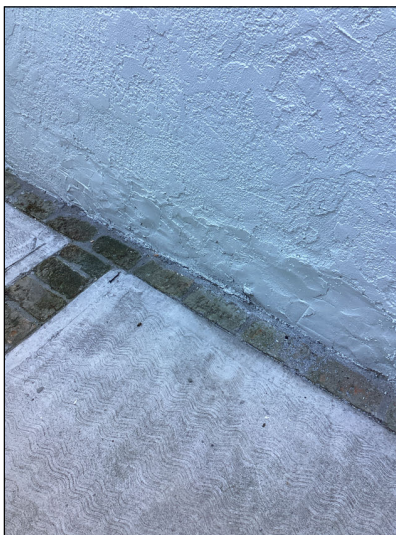
- Appeared in satisfactory condition at time of inspection.
- Cracks noted in stucco. Recommend sealing to prevent moisture intrusion and monitor.

Crack

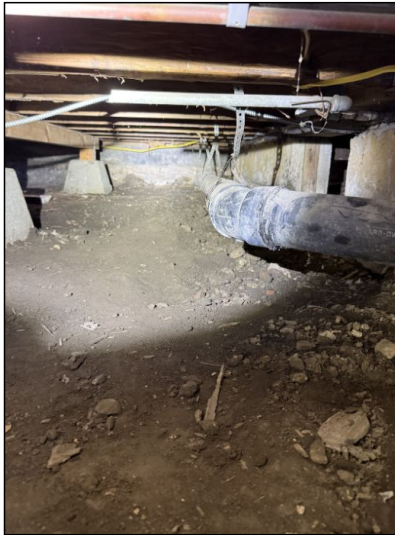
Moisture noted

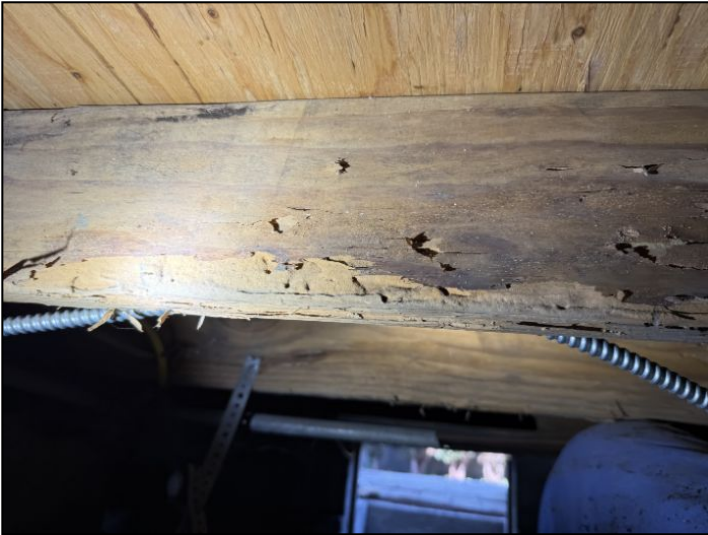
- Plywood sheathing sub floor.
- Dimensional lumber wood Joists
- Evidence of what appears to be consistent with termite damage was noted at one or more locations, recommend further review by a qualified Wood Destroying Organism Contractor to assure that no current infestation is present.

Termite eaten

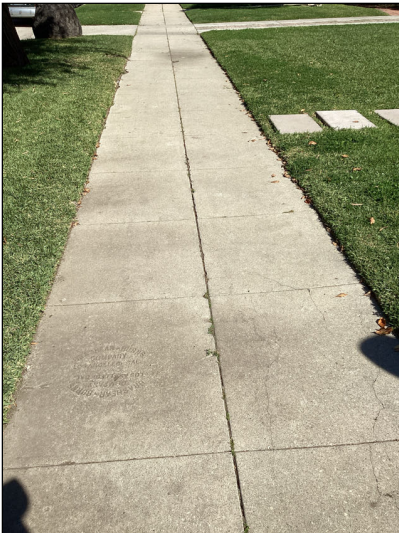
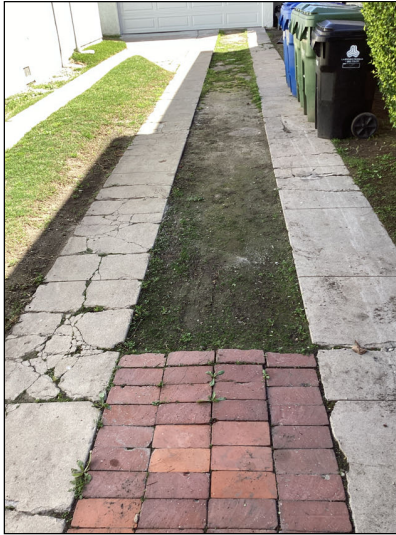
• There are numerous areas of damaged concrete surfaces. Concrete replacement is expensive. Recommend a concrete specialist provide an estimate for repair and or replacing.

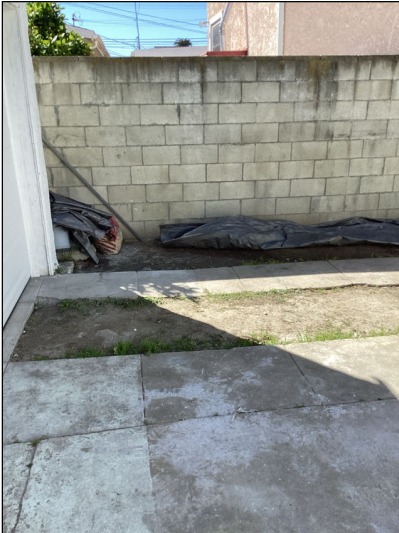
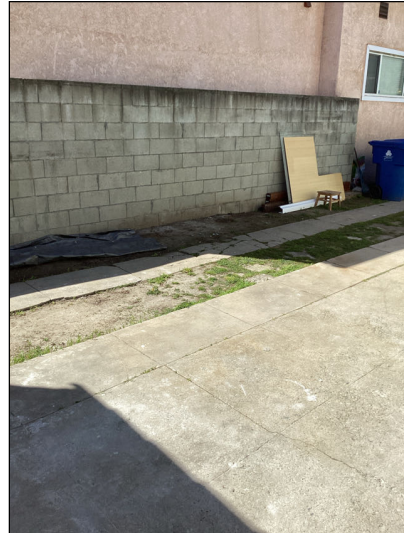
- Stress crack in block wall. Recommend monitoring.
- Appeared serviceable at time of inspection.
- Loose top blocks observed. This is a safety concern. Suggest maintenance/repairs as needed to ensure safety.

Crack
